Affiliated to Federation Internationale Des Experts En Automobile				
MS FIRST CAPITAL INSURANCE LTD 36 ROBINSON ROAD #16-01 CITY HOUSESINGAPORE 068877			Ref: CC4/FCI20009655/Ues3q2	
			Date: 14/01/2021	
			Code: FCI2

ADJUSTMENT ON REPAIR COST FOR VEHICLE NO. SMN 4073K

PHOTOGRAPHS FOR VEHICLE NO. SMN 4073K

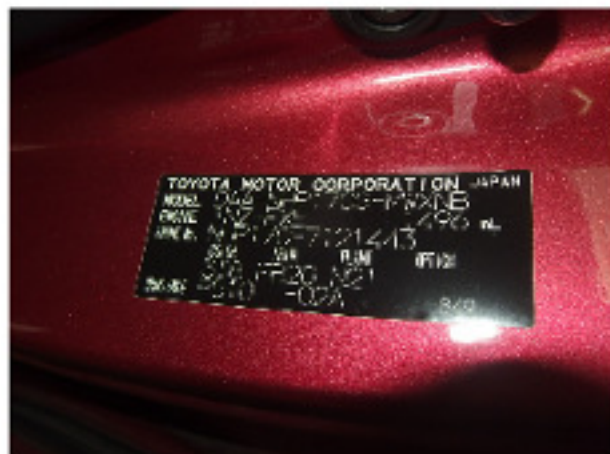
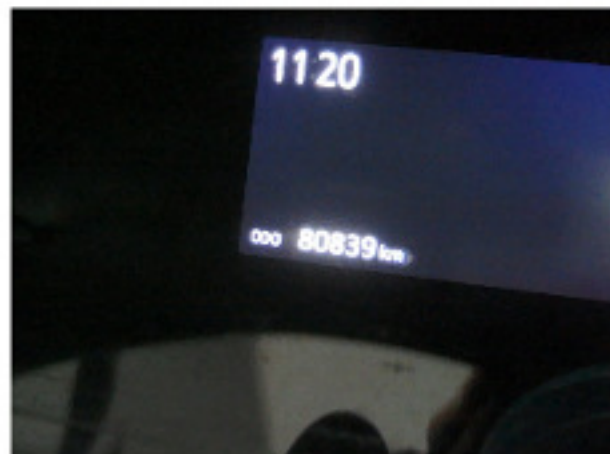
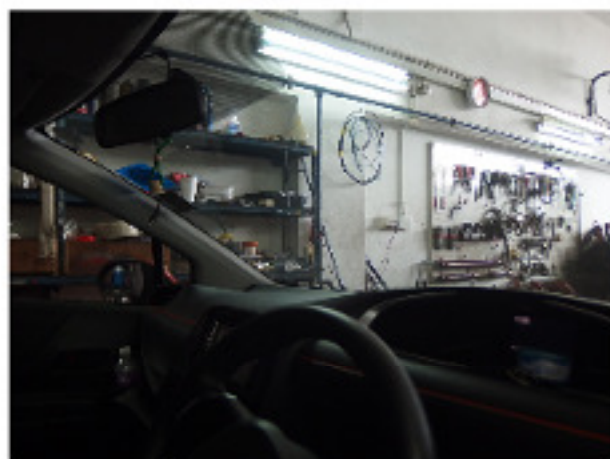
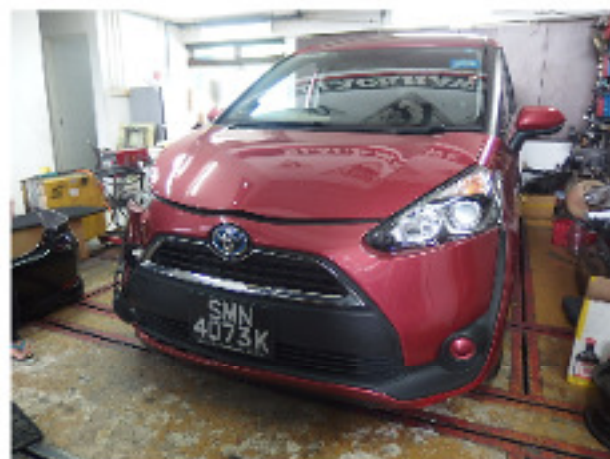
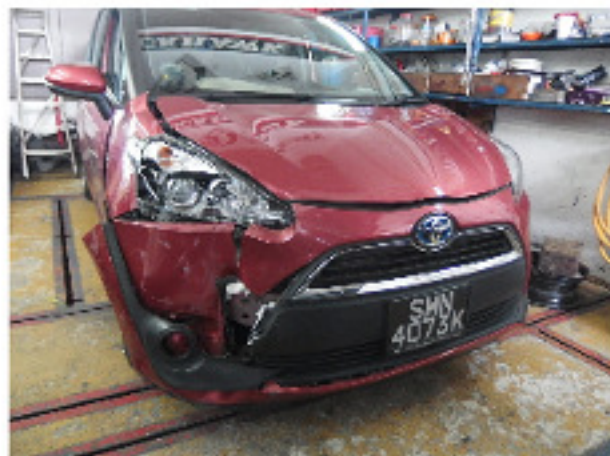
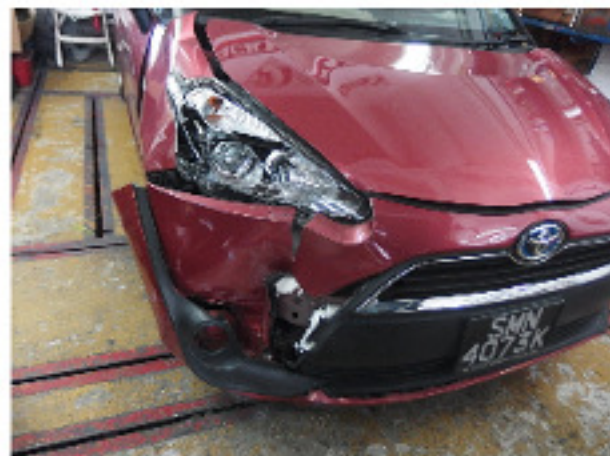
4. Description of Damages				
THE VEHICLE SUSTAINED DAMAGES AT THE FRONT O/S PORTION. DAMAGES SEE DETAILS.				
5. General Information				
Accident Date	04/09/2020	Inspection Date	09/09/2020	
Survey held at	FOCUS AUTO PTE LTD NO 1 KAKI BUKIT AVE 6 AUTOBAY #02-48 SINGAPORE 417883			
5a. Remarks				
A)THE INSPECTION WAS CONDUCTED ON A"WITHOUT PREJUDICE" BASIS. B)IN ACCORDANCE TO YOUR INSTRUCTIONS, WE HAVE NOT AUTHORISED REPAIRS.				
5b. Estimate Days of Repair				
ESTIMATED NORMAL PERIOD FOR REPAIR:			6 Working Days

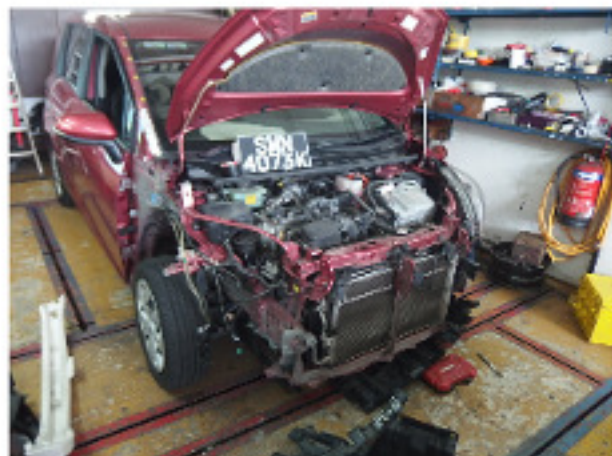
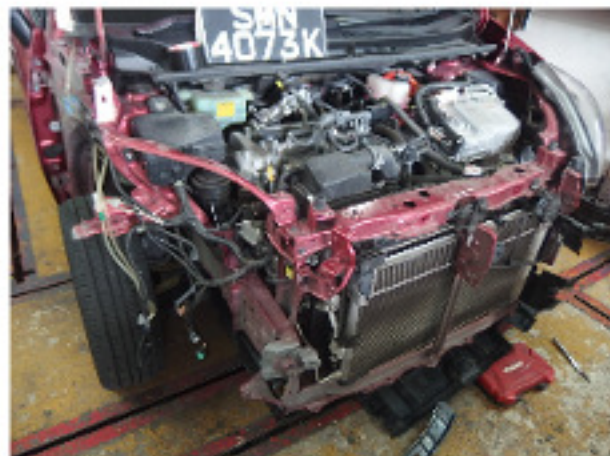
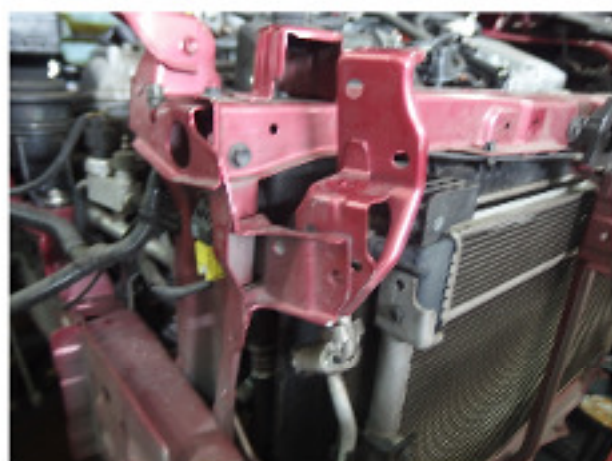
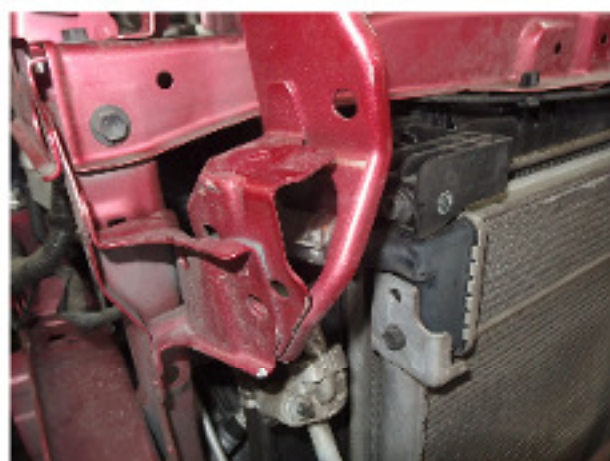
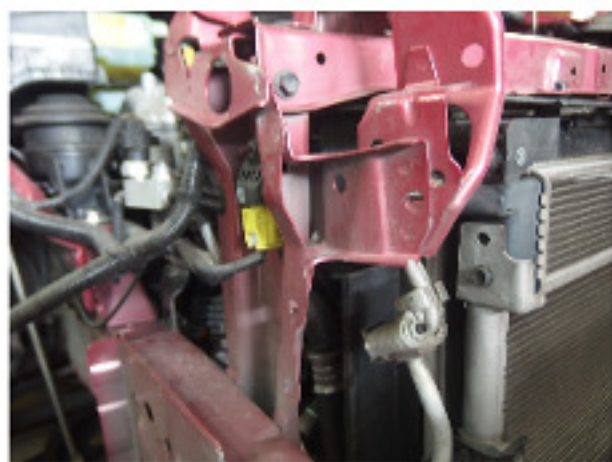
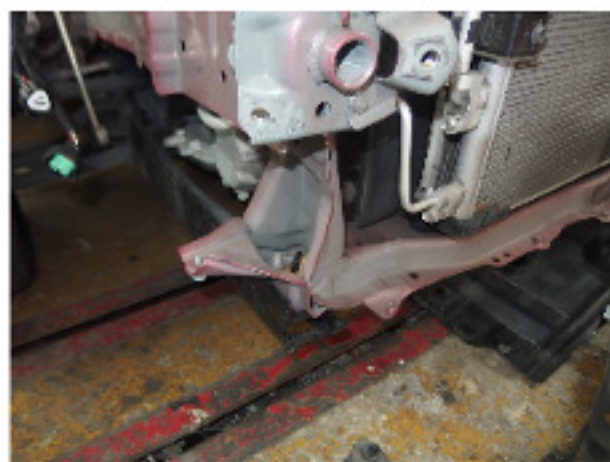
PHOTOGRAPHS FOR VEHICLE NO. SMN 4073K

RE-INSPECTION
