## LKK Auto Consultants Pte Ltd

### PROFESSIONAL SERVICE FEE

Vehicle No. SMH 4372D  
Insured Veh. SHC 2868P  
Claim No. D20003721MFSH  
Policy No. D-20094922MFSH  
Accident Date 13/09/2020  
Inspection Date 06/10/2020

## ADJUSTMENT ON REPAIR COST FOR VEHICLE NO. SMH 4372D

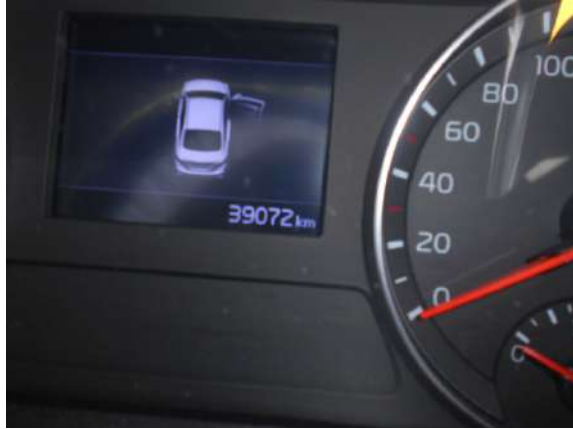
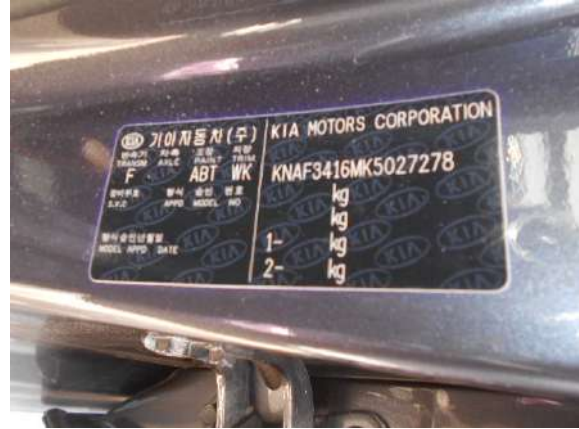
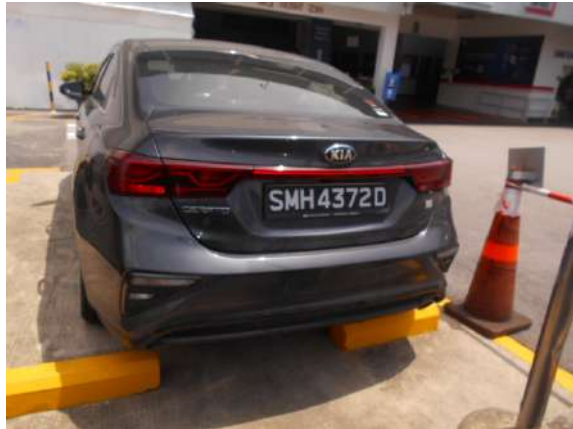
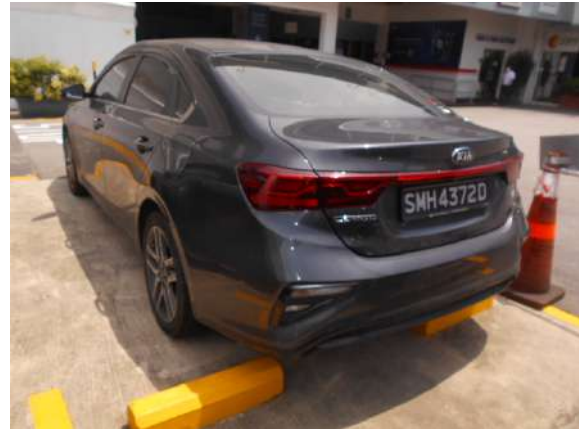
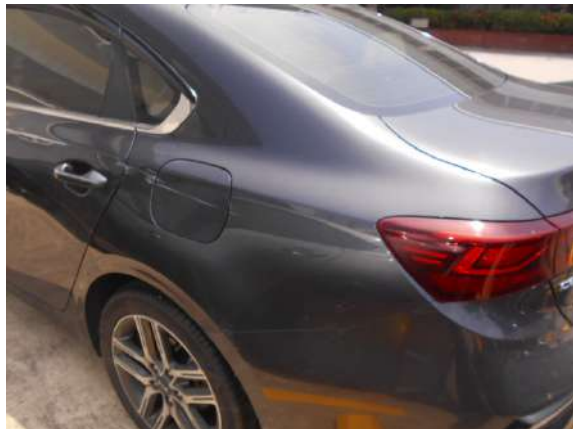
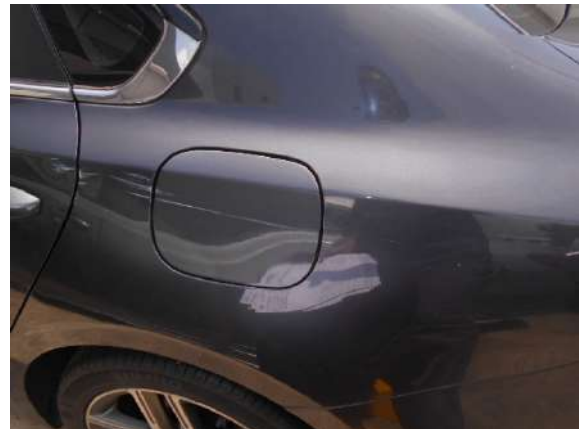
### PHOTOGRAPHS FOR VEHICLE NO. SMH 4372D

### INSPECTION

| Affiliated to Federation Internationale Des Experts En Automobile | | | | |
|---|---|---|---|--|
| THE VEHICLE SUSTAINED DAMAGES AT THE N/S BODY.<br><br>DAMAGES SEE DETAILS. | | | | |

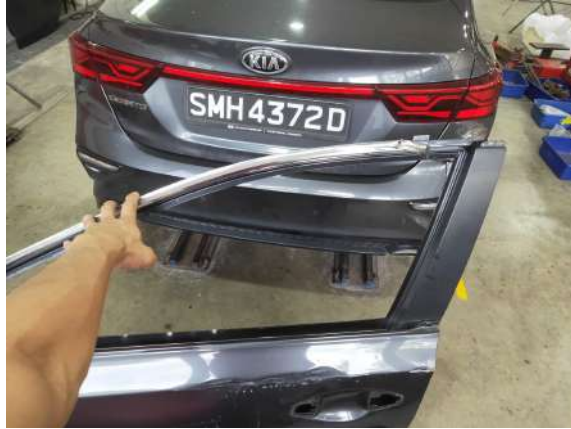
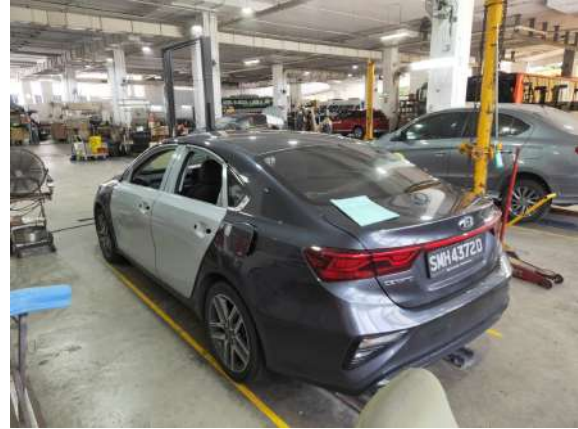
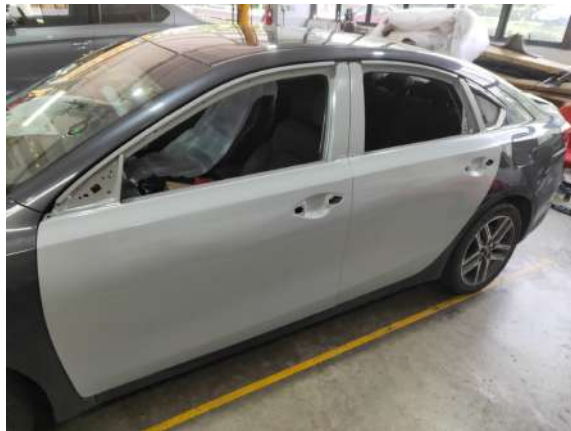
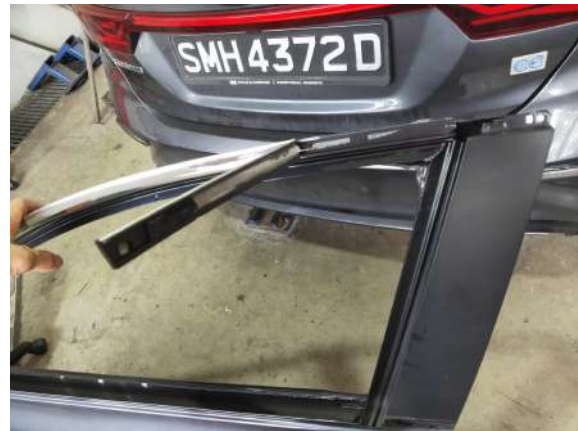
PHOTOGRAPHS FOR VEHICLE NO. SMH 4372D

RE-INSPECTION
