## LKK Auto Consultants Pte Ltd

### ADJUSTMENT ON REPAIR COST FOR VEHICLE NO. SJA 5611E

PHOTOGRAPHS FOR VEHICLE NO. SJA 5611E

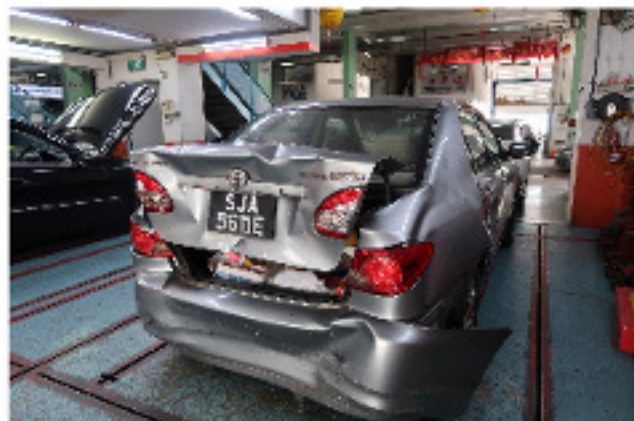
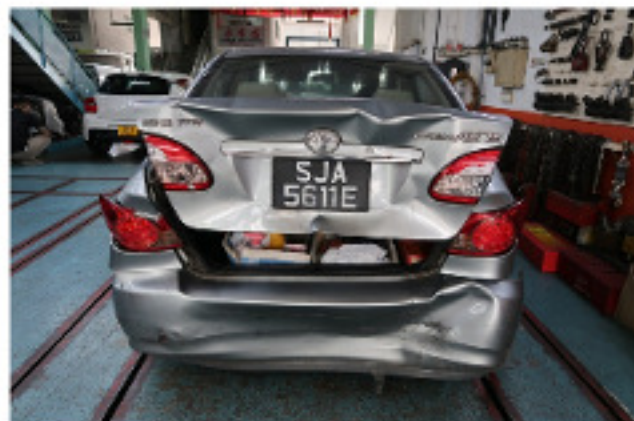
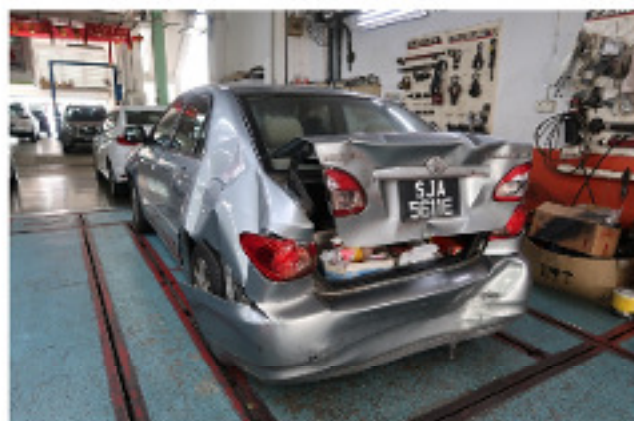
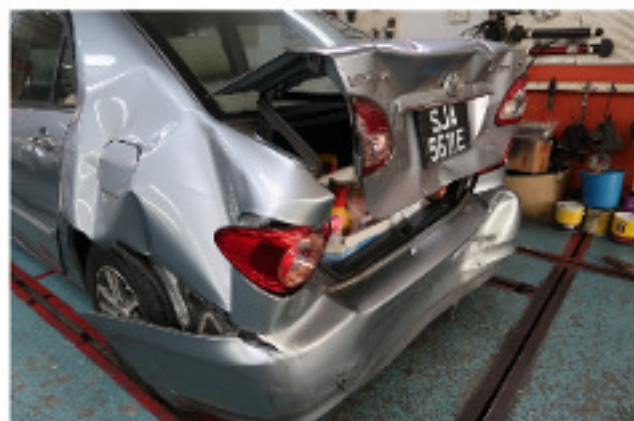
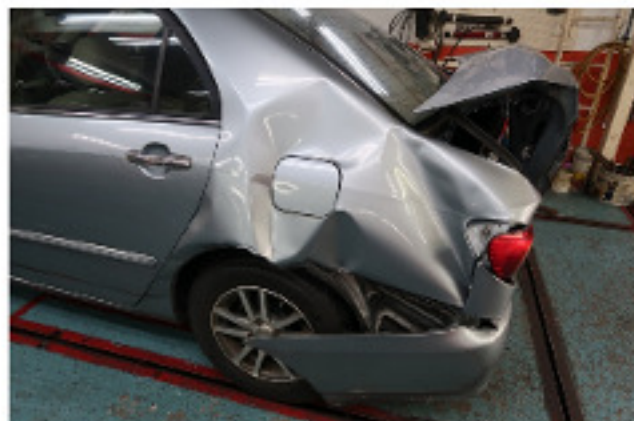
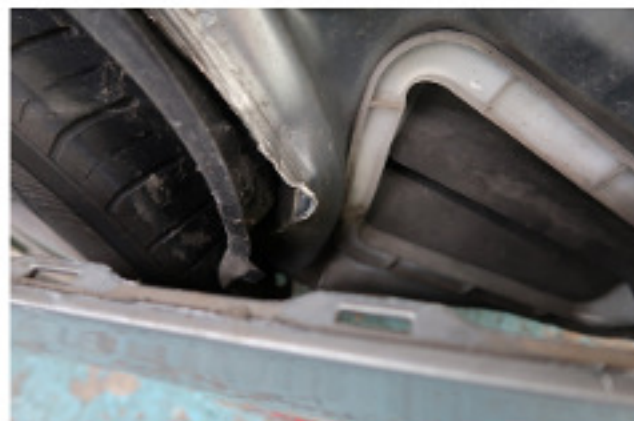
| Affiliated to Federation Internationale Des Experts En Automobile | | | | |
|---|---|---|---|--|
| | THE VEHICLE SUSTAINED DAMAGES AT THE REAR & FRONT PORTION.<br>DAMAGES SEE DETAILS. | | | |

INSPECTION

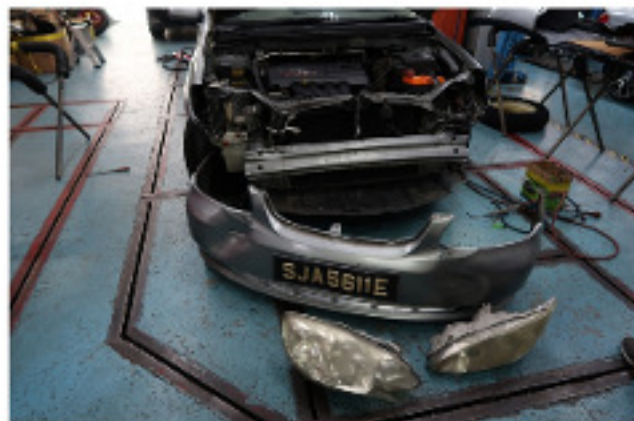
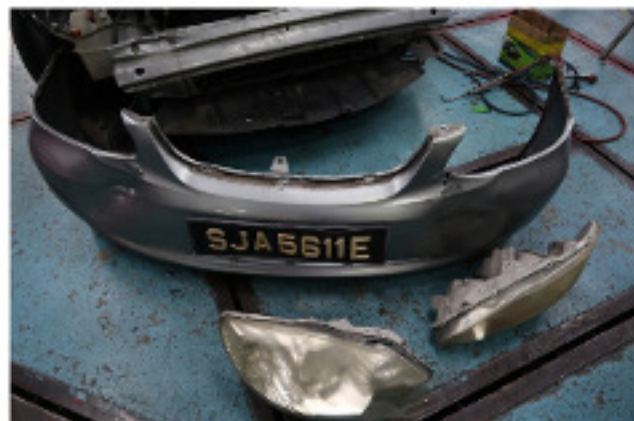
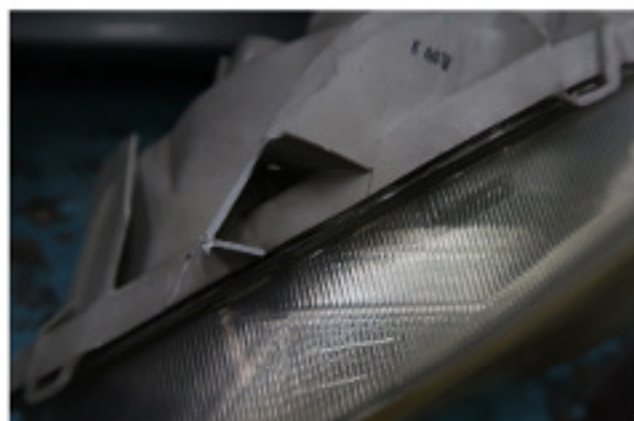
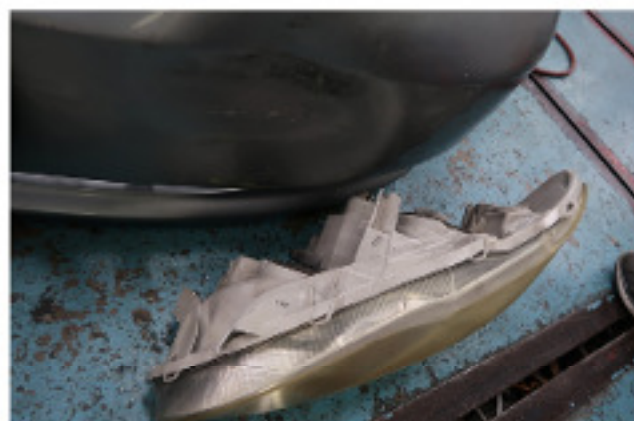
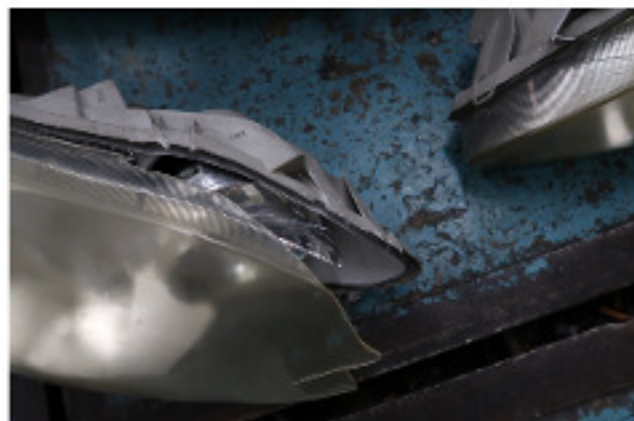
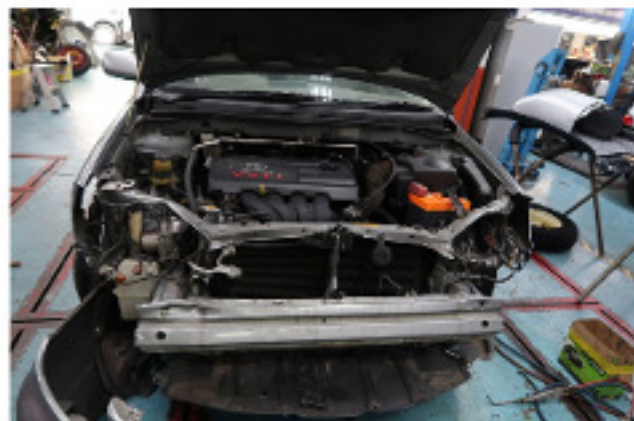
PHOTOGRAPHS FOR VEHICLE NO. SJA 5611E

RE-INSPECTION
