No.	Description	Qty	Unit Price	Total
1	To supply labour and materials to repair below mentioned vehicle to its pre-accident condition.  Vehicle: <u>SME5581B</u> Make/Model: <u>TOYOTA / NOAH HYBRID 1.8X CVT</u> Accident Date: <u>16 September 2019</u>			
			Amount Due	\$12,000.00

## ACCIDENT DAMAGED VEHICLE INSPECTION REPORT

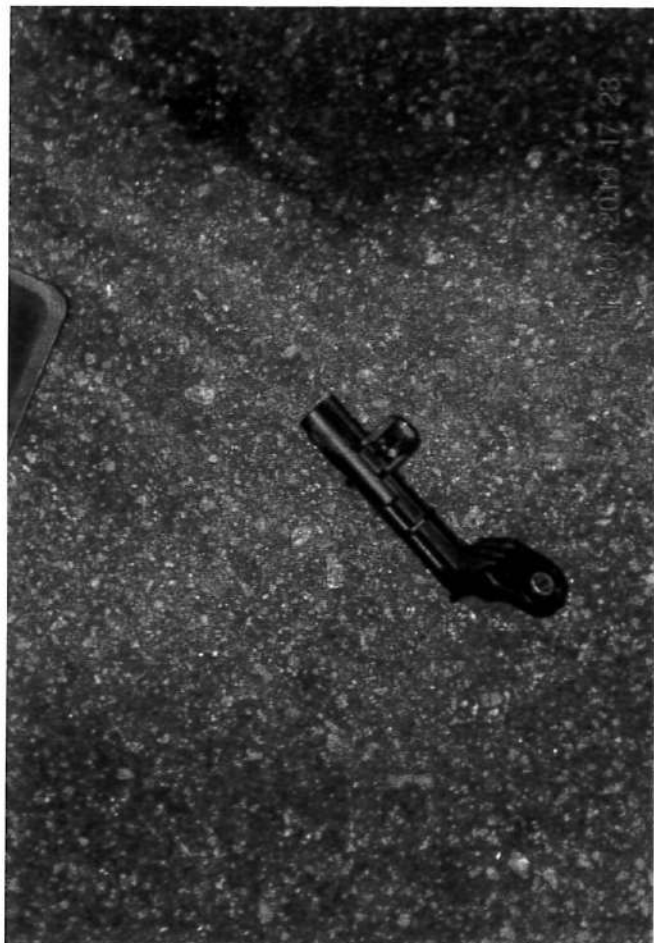
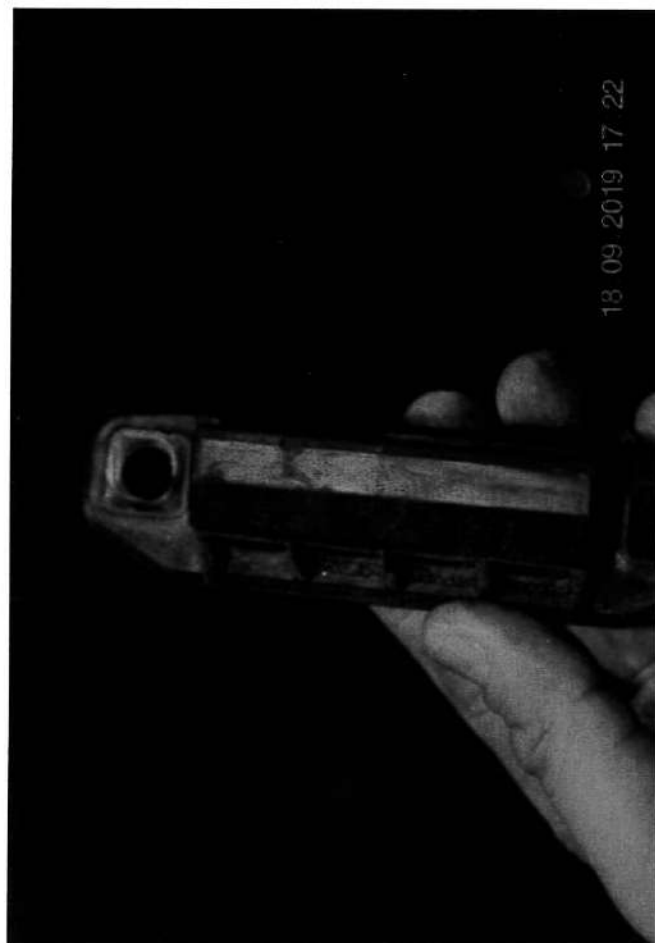
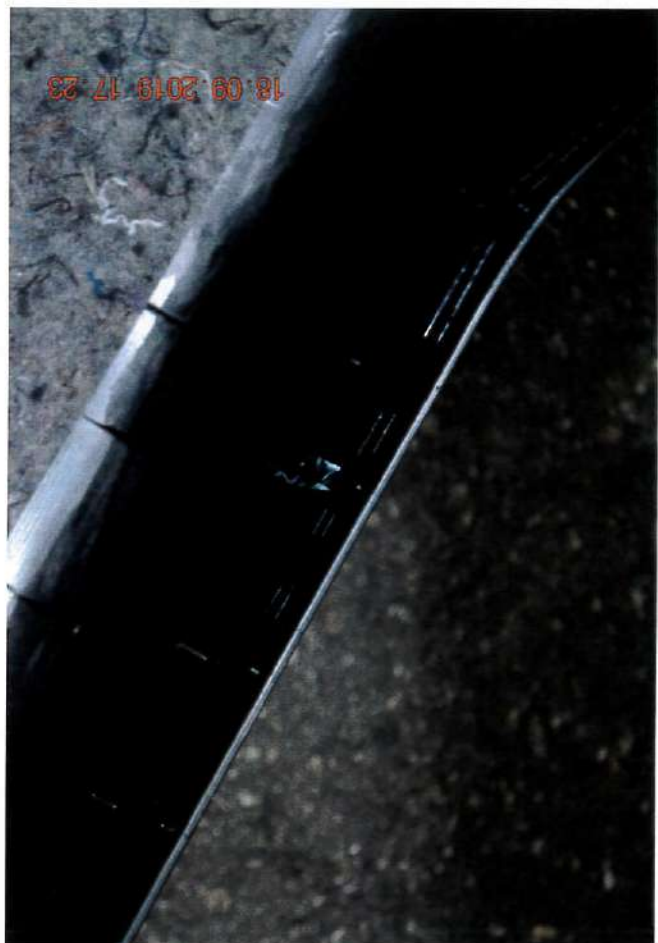
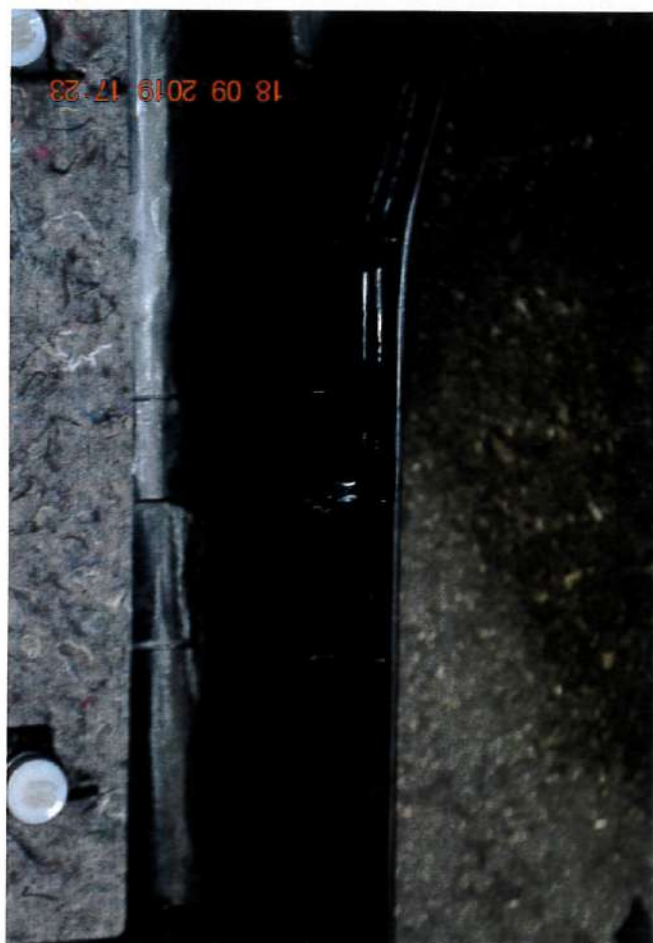
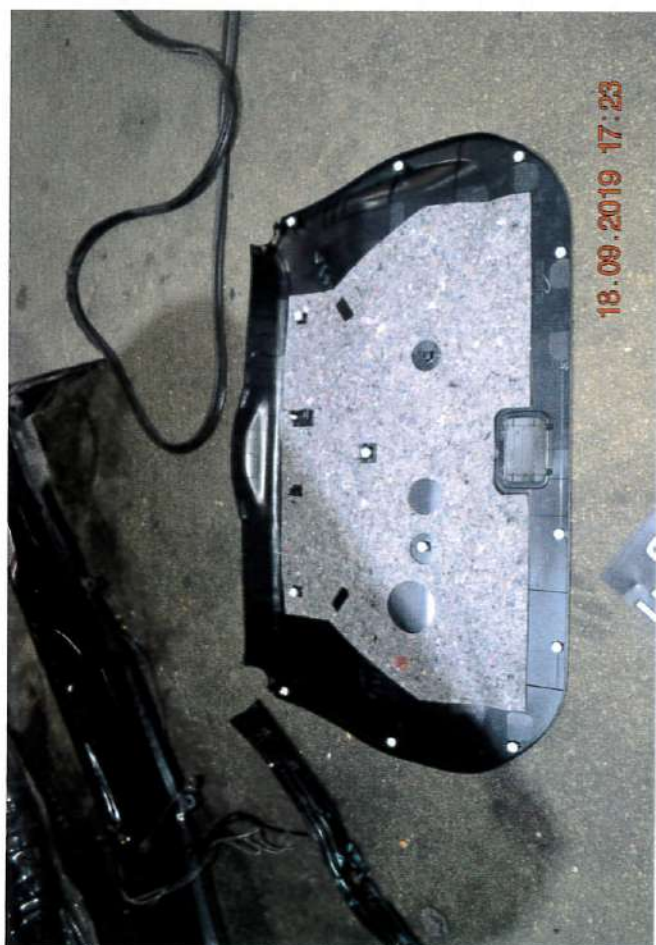
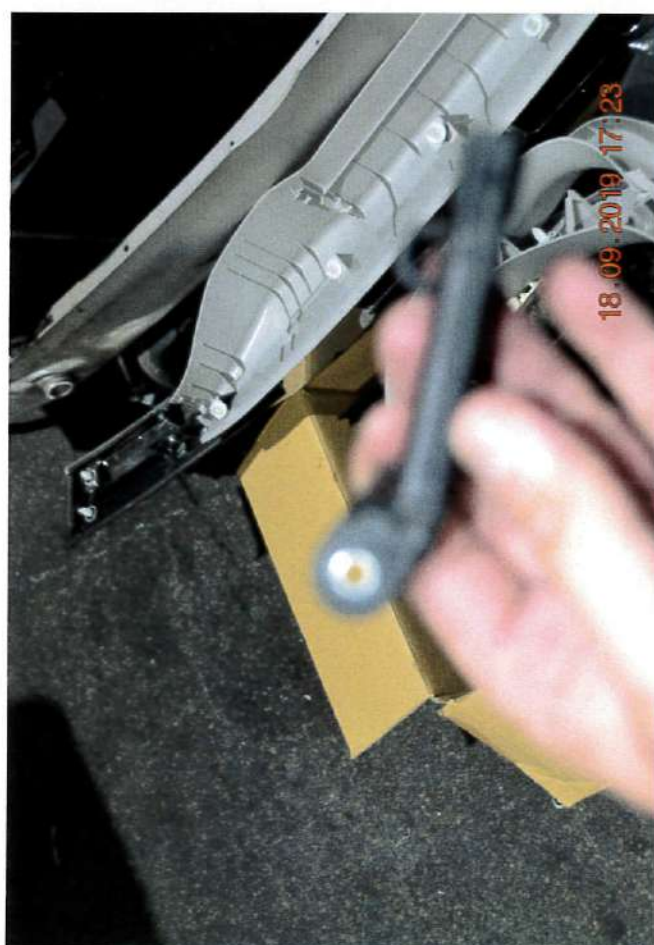
The vehicle sustained damage at the rear portion.  
For details, refer to assessment for repairs and photographs attached.

Enclosed Seventy ( 70 ) photographs depicting damage to the vehicle.

The impact was confined to the rear portion of the vehicle.  
The damages appeared to be consistent as per the accident report statement.  
Please refer the attached schedule and photographs for details.
