Vehicle No. SLT 7464B  
Insured Veh. SHC 8828R  
Claim No. D20003733MFSH  
Policy No. D-20094922MFSH  
Accident Date 12/09/2020  
Inspection Date 17/09/2020

# LKK Auto Consultants Pte Ltd

### ADJUSTMENT ON REPAIR COST FOR VEHICLE NO. SLT 7464B

### PHOTOGRAPHS FOR VEHICLE NO. SLT 7464B

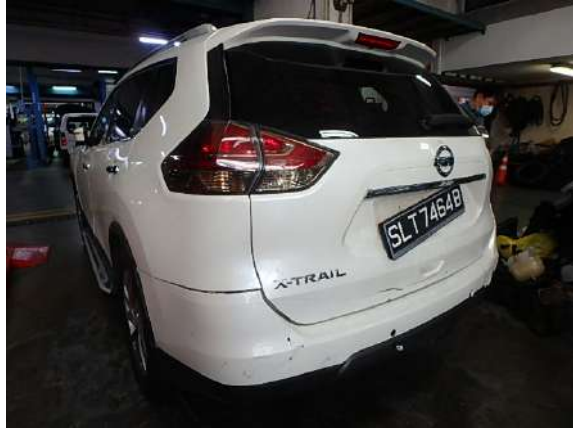
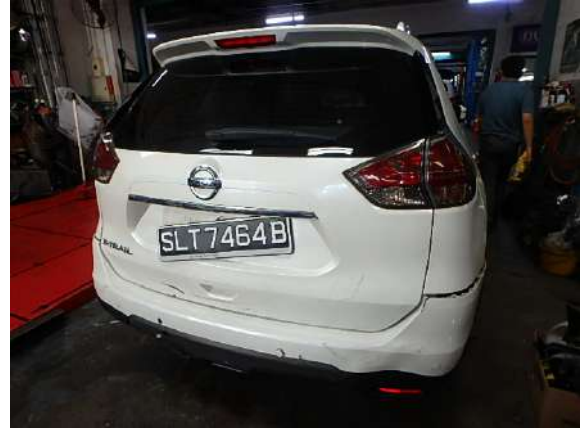
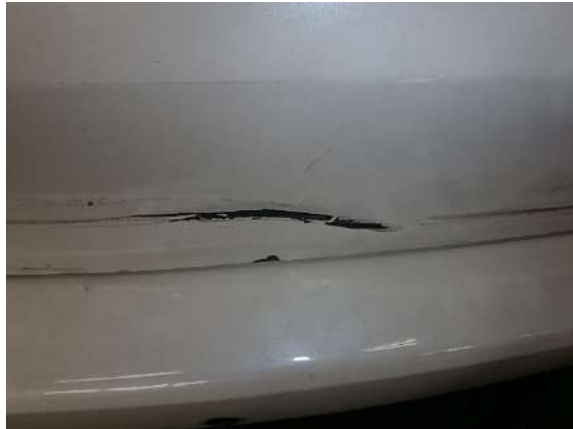
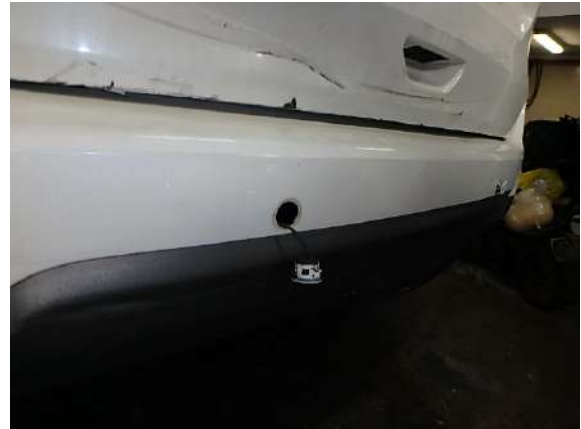
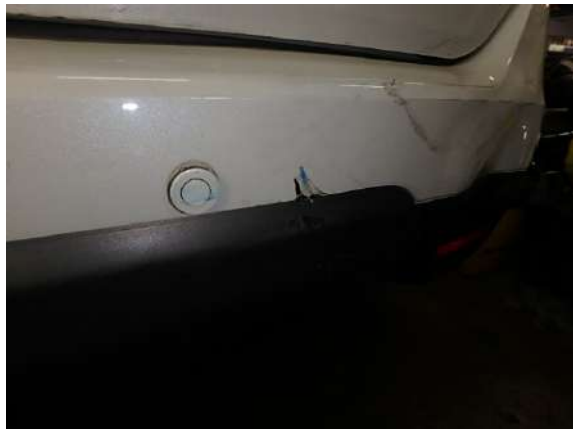
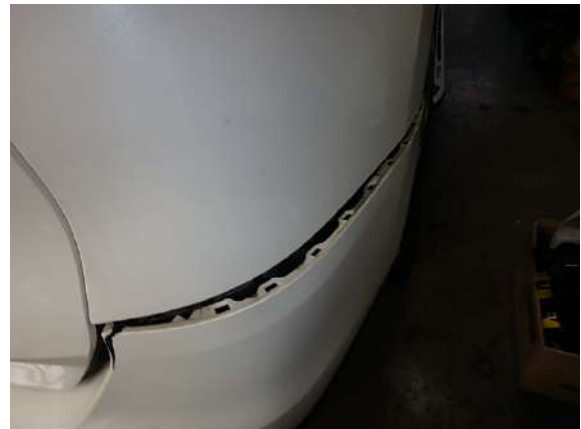
| Affiliated to Federation Internationale Des Experts En Automobile | | | | |
|---|---|---|---|--|
| THE VEHICLE SUSTAINED DAMAGES AT THE REAR & FRONT PORTION.<br><br>DAMAGES SEE DETAILS. | | | | |

### INSPECTION
