| Affiliated to Federation Internationale Des Experts En Automobile | | | | |
|---|---|---|---|--|
| <b>4. Description of Damages</b> | | | | |

## ADJUSTMENT ON REPAIR COST FOR VEHICLE NO. SHD 9567G

### PHOTOGRAPHS FOR VEHICLE NO. SHD 9567G

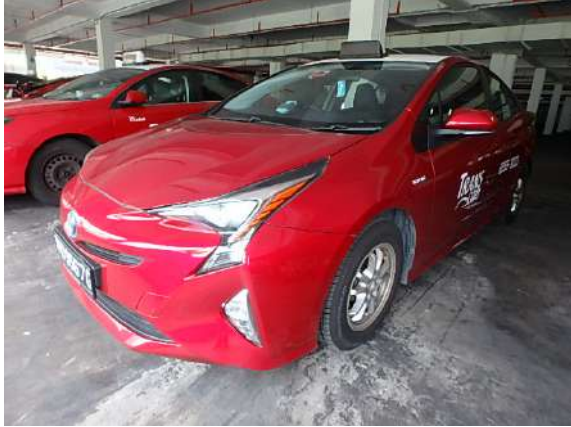
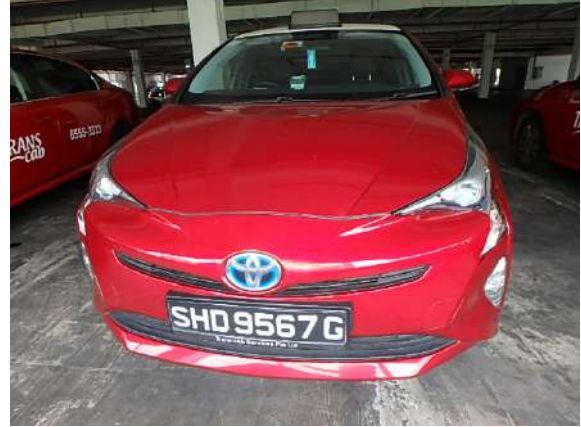
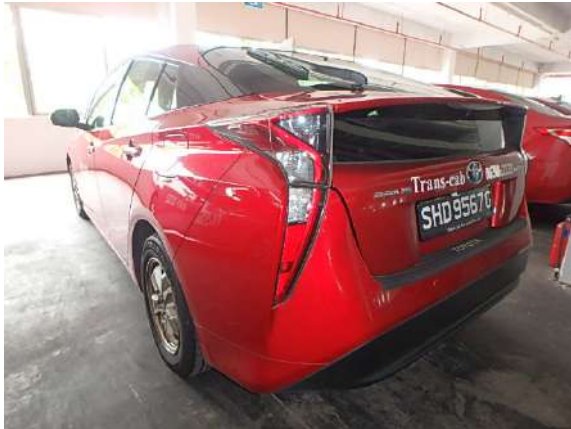
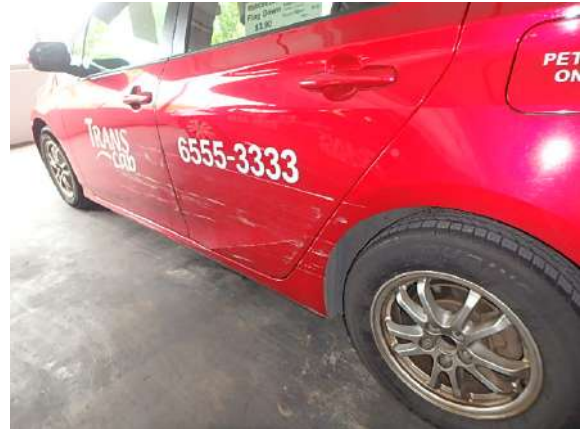
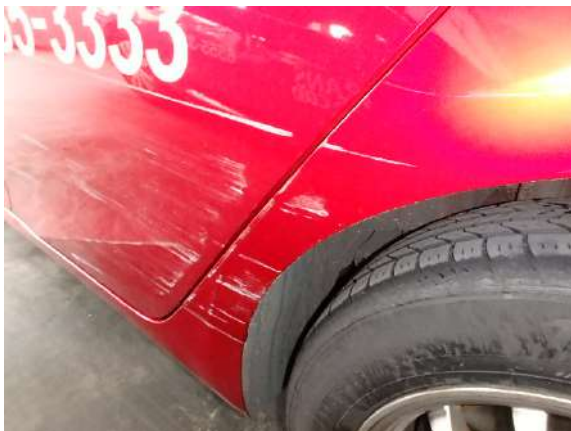
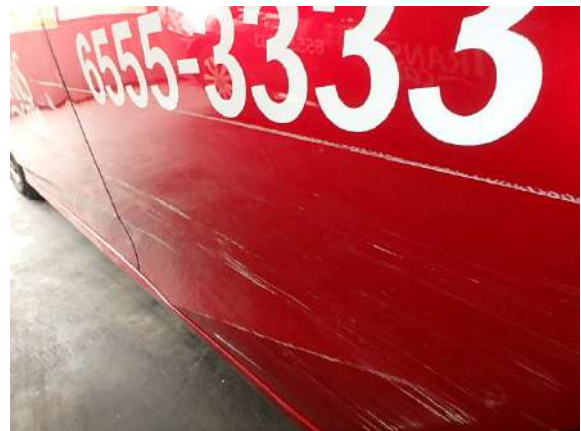
### INSPECTION

| Affiliated to Federation Internationale Des Experts En Automobile | | | | |
|---|---|---|---|--|
| THE VEHICLE SUSTAINED DAMAGES AT THE N/S BODY.<br>DAMAGES SEE DETAILS. | | | | |

| Qty | Description of Parts | Condition | Estimate By Workshop (\$) | Our Adjusted (\$) |
|---|---|---|---|---|
| | PANEL BEATING ,KNOCKING AND STRAIGHTENING THE NECESSARY PORTION,REMOVE AND RENEWAL OF PARTS ,ADJUST AND REALIGN THE SAME.INCLUSIVE OF THE REPAIR OF PANEL SUB-ASSY ,REAR DOOR ,LH,HINGE ASSY ,REAR DOOR ,LOWER LH ,REINFORCEMENT SUB-ASSY ,ROCKER ,OUTER LH AND PANEL SUB-ASSY ,QUARTER LH . | | 1,400.00 | 500.00 |

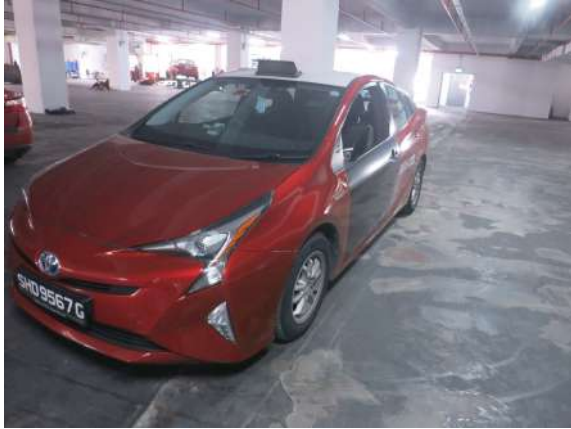
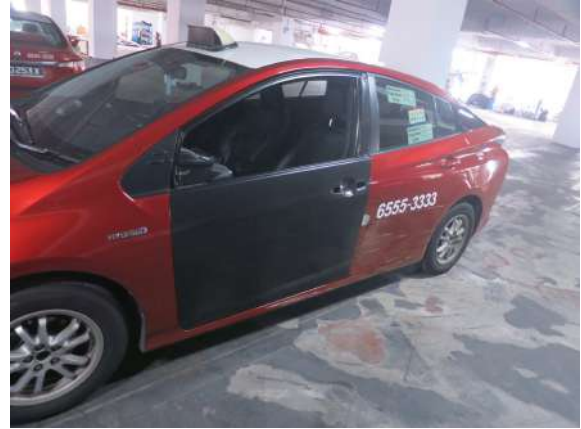
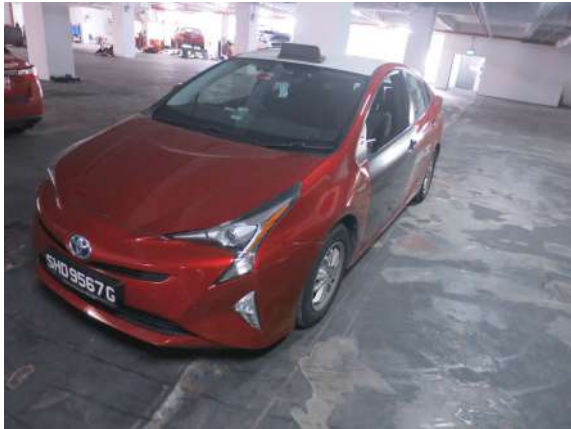
**RE-INSPECTION**

**PHOTOGRAPHS FOR VEHICLE NO. SHD 9567G**
