## LKK Auto Consultants Pte Ltd

## ADJUSTMENT ON REPAIR COST FOR VEHICLE NO. SHD 1547S

PHOTOGRAPHS FOR VEHICLE NO. SHD 1547S

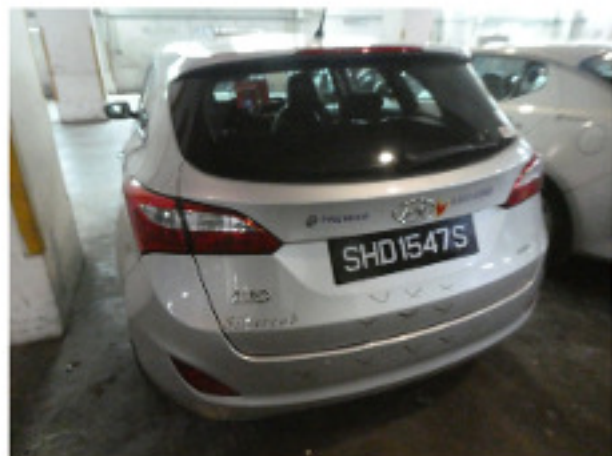
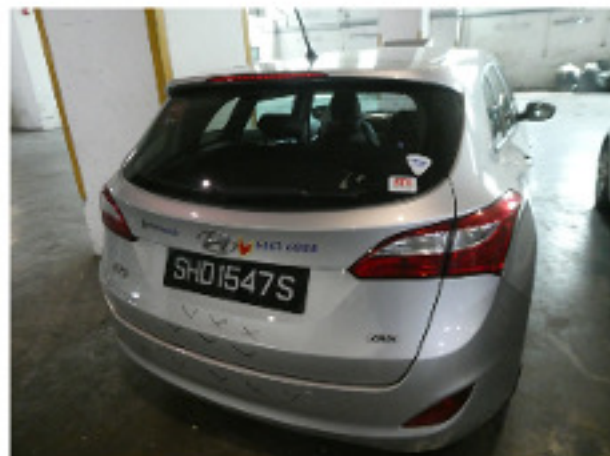
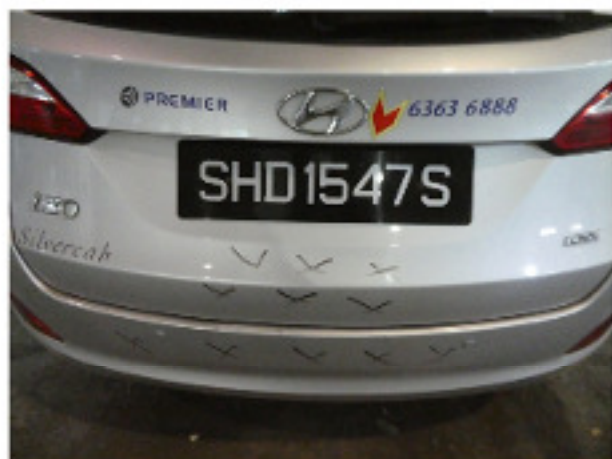
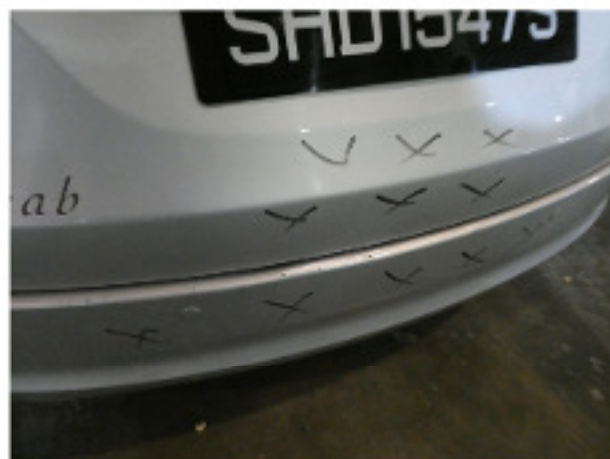
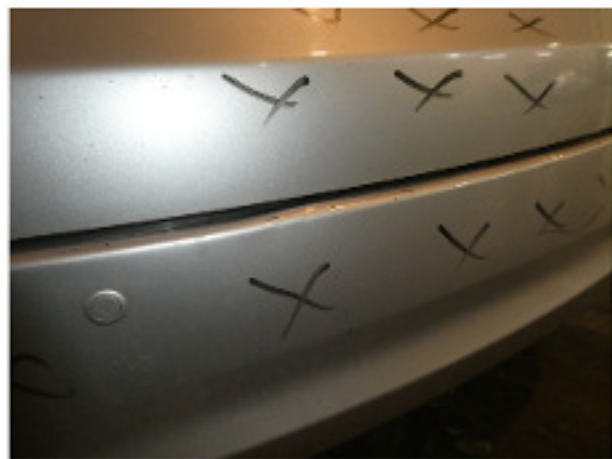
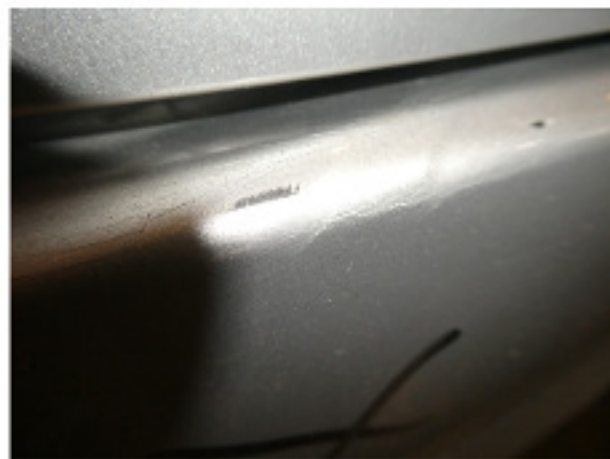
INSPECTION

THE VEHICLE SUSTAINED DAMAGES AT THE REAR PORTION. DAMAGES SEE DETAILS.
--

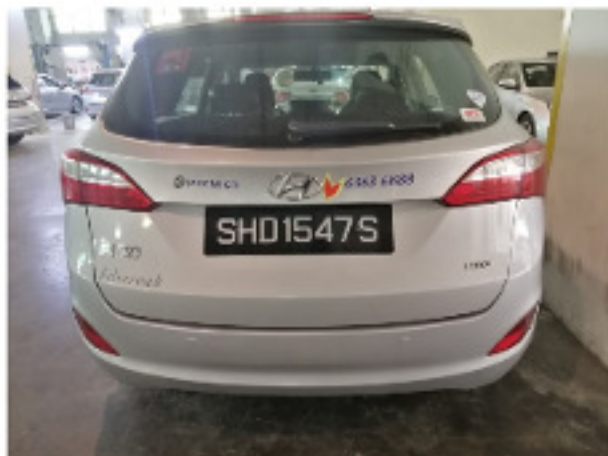
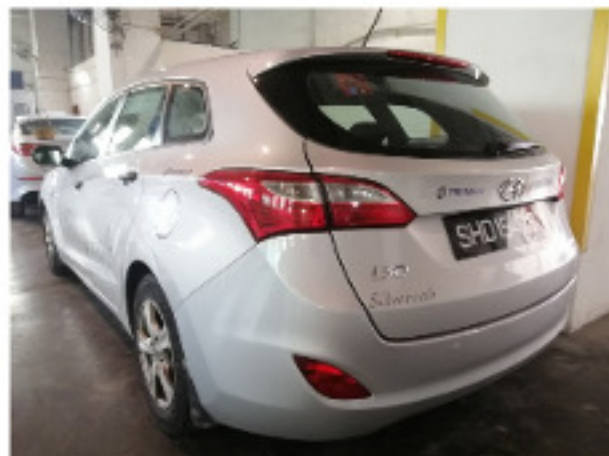
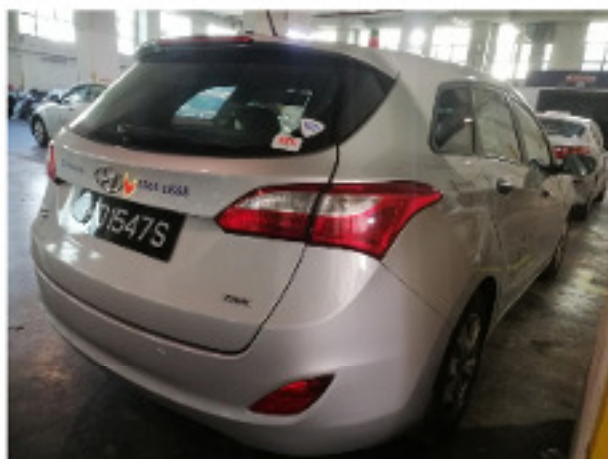
PHOTOGRAPHS FOR VEHICLE NO. SHD 1547S

RE-INSPECTION
