LKK Auto Consultants Pte Ltd

ADJUSTMENT ON REPAIR COST FOR VEHICLE NO. GBC 5142B

PHOTOGRAPHS FOR VEHICLE NO. GBC 5142B

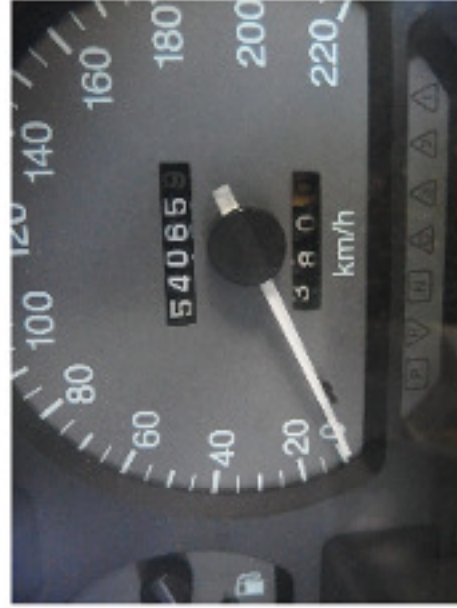
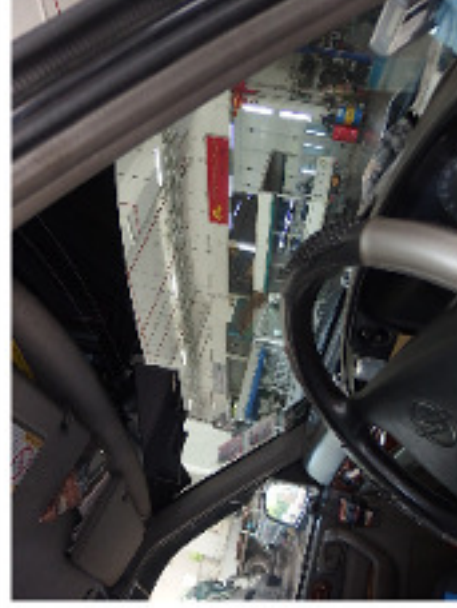
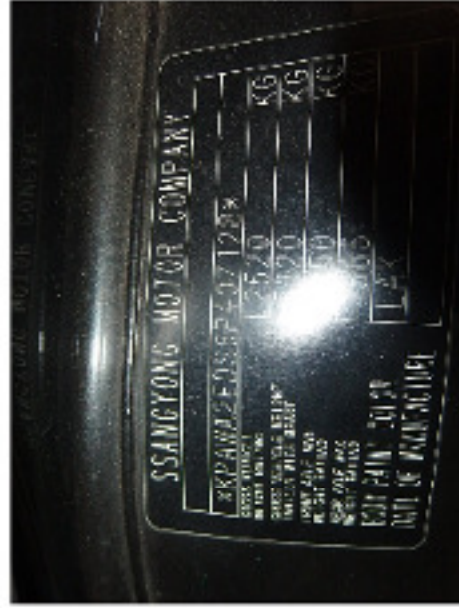
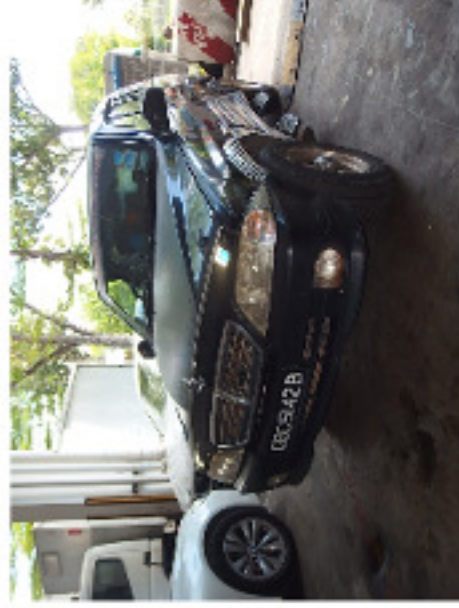
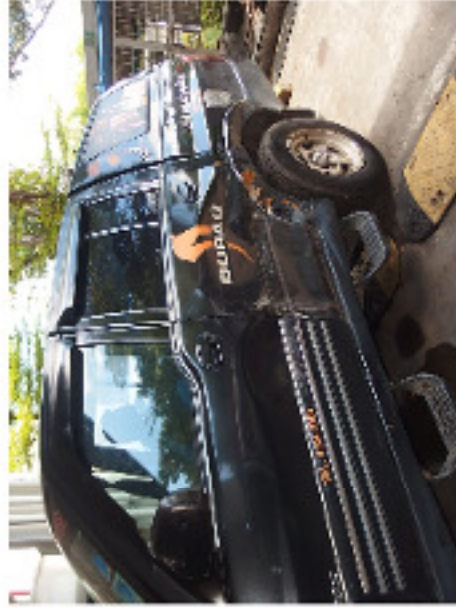
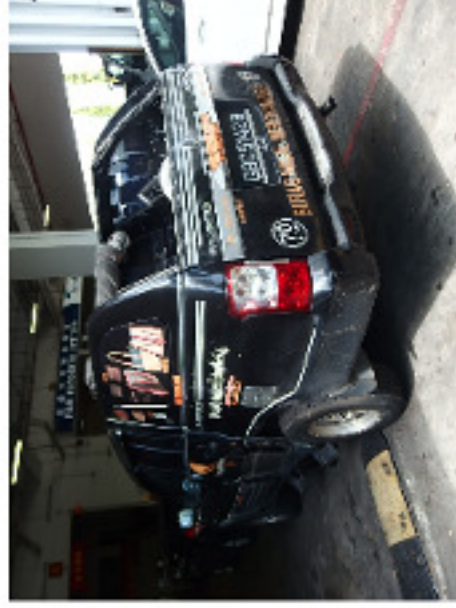
4. Description of Damages				
	THE VEHICLE SUSTAINED DAMAGES AT THE N/S BODY. DAMAGES SEE DETAILS.			
5. General Information				
	Accident Date	23/09/2020	Inspection Date	30/09/2020
	Survey held at	STYTECH AUTO PTE LTD 2 KAKI BUKIT AVENUE 2 #02-30 KAKI BUKIT AUTOHUB SINGAPORE 417921		
5a. Remarks				
	A)THE INSPECTION WAS CONDUCTED ON A"WITHOUT PREJUDICE" BASIS. B)IN ACCORDANCE TO YOUR INSTRUCTIONS, WE HAVE NOT AUTHORISED REPAIRS.			
5b. Estimate Days of Repair				
	ESTIMATED NORMAL PERIOD FOR REPAIR:		5 Working Days

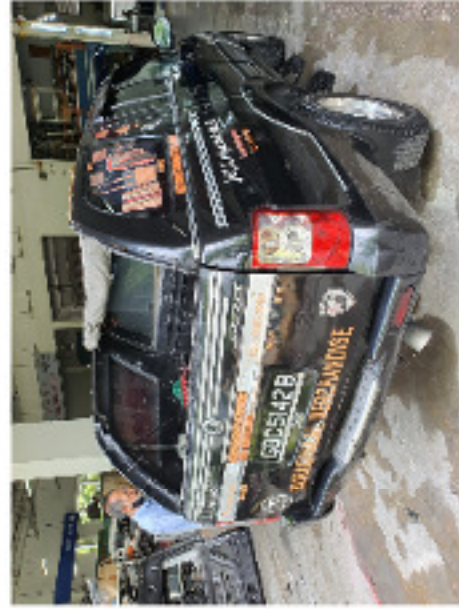
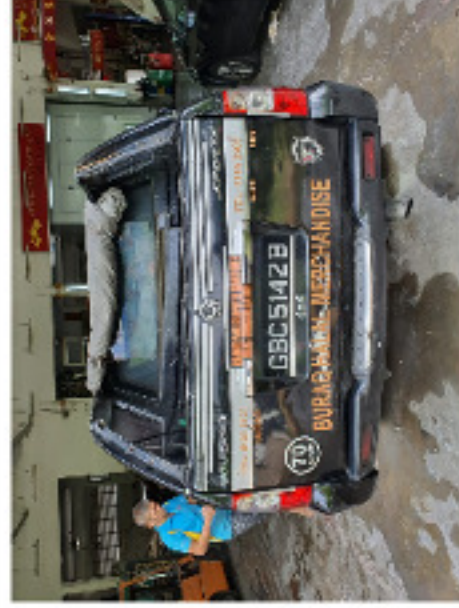
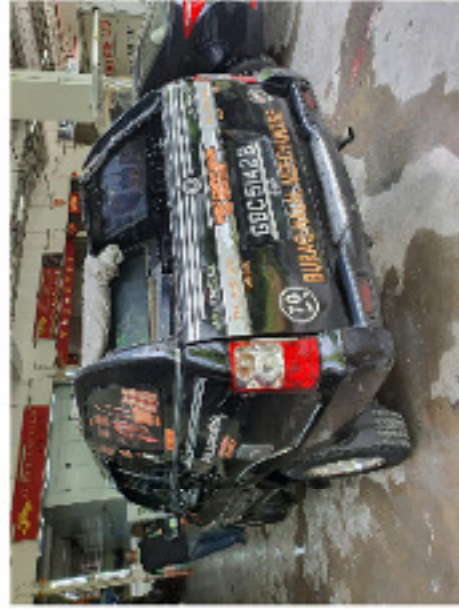
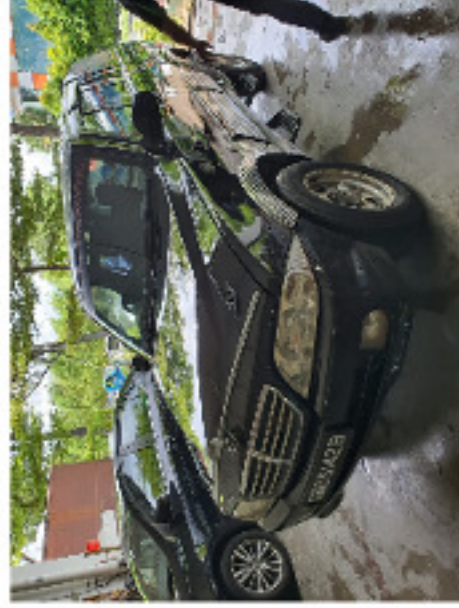
PHOTOGRAPHS FOR VEHICLE NO. GBC 5142B

RE-INSPECTION
