## ACCIDENT DAMAGED VEHICLE INSPECTION REPORT

Registration No : YQ1638T  
Make : HINO  
Model : XZU710R 14FT WIDE CAB 5T  
Year : 2019

The vehicle sustained damage at the front and front right portions..  
For details, refer to assessment for repairs and photographs attached.

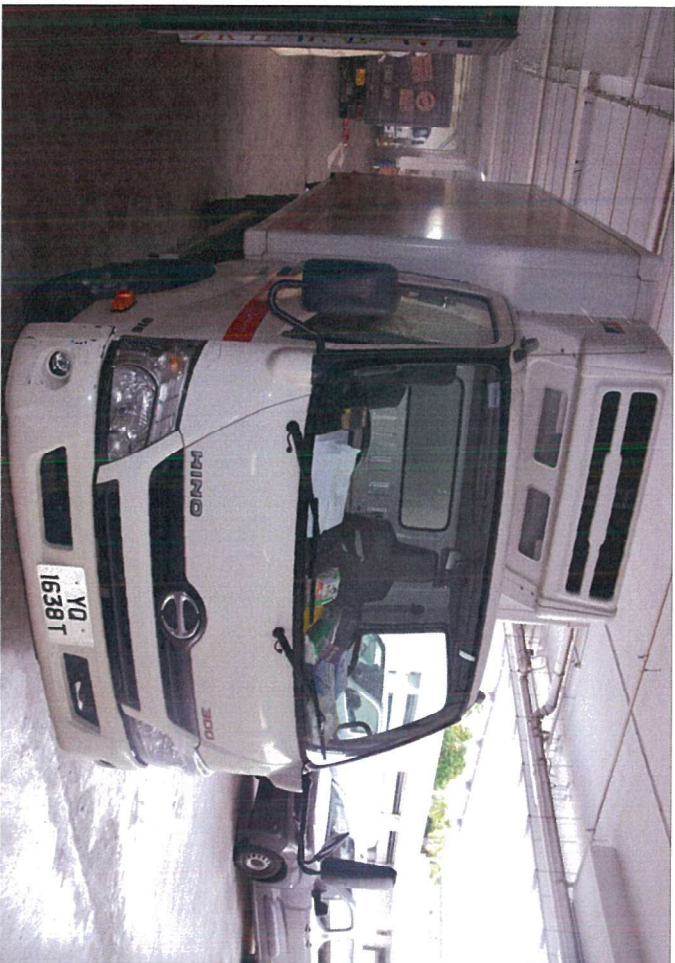
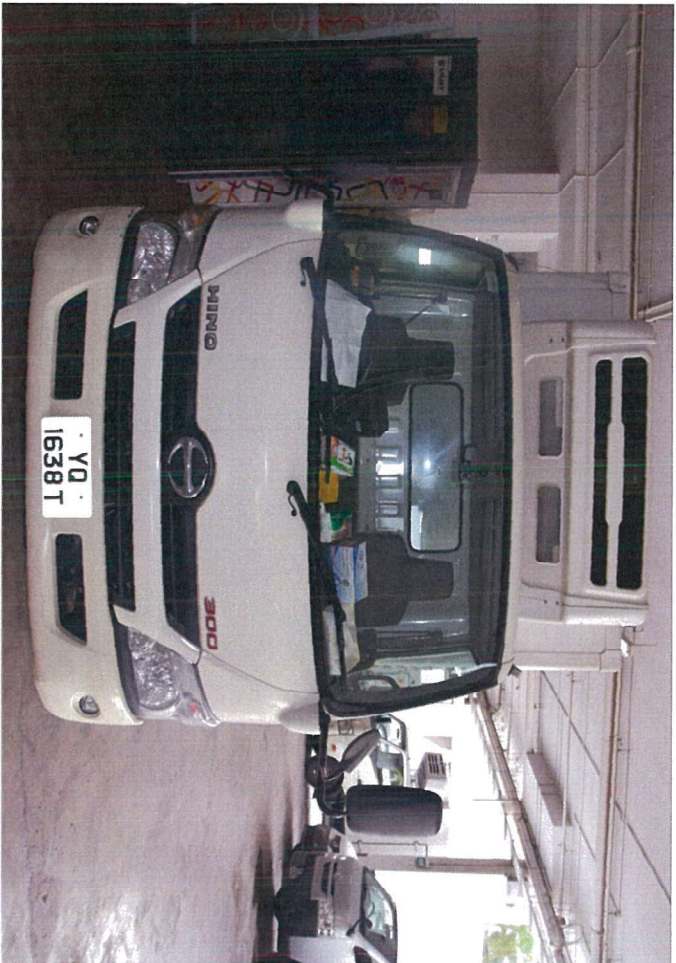
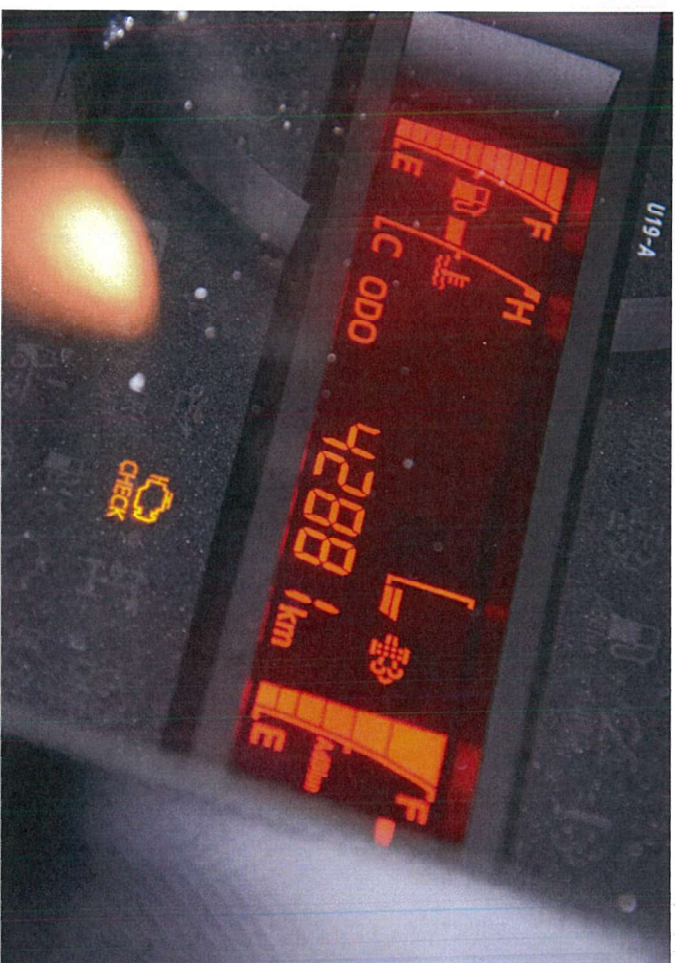
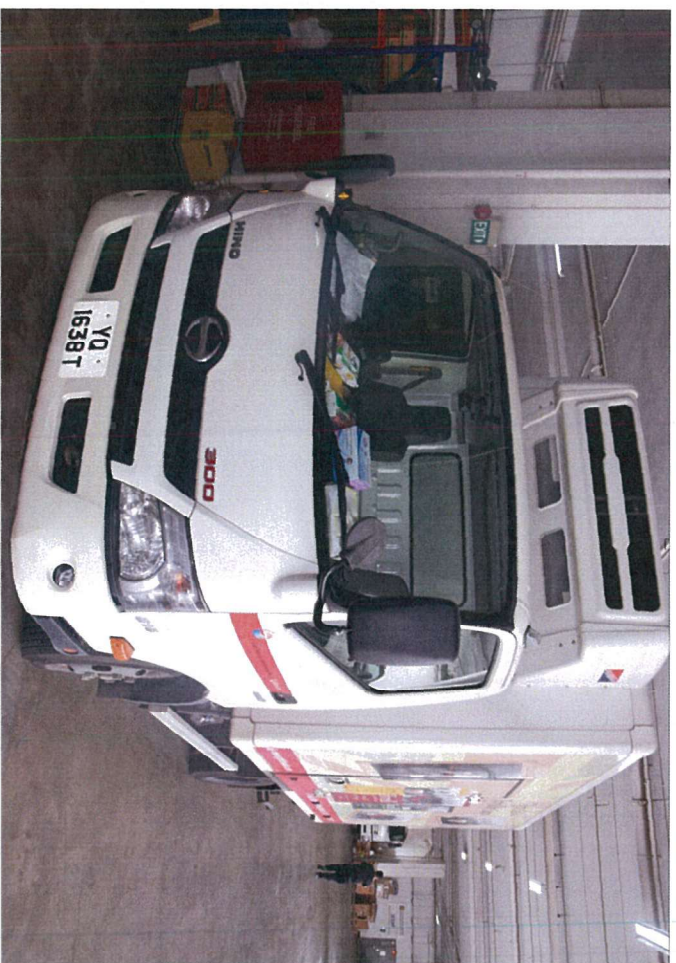
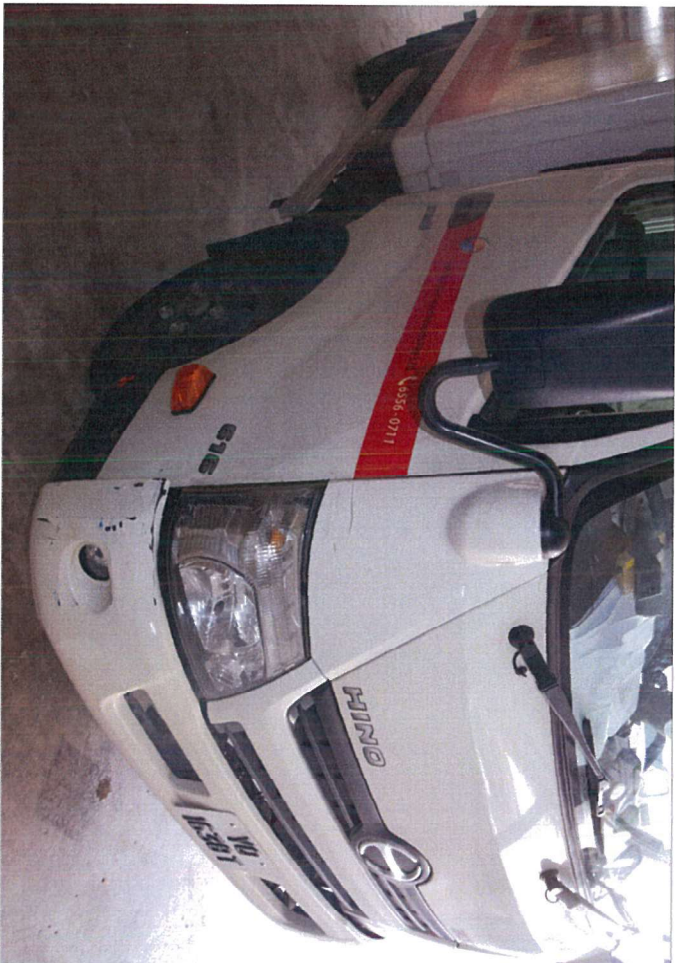
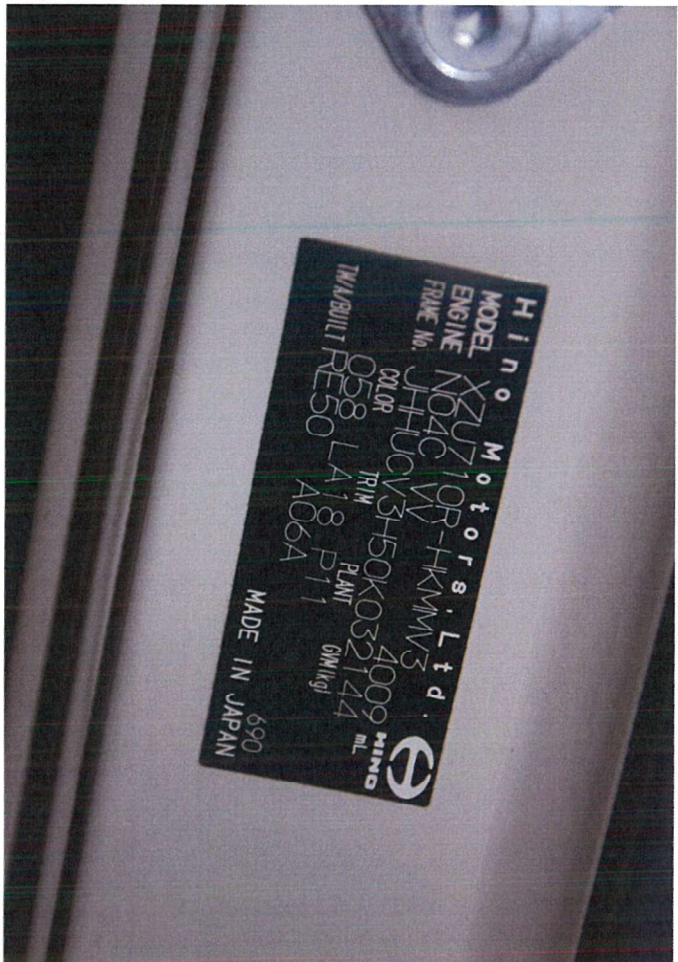
Enclosed Thirty -seven ( 37 ) photographs depicting damage to the vehicle.

The impact was confined to the front right portion of the vehicle.  
The damages appeared to be consistent as per the accident report statement.  
Please refer the attached schedule and photographs for details.
