## LKK Auto Consultants Pte Ltd

## ADJUSTMENT ON REPAIR COST FOR VEHICLE NO. SML 6925A

PHOTOGRAPHS FOR VEHICLE NO. SML 6925A

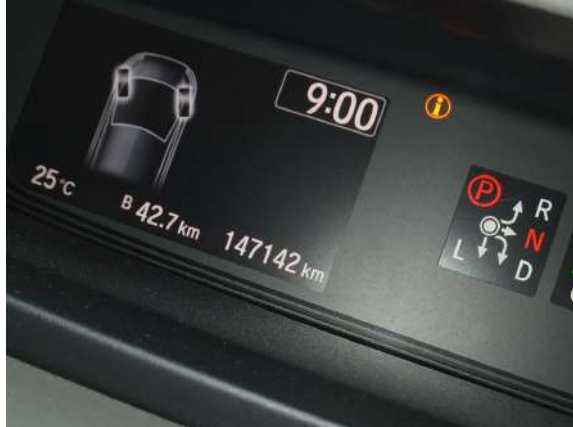
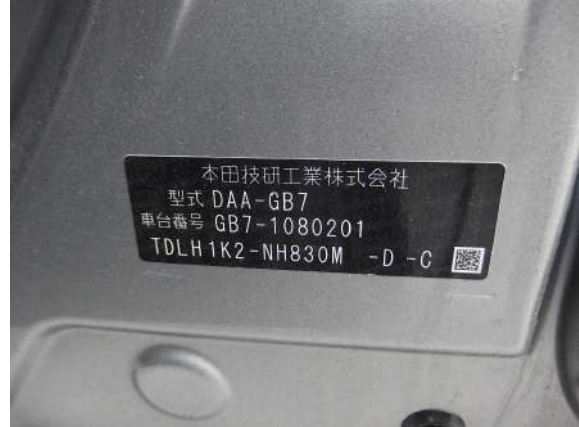
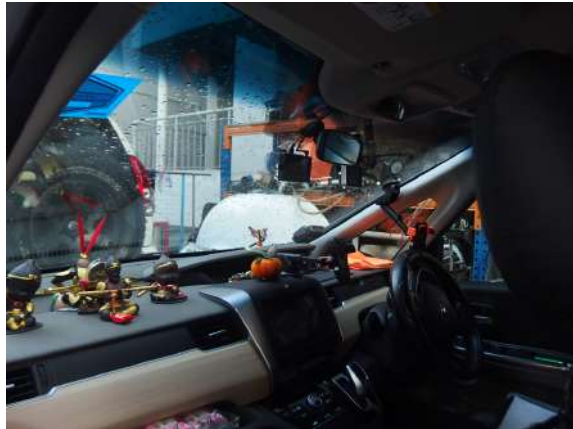
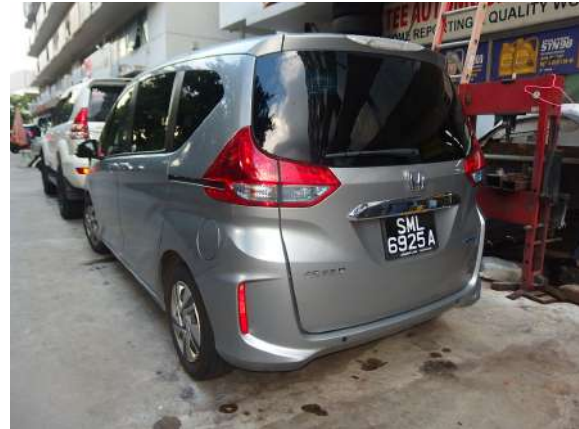
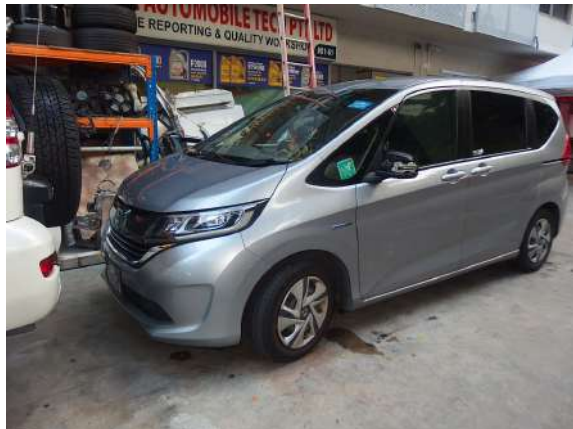
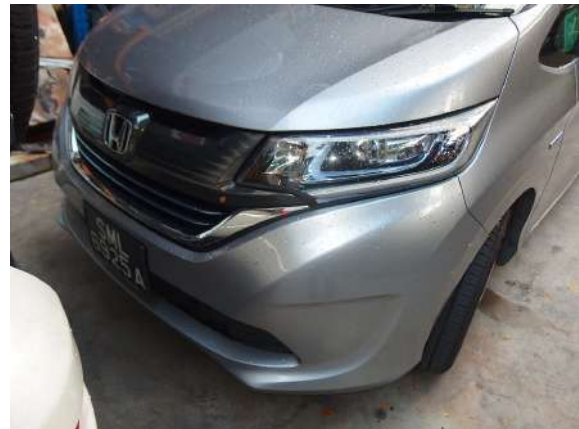
INSPECTION

| Affiliated to Federation Internationale Des Experts En Automobile | | | | |
|---|---|---|---|--|
| THE VEHICLE SUSTAINED DAMAGES AT THE N/S FRONT PORTION AND N/S BODY.<br>DAMAGES SEE DETAILS. | | | | |
