Vehicle No. SJG 5236Z  
Insured Veh. SHA 3260X  
Claim No. D20004041MFSH  
Policy No. D-20094922MFSH  
Accident Date 04/10/2020  
Inspection Date 06/10/2020

### ADJUSTMENT ON REPAIR COST FOR VEHICLE NO. SJG 5236Z

### PHOTOGRAPHS FOR VEHICLE NO. SJG 5236Z

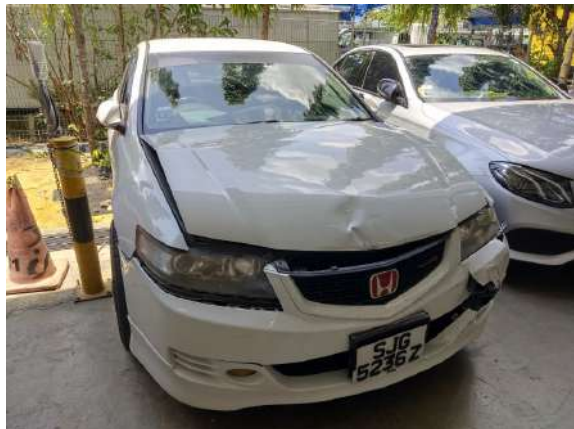
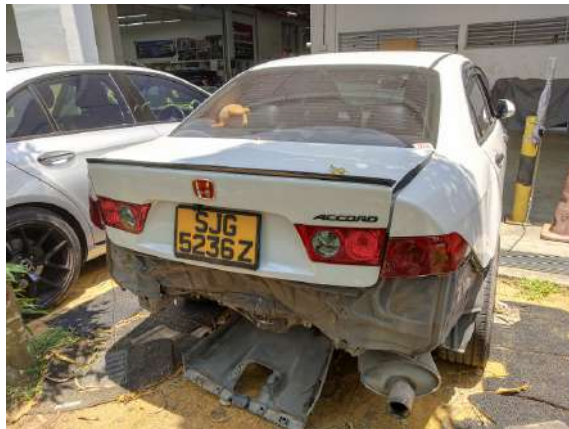
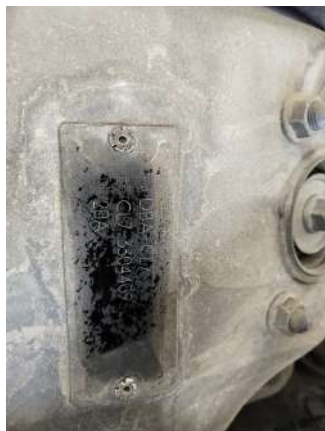
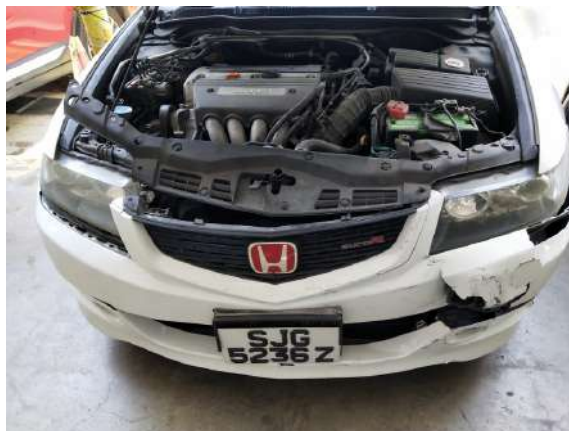
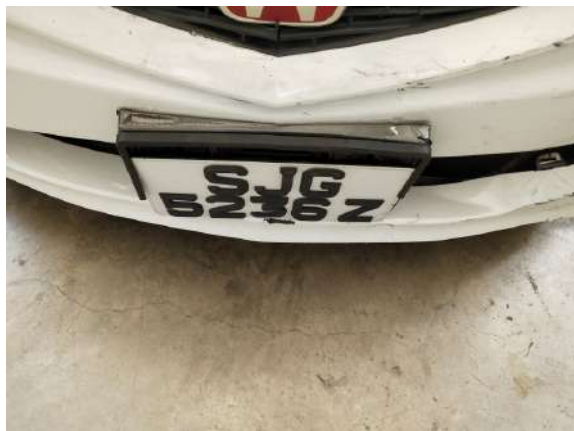
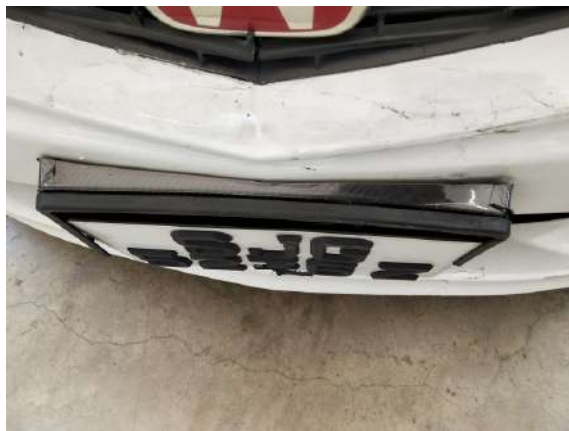
### INSPECTION

| Affiliated to Federation Internationale Des Experts En Automobile | | | | |
|---|---|---|---|---|
| | THE VEHICLE SUSTAINED DAMAGES AT THE FRONT AND REAR PORTION.<br><br>DAMAGES SEE DETAILS. | | | |

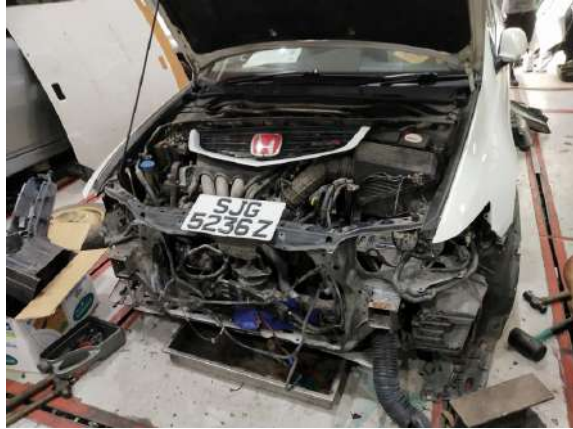
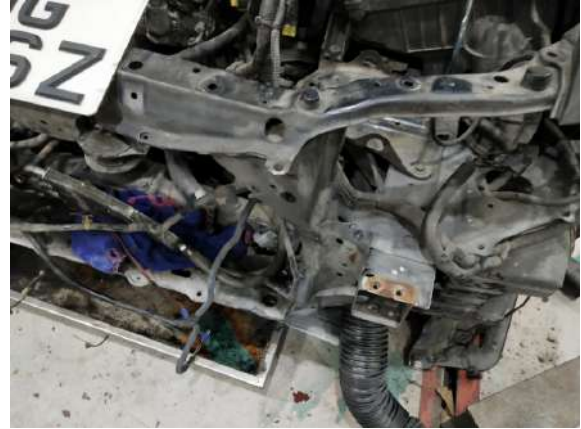
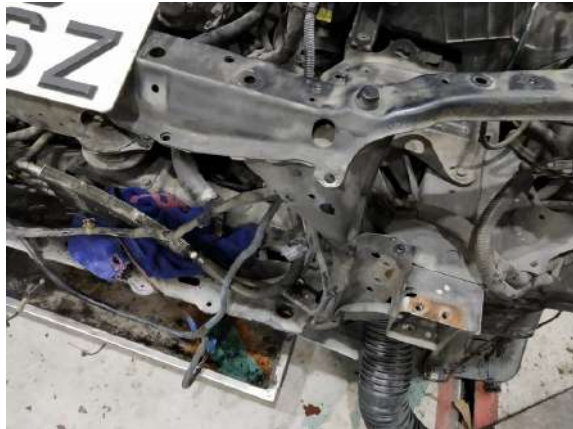
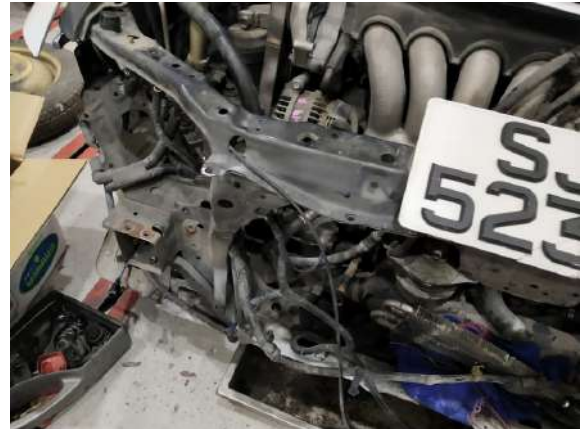
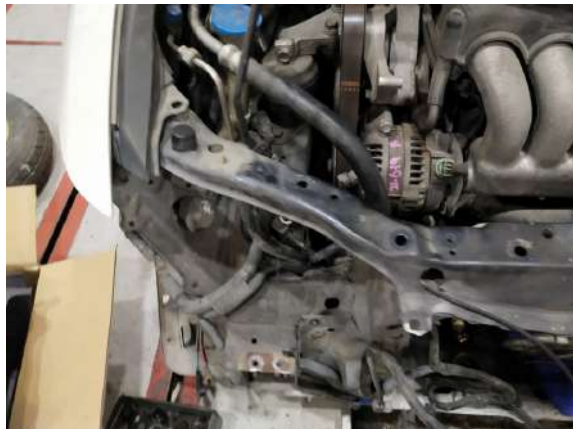
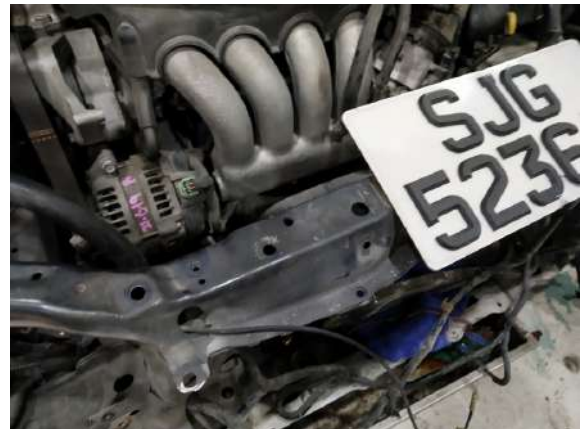
PHOTOGRAPHS FOR VEHICLE NO. SJG 5236Z

RE-INSPECTION
