Vehicle No. SJV 7534X  
Insured Veh. SHA 8660S  
Claim No. D20004053MFSH  
Policy No. D-20094921MFSH  
Accident Date 03/10/2020  
Inspection Date 08/10/2020

# LKK Auto Consultants Pte Ltd

### ADJUSTMENT ON REPAIR COST FOR VEHICLE NO. SJV 7534X

PHOTOGRAPHS FOR VEHICLE NO. SJV 7534X

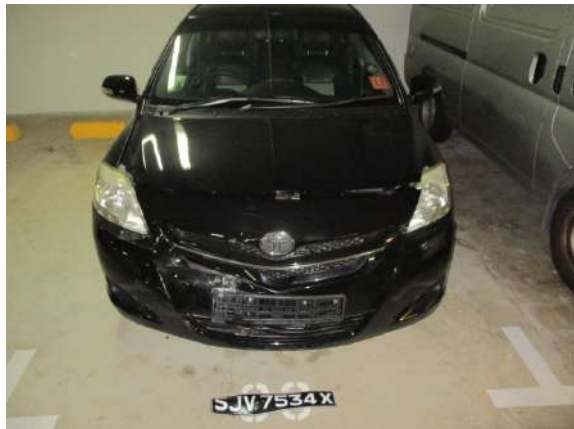
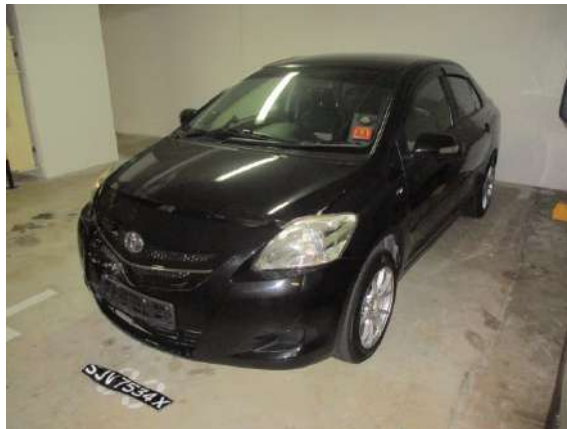
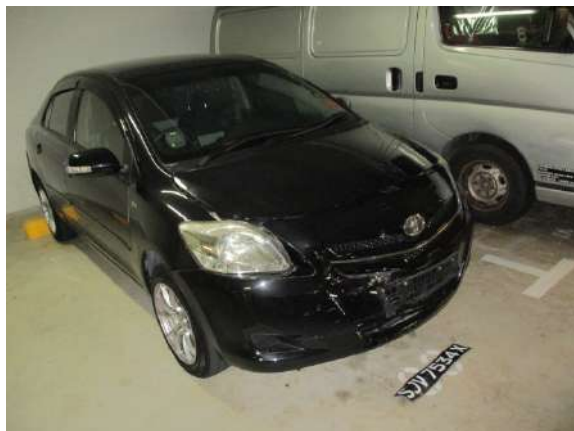
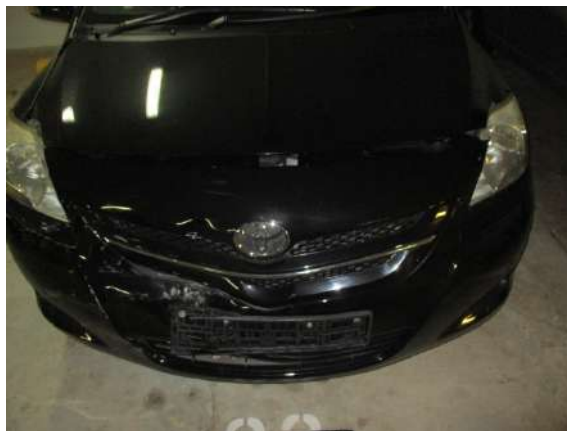
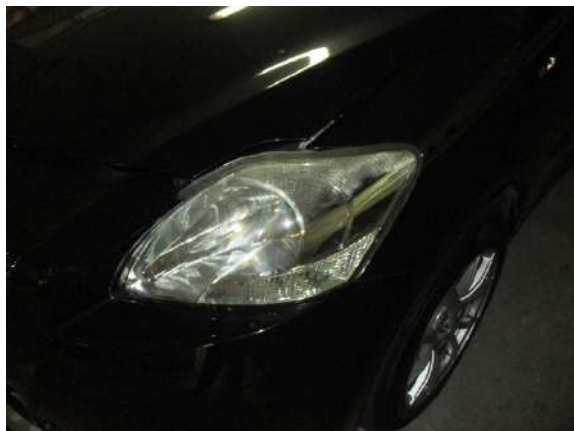
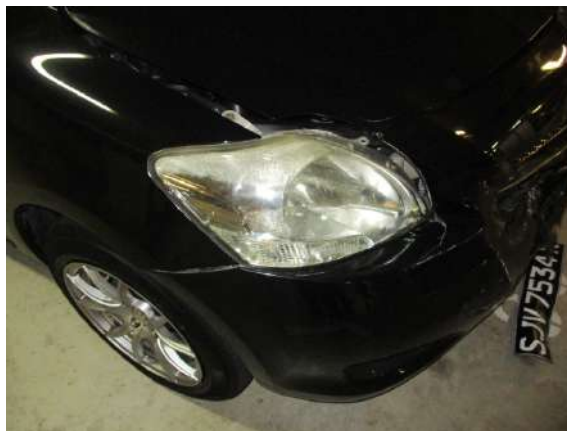
INSPECTION

| Affiliated to Federation Internationale Des Experts En Automobile | | | | |
|---|---|---|---|--|
| THE VEHICLE SUSTAINED DAMAGES AT THE FRONT AND REAR PORTION.<br>DAMAGES SEE DETAILS. | | | | |

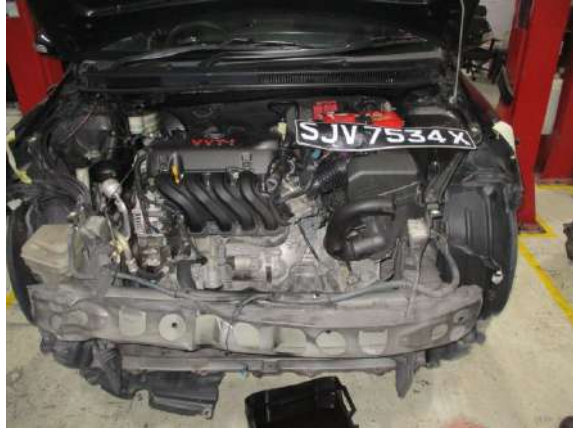
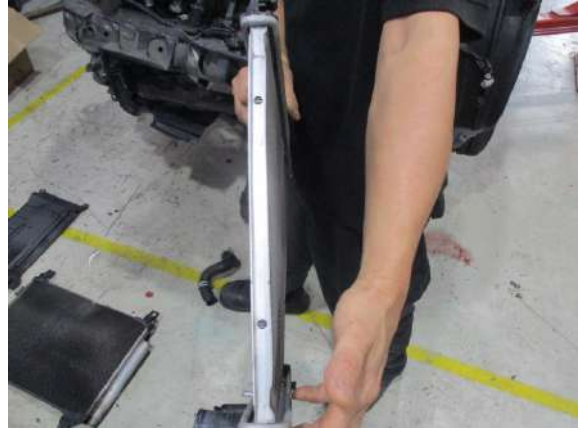
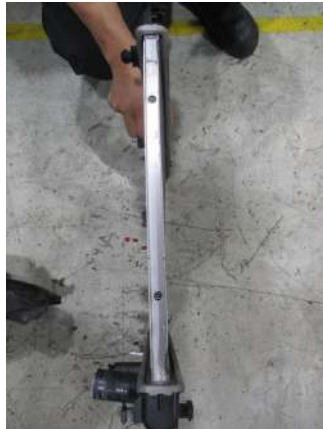
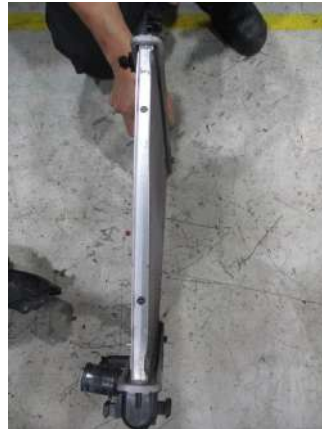
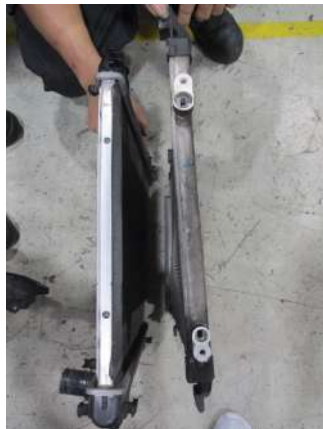
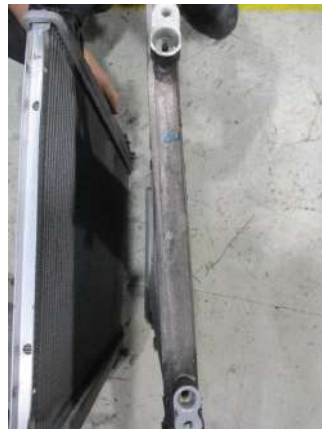
### RE-INSPECTION

### PHOTOGRAPHS FOR VEHICLE NO. SJV 7534X
