## LKK Auto Consultants Pte Ltd

## ADJUSTMENT ON REPAIR COST FOR VEHICLE NO. SGQ 390B

### PHOTOGRAPHS FOR VEHICLE NO. SGQ 390B

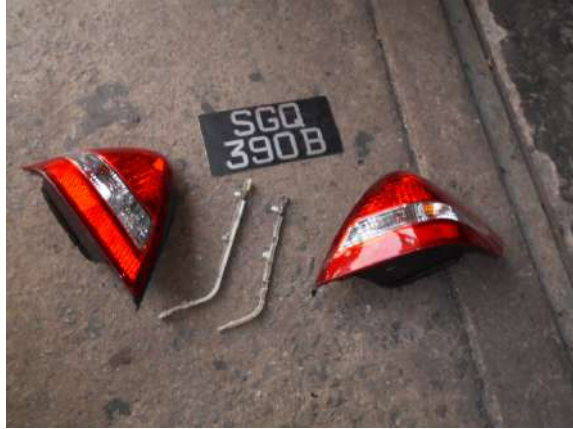
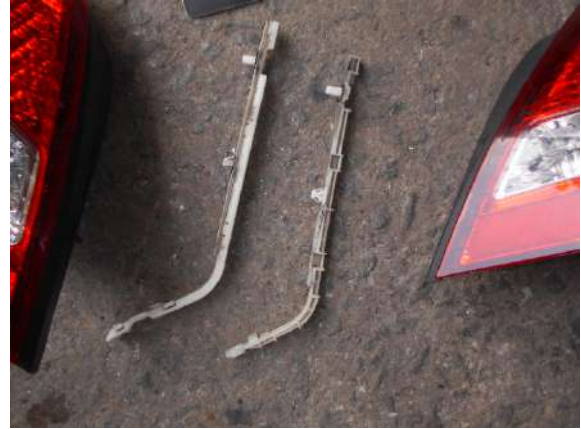
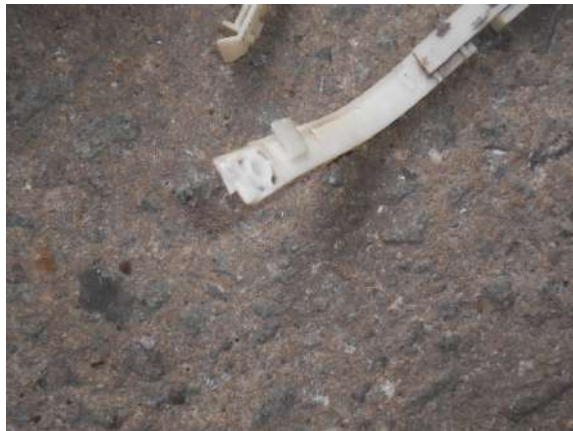
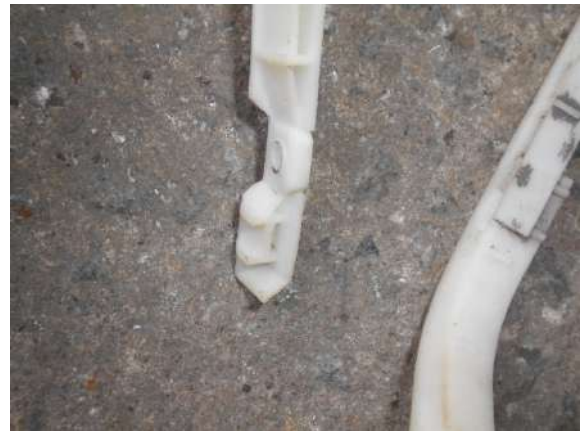
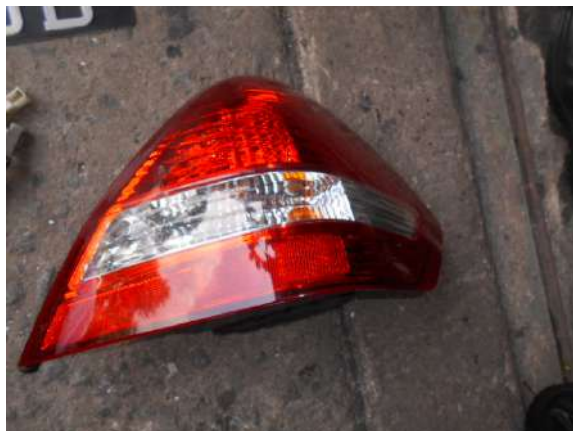
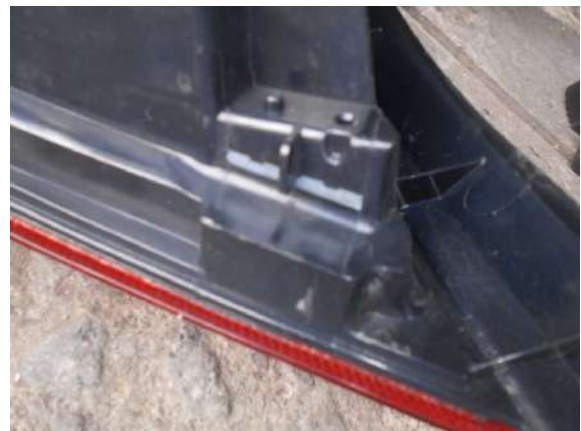
**PHOTOGRAPHS FOR VEHICLE NO. SGQ 390B**

**RE-INSPECTION**

| Affiliated to Federation Internationale Des Experts En Automobile | | | | |
|---|---|---|---|--|
| THE VEHICLE SUSTAINED DAMAGES AT THE REAR PORTION.<br>DAMAGES SEE DETAILS. | | | | |
