## LKK Auto Consultants Pte Ltd

## ADJUSTMENT ON REPAIR COST FOR VEHICLE NO. YN 4023M

### PHOTOGRAPHS FOR VEHICLE NO. YN 4023M

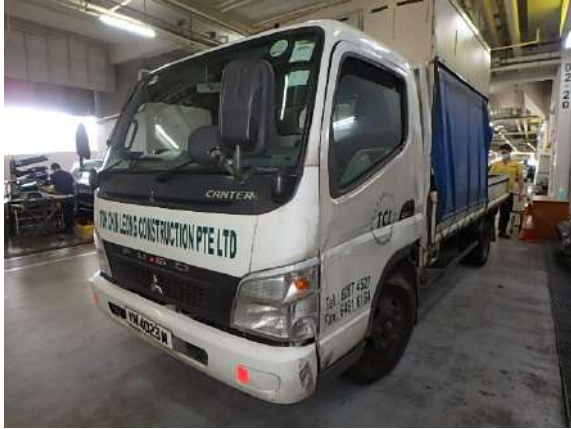
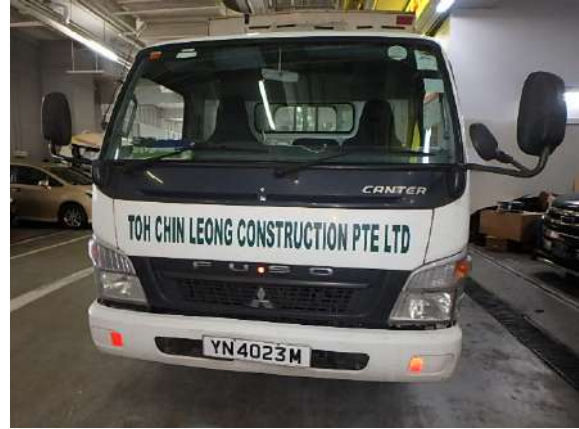
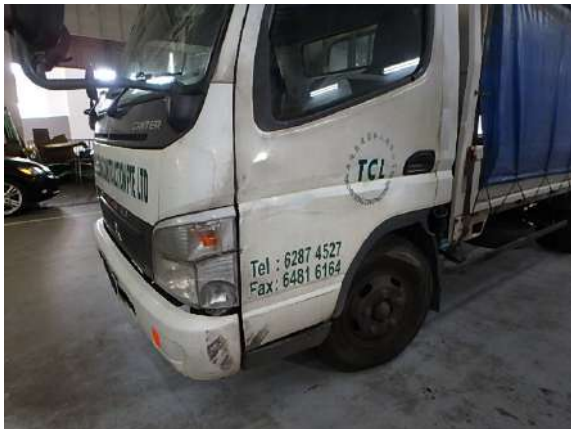
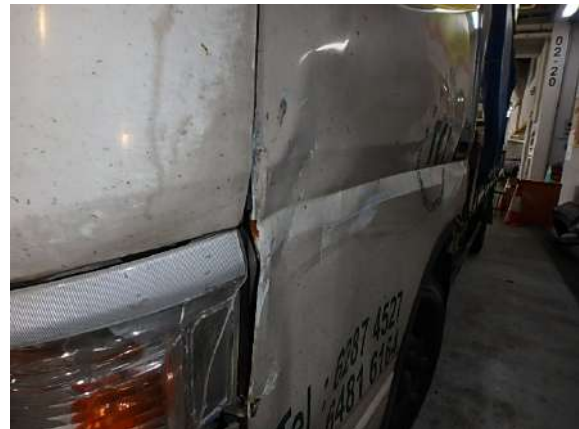
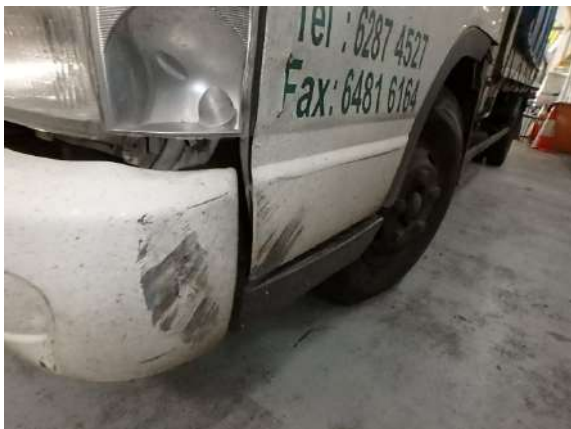
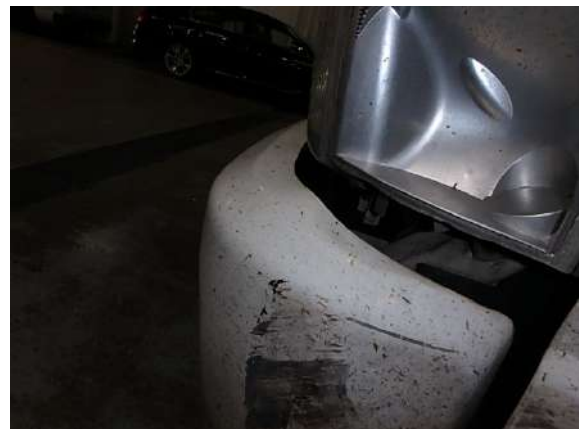
### INSPECTION

| Affiliated to Federation Internationale Des Experts En Automobile | | | | |
|---|---|---|---|--|
| | THE VEHICLE SUSTAINED DAMAGES AT THE N/S FRONT PORTION.<br>DAMAGES SEE DETAILS. | | | |

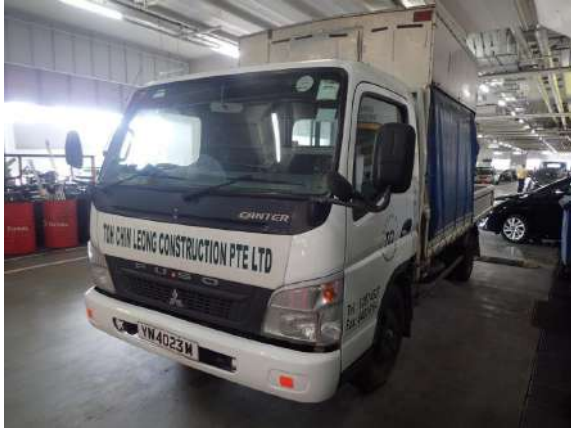
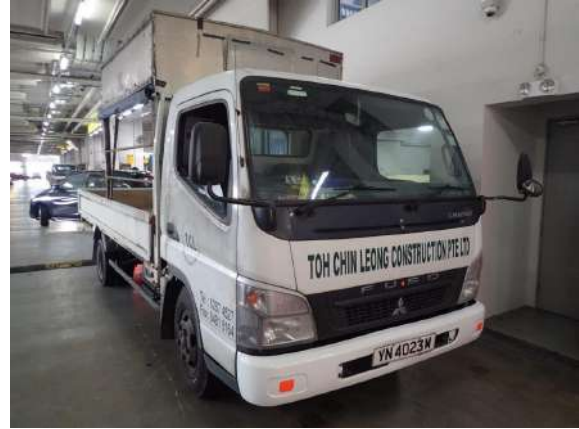
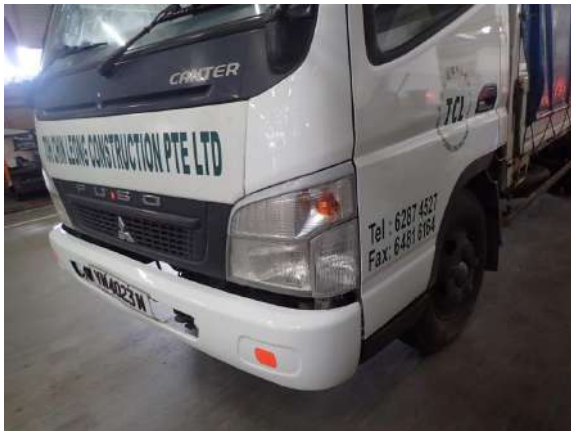
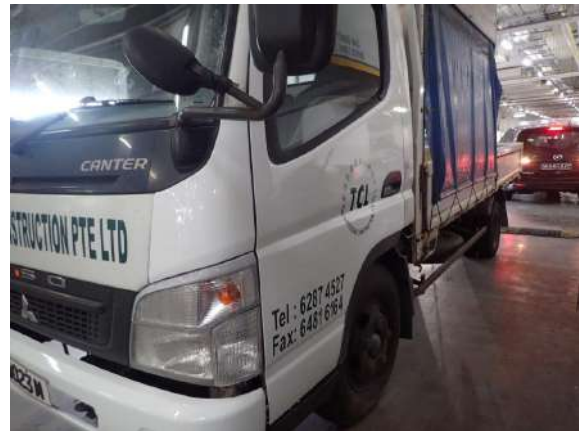
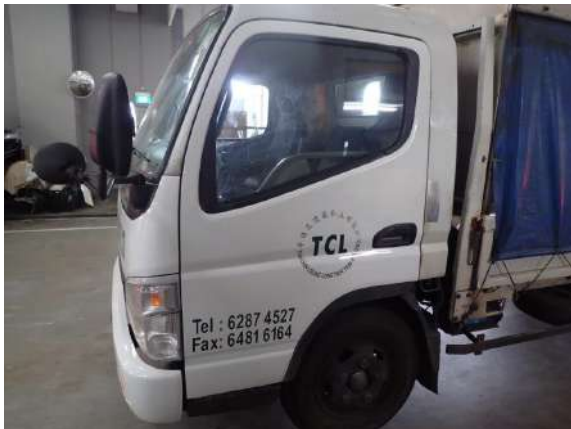
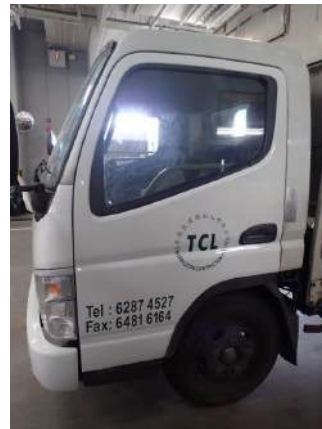
### RE-INSPECTION

### PHOTOGRAPHS FOR VEHICLE NO. YN 4023M
