ADJUSTMENT ON REPAIR COST FOR VEHICLE NO. SKX 7999R

PHOTOGRAPHS FOR VEHICLE NO. SKX 7999R

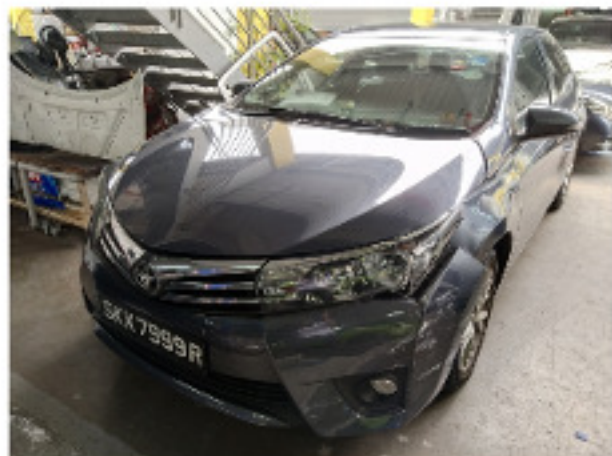
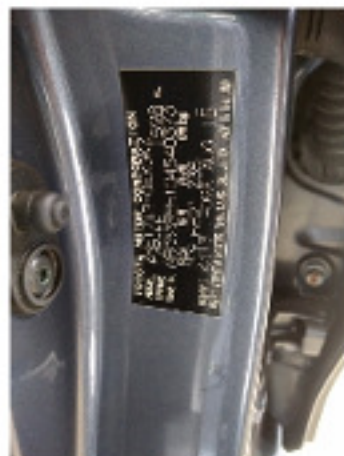
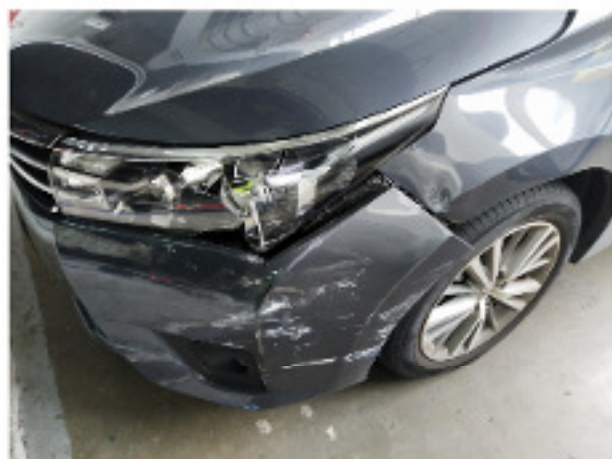
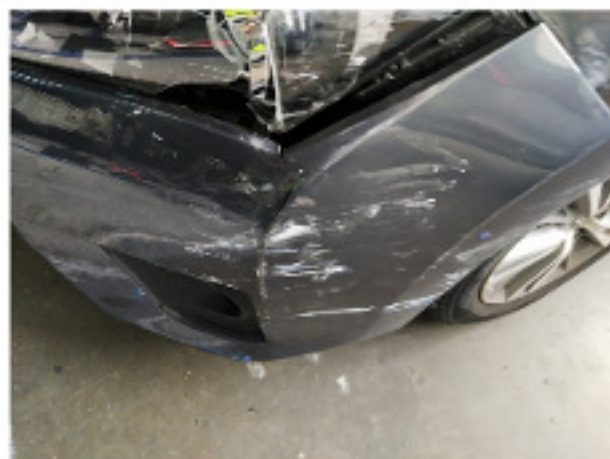
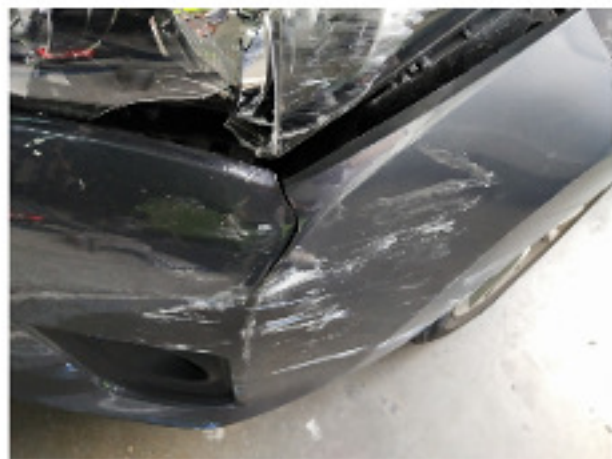
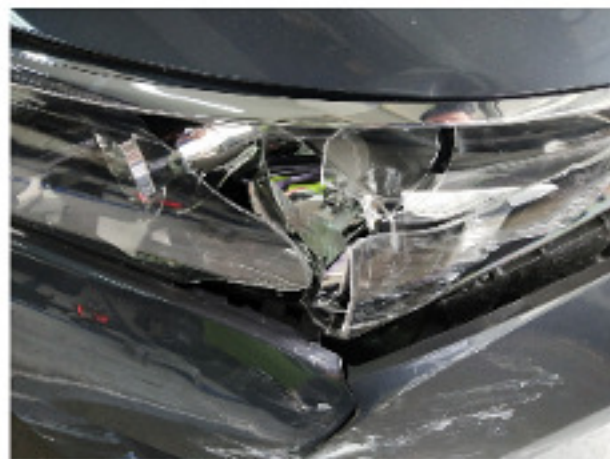
4. Description of Damages				
	THE VEHICLE SUSTAINED DAMAGES AT THE FRONT N/S PORTION. DAMAGES SEE DETAILS.			
5. General Information				
	Accident Date	12/10/2020	Inspection Date	13/10/2020
	Survey held at	LC AUTOMOTIVE BLOCK 10 SIN MING IND.ESTATE , SECTOR C #01-20 SINGAPORE 575645		
5a. Remarks				
	A)THE INSPECTION WAS CONDUCTED ON A"WITHOUT PREJUDICE" BASIS. B)IN ACCORDANCE TO YOUR INSTRUCTIONS, WE HAVE NOT AUTHORISED REPAIRS.			
5b. Estimate Days of Repair				
	ESTIMATED NORMAL PERIOD FOR REPAIR:		5 Working Days

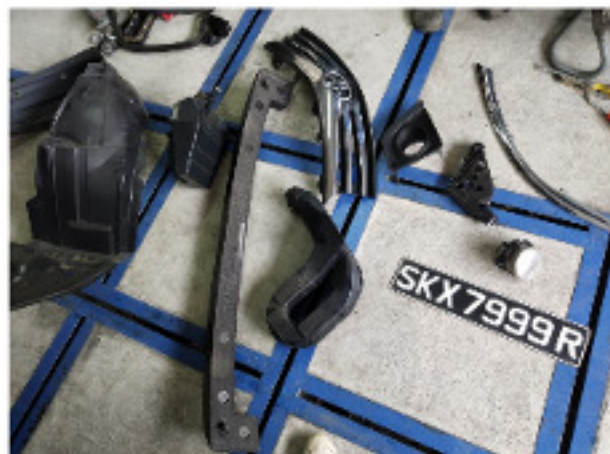
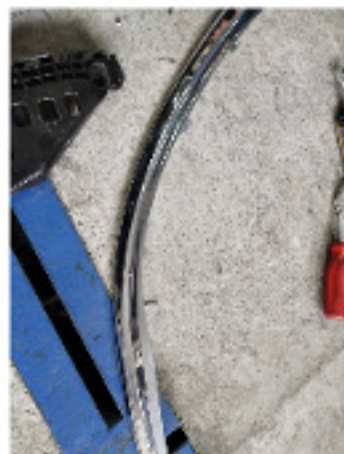
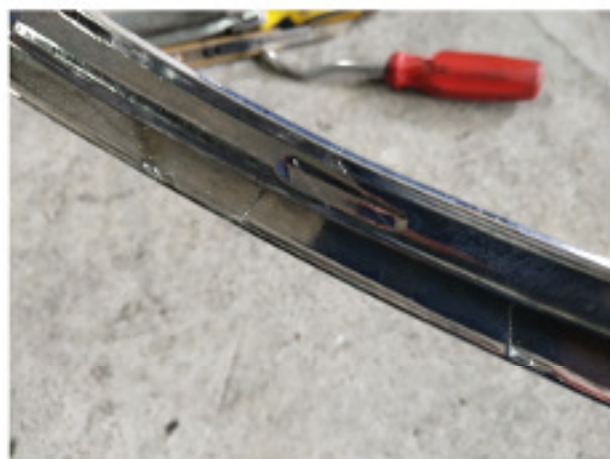
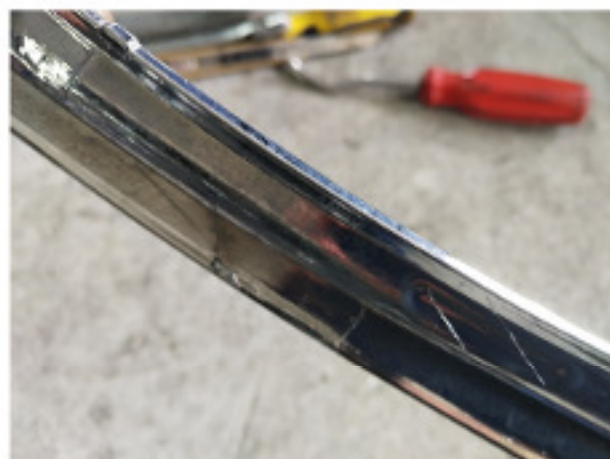
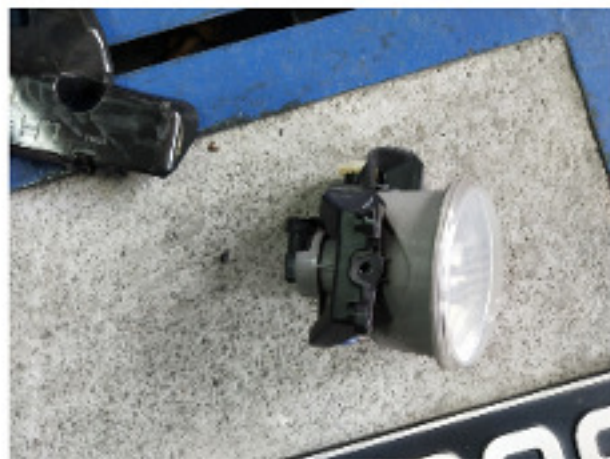
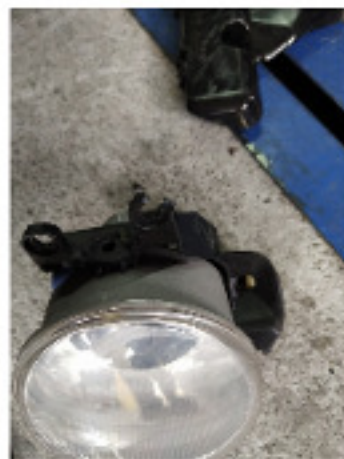
RE-INSPECTION

PHOTOGRAPHS FOR VEHICLE NO. SKX 7999R
