## LKK Auto Consultants Pte Ltd

### ADJUSTMENT ON REPAIR COST FOR VEHICLE NO. SHD 9945Z

PHOTOGRAPHS FOR VEHICLE NO. SHD 9945Z

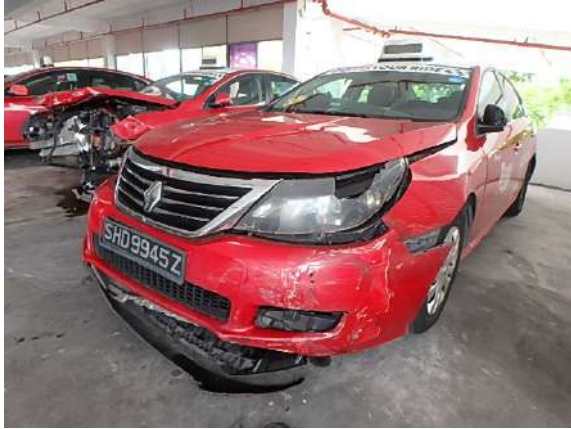
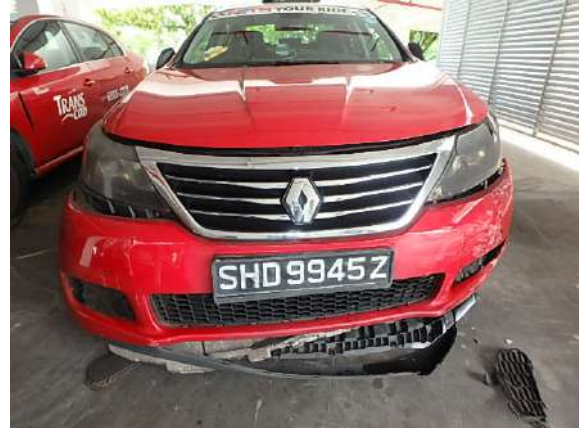
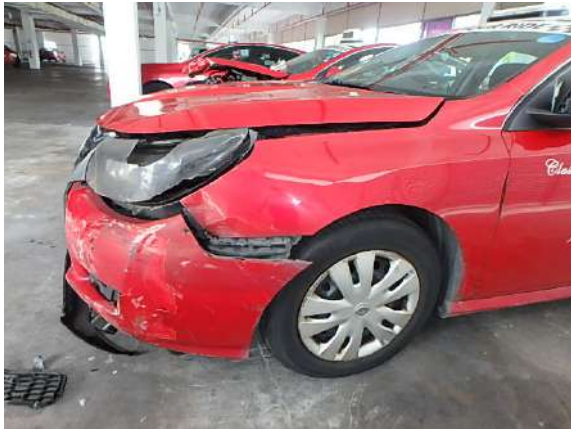
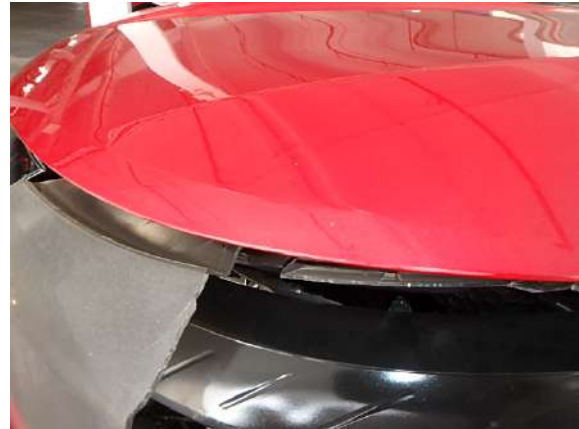
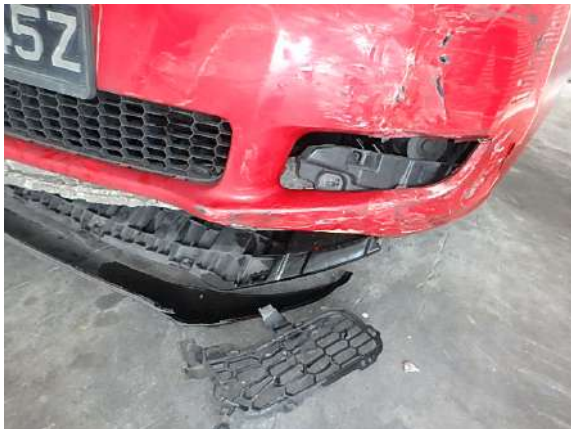
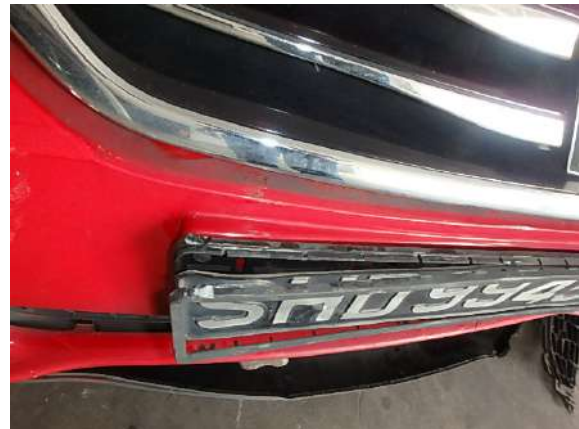
| Affiliated to Federation Internationale Des Experts En Automobile | | | | |
|---|---|---|---|---|
| | THE VEHICLE SUSTAINED DAMAGES AT THE N/S FRONT PORTION.<br>DAMAGES SEE DETAILS. | | | |

INSPECTION

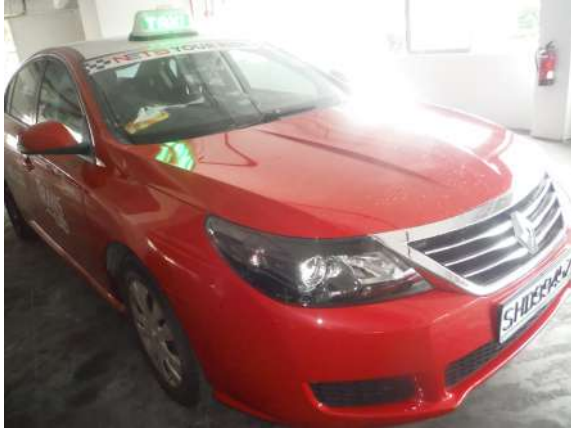
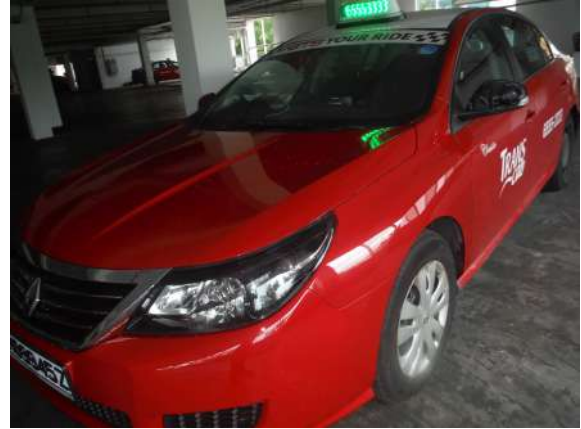
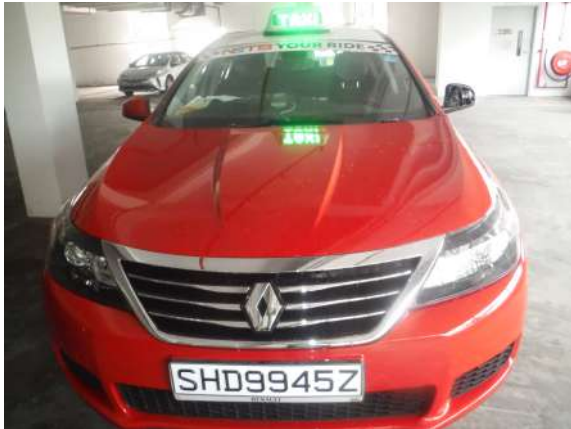
**PHOTOGRAPHS FOR VEHICLE NO. SHD 9945Z**

**RE-INSPECTION**
