# UNITED Appraisal And Management Pte Ltd

Our ref. : UAM20.10.02-PT-STP-CSM-SLG2589B

Re : Third Party Claim For Vehicle Registration No. SLG2589B

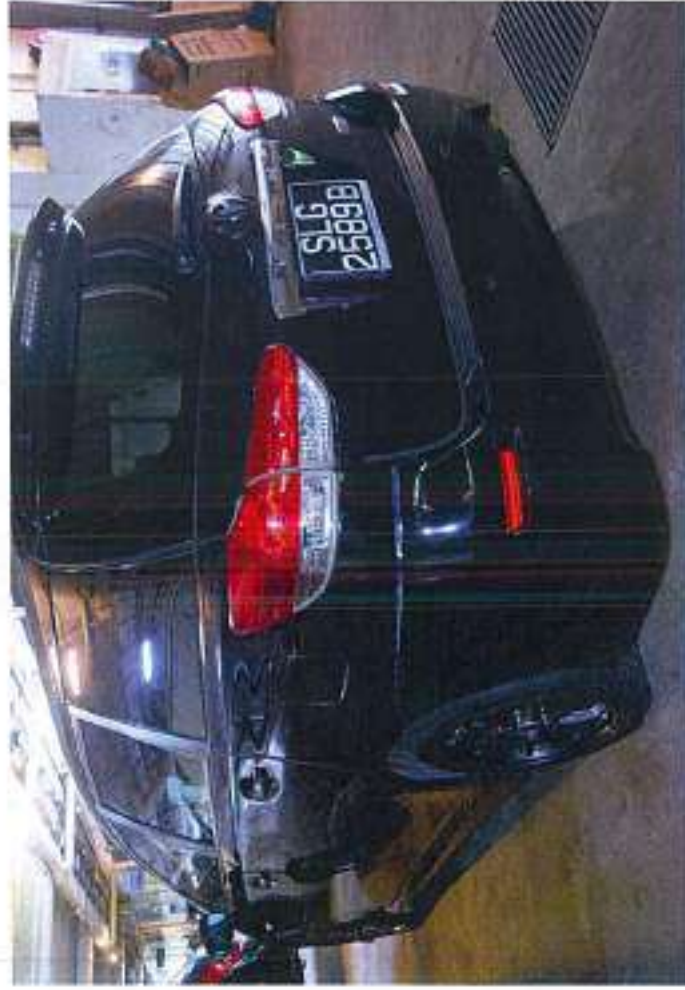
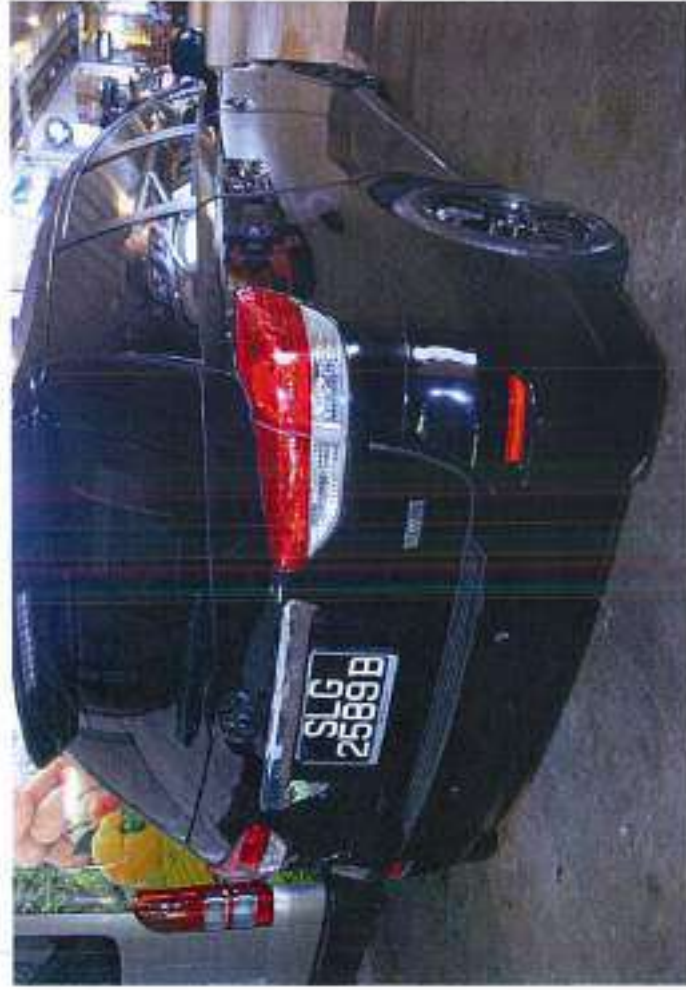
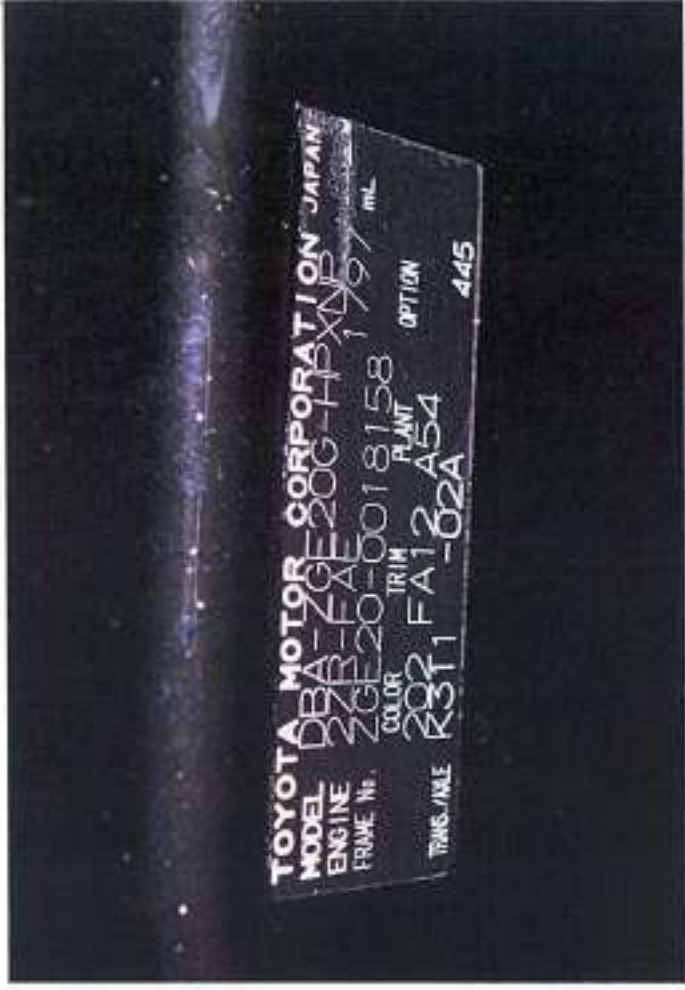
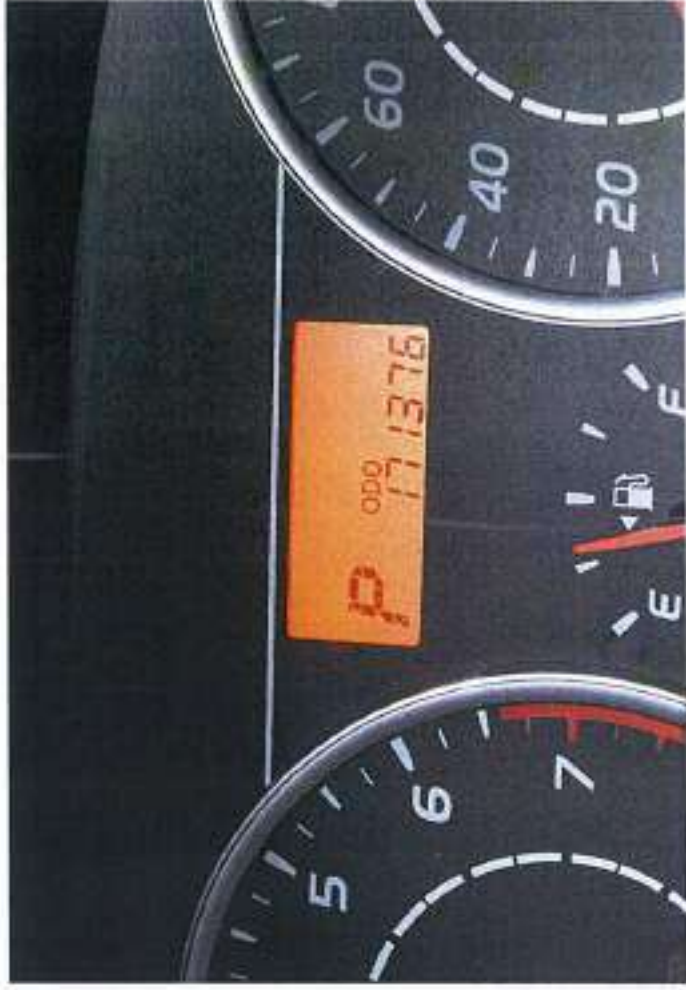
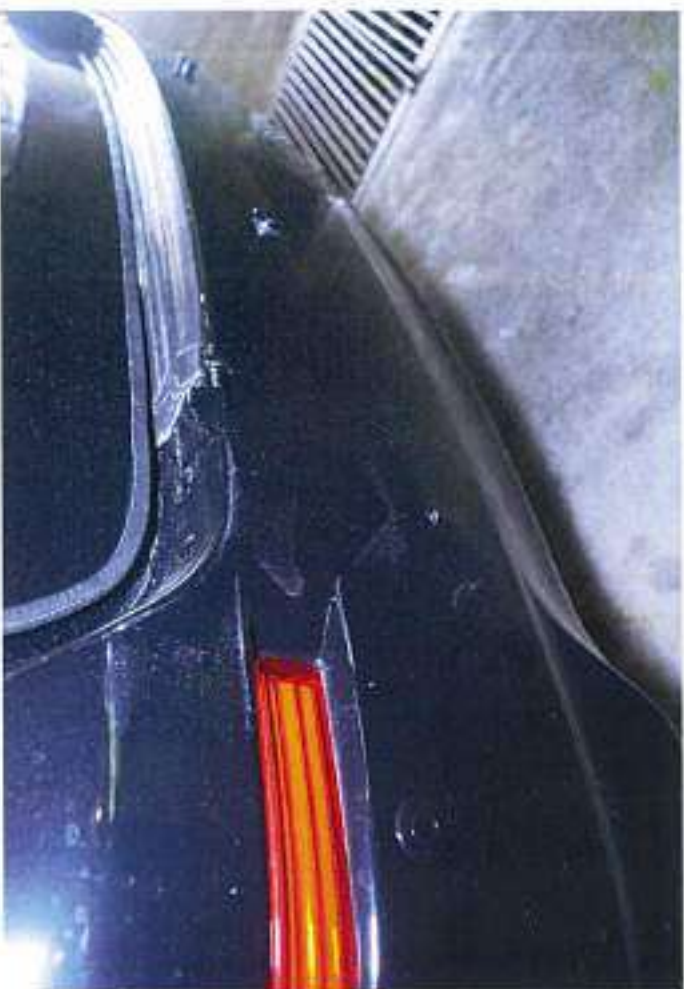
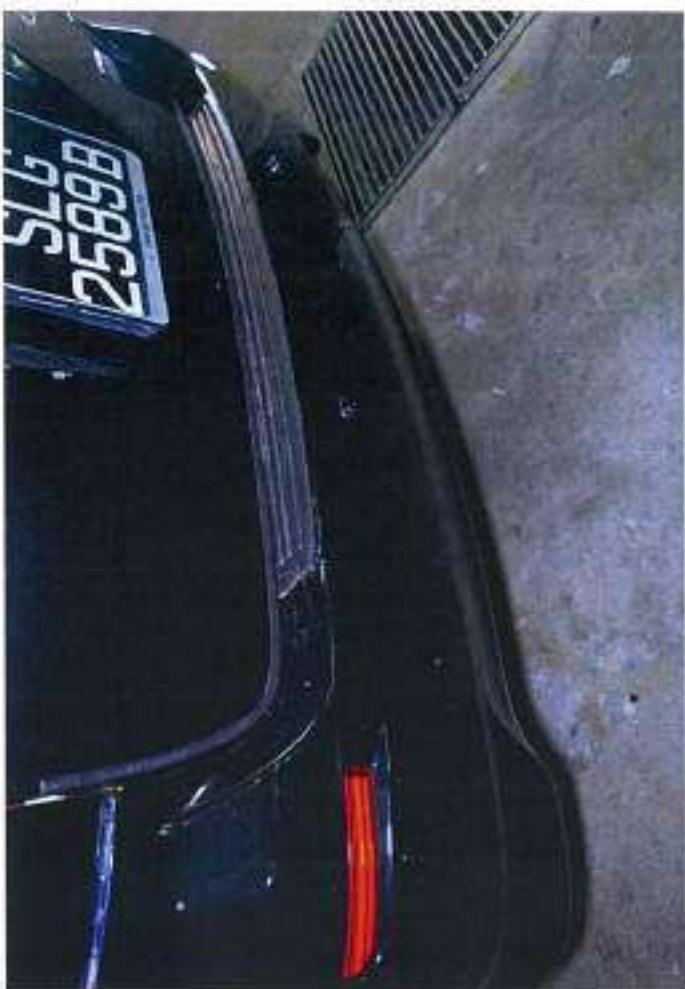
The impact of the collision has damaged / affected the tailgate, taillamps, rear bumper, rear end panel and etc...

Please refer to Annex A (Appraisement Schedule) for a detailed account of the damages and photographs taken.
