**SINCERE**  
APPRAISAL SERVICES PTE LTD

**VEHICLE DAMAGE INSPECTION REPORT**

Our Ref: 592/TP/2018

Reg No:	GBF7912S	Make &	Nissan
Reg date:	16/3/2017	Model	NV200
Colour:	Silver	Engine No:	HR16074351D
Type:	Motor Car	Chassis No:	VM20100365
Type of Claims:	Third Party	Odometer No:	23728km
		Engine Cap:	1597cc

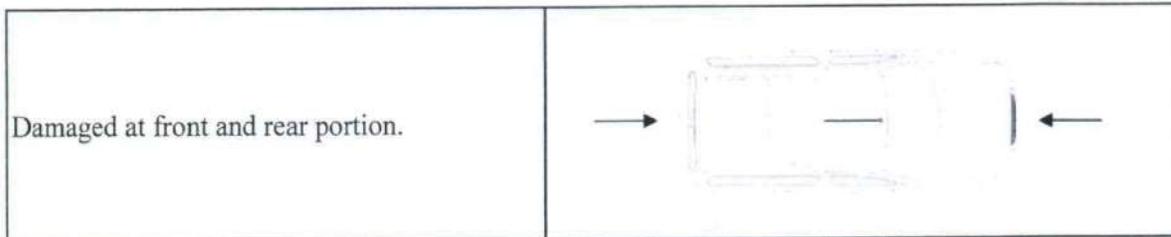
**POINT OF IMPACT**

Our visual inspection of the vehicle revealed that the damages noted are at the front and rear portion.
