## LKK Auto Consultants Pte Ltd

### TAX INVOICE

Vehicle No. SMT 7474K  
Insured Veh. SHB 6616D  
Claim No. D20004266MFSH  
Policy No. D-20094922MFSH  
Accident Date 20/10/2020  
Inspection Date 26/10/2020

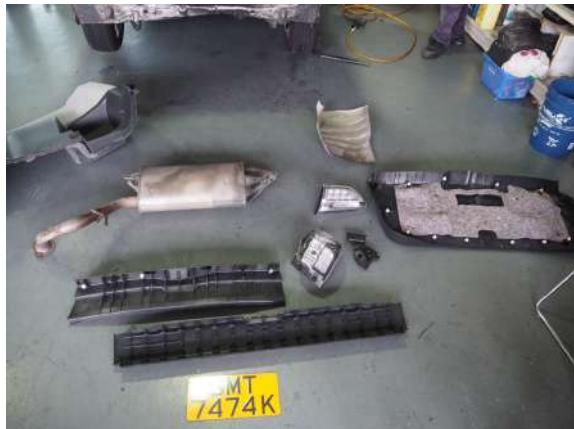
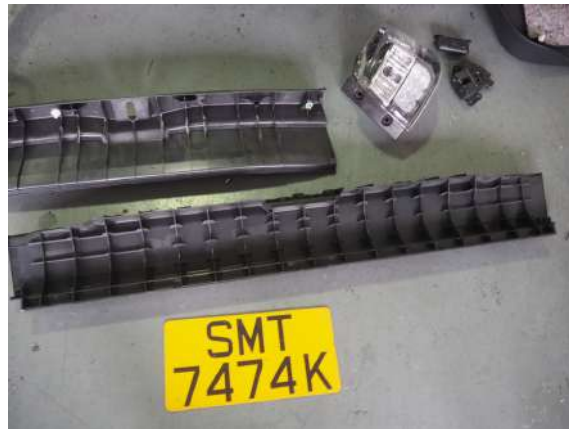
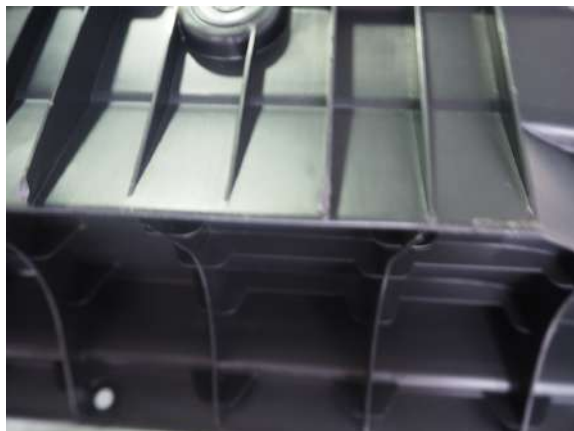
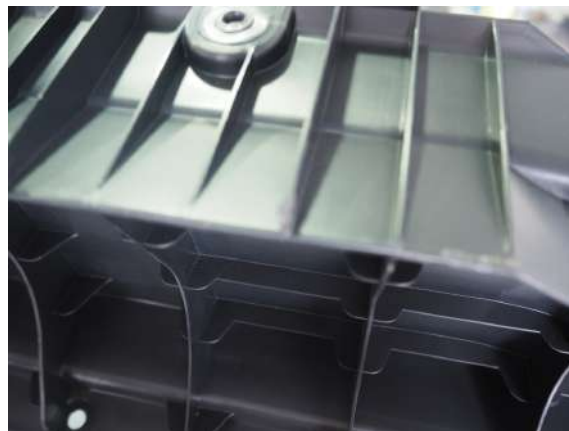
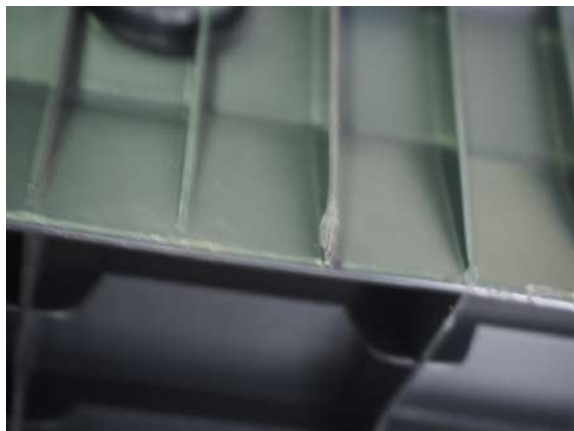
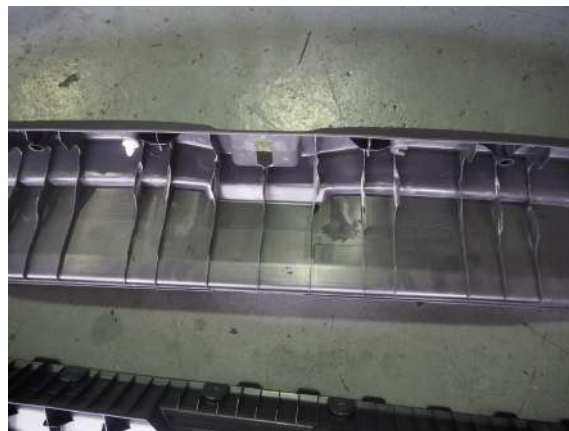
PHOTOGRAPHS FOR VEHICLE NO. SMT 7474K

RE-INSPECTION

| Affiliated to Federation Internationale Des Experts En Automobile | | | | |
|---|---|---|---|--|
| THE VEHICLE SUSTAINED DAMAGES AT THE REAR PORTION.<br><br>DAMAGES SEE DETAILS. | | | | |
