## LKK Auto Consultants Pte Ltd

### PROFESSIONAL SERVICE FEE

### ADJUSTMENT ON REPAIR COST FOR VEHICLE NO. PC 841J

### PHOTOGRAPHS FOR VEHICLE NO. PC 841J

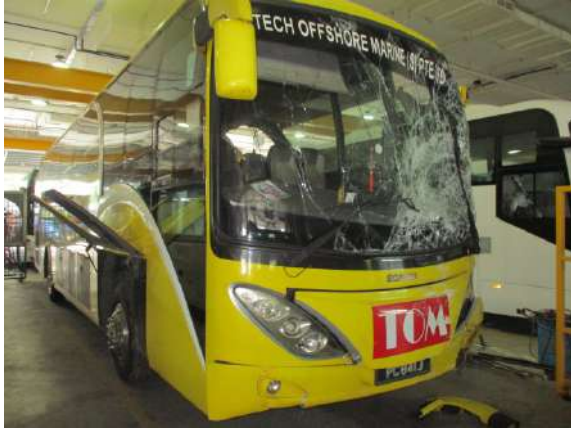
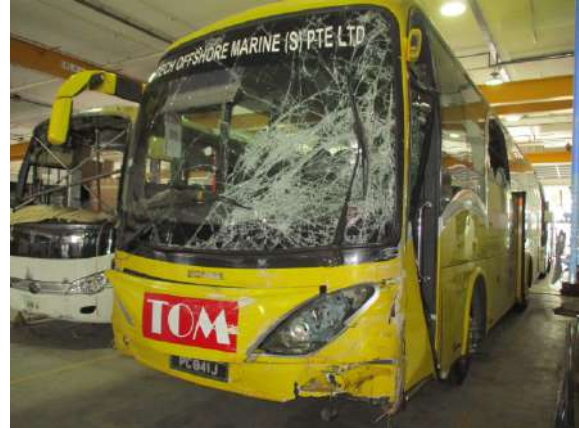
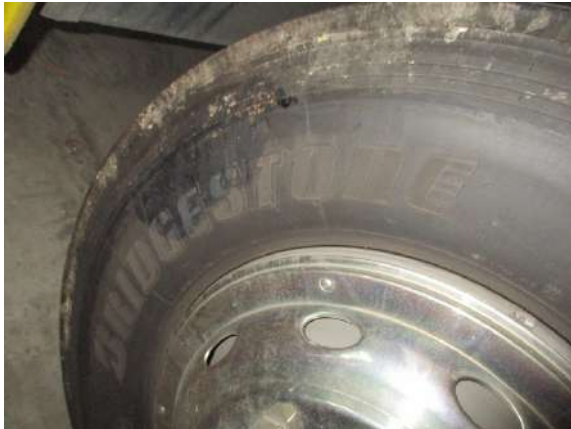
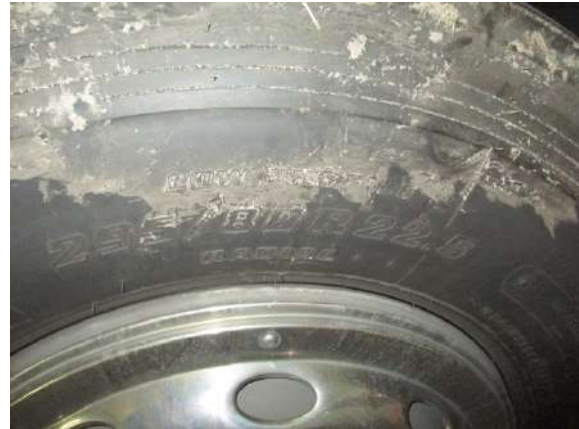
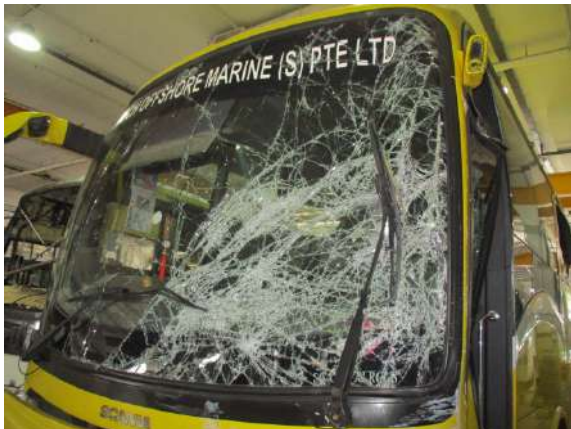
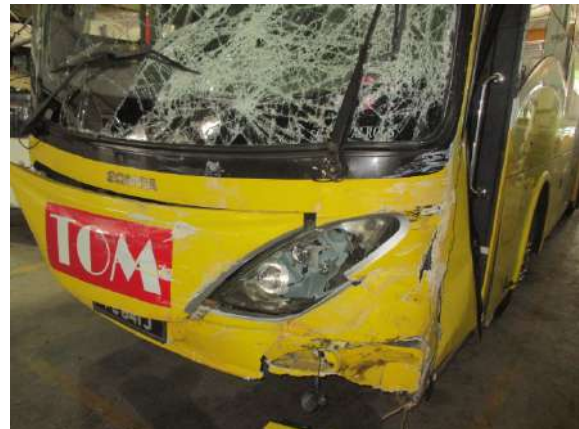
### INSPECTION

| Affiliated to Federation Internationale Des Experts En Automobile | | | | |
|---|---|---|---|--|
| THE VEHICLE SUSTAINED DAMAGES AT THE FRONT PORTION AND N/S BODY.<br>DAMAGES SEE DETAILS. | | | | |

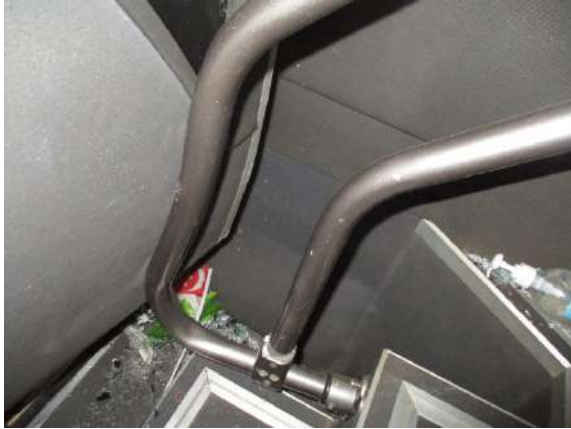
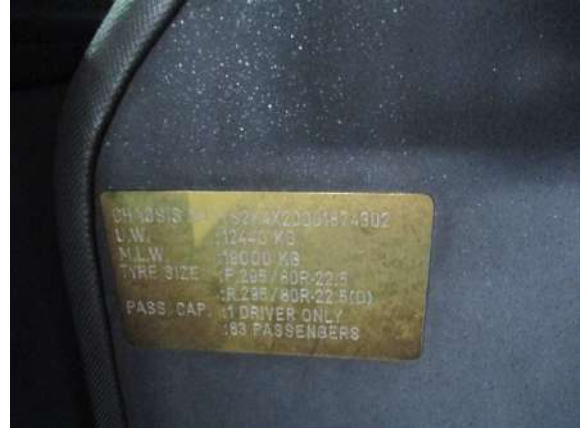
CH10SIS 5274X20001874302  
G.W. 12440 KG  
M.L.W. 18000 KG  
TYRE SIZE F 295/80R-22.5  
R 295/80R-22.5(D)  
PASS. CAP. 1 DRIVER ONLY  
183 PASSENGERS

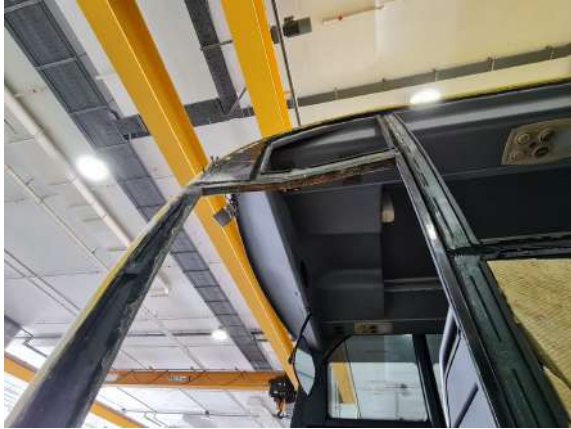
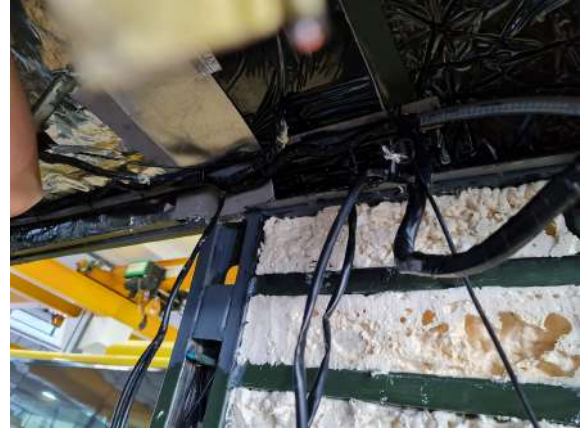
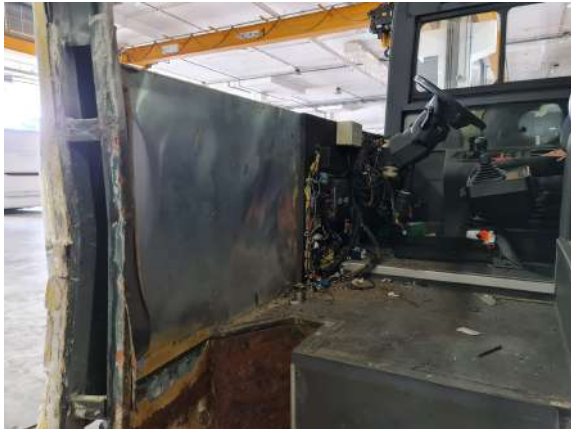
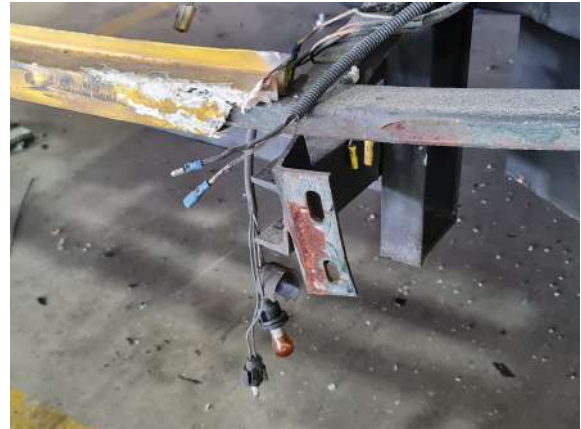
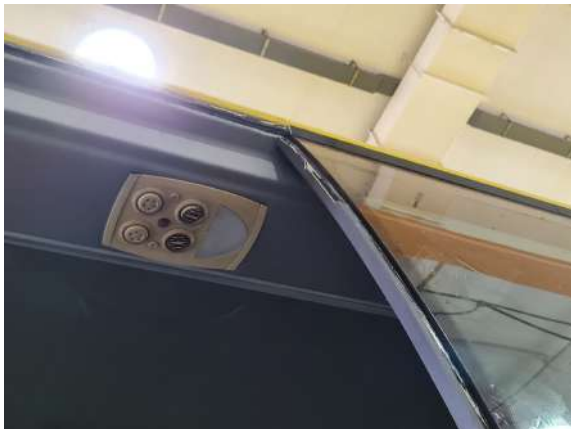
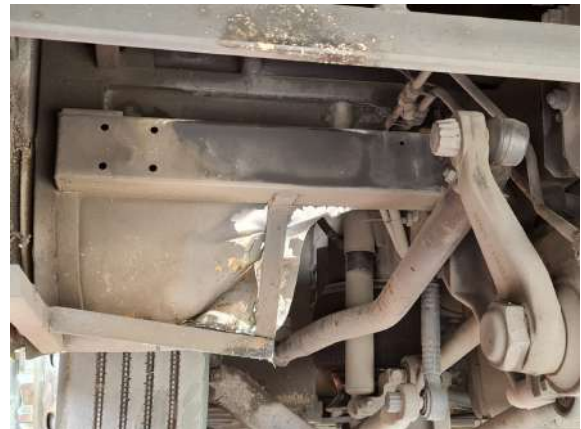
**PHOTOGRAPHS FOR VEHICLE NO. PC 841J**

**RE-INSPECTION**
