2. Vehicle Particulars & Condition				
Make & Model	HONDA FIT (A)	c.c	1317	
Engine No.	HIDDEN	Year of Reg.	2020	
Chassis No.	GK31352957	Colour	METALLIC YELLOW	
Odometer	12023 KM	Steering	IN ORDER	
Brakes	IN ORDER	Modification	SPORTS RIM	
General	GOOD

ADJUSTMENT ON REPAIR COST FOR VEHICLE NO. SMS 426B

PHOTOGRAPHS FOR VEHICLE NO. SMS 426B

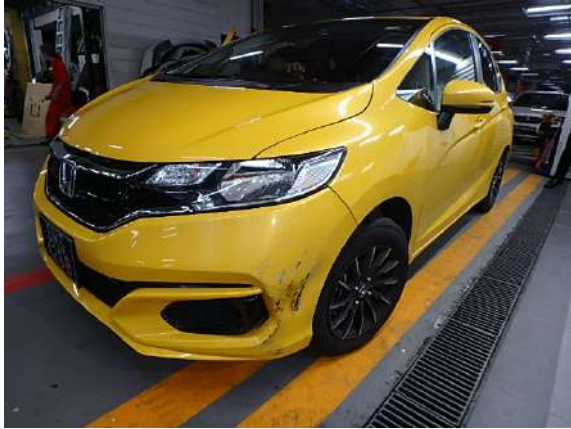
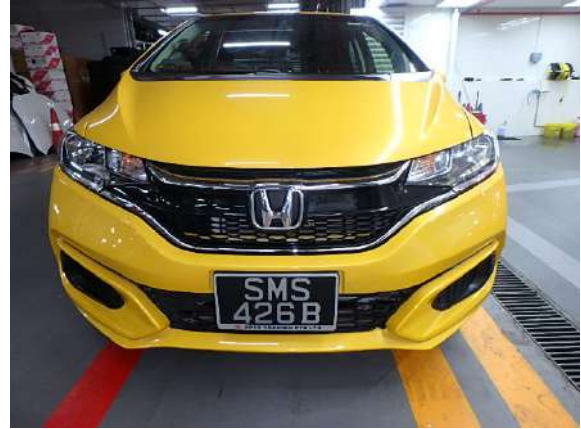
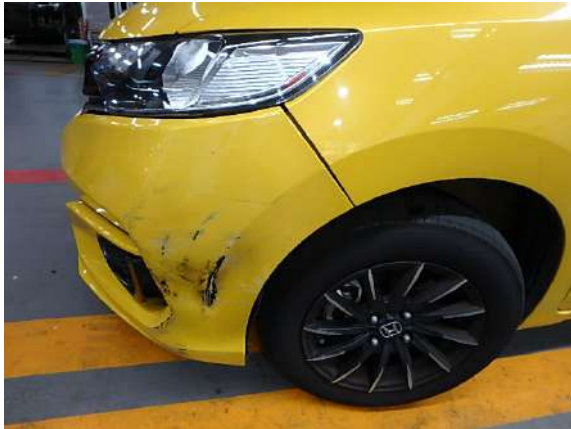
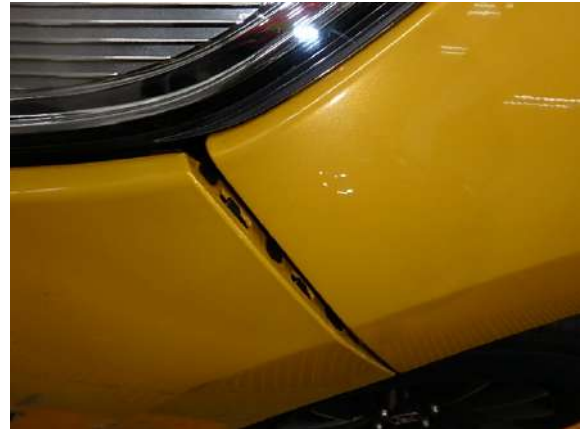
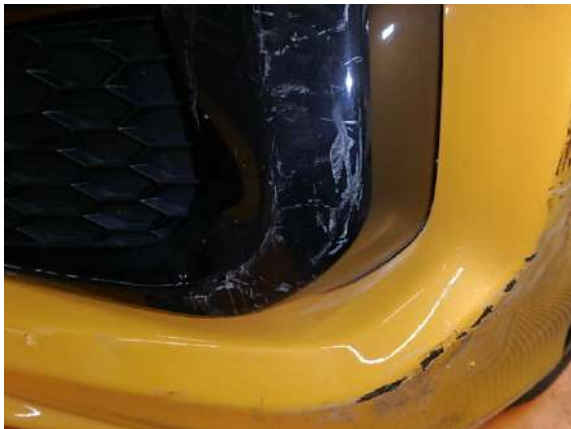
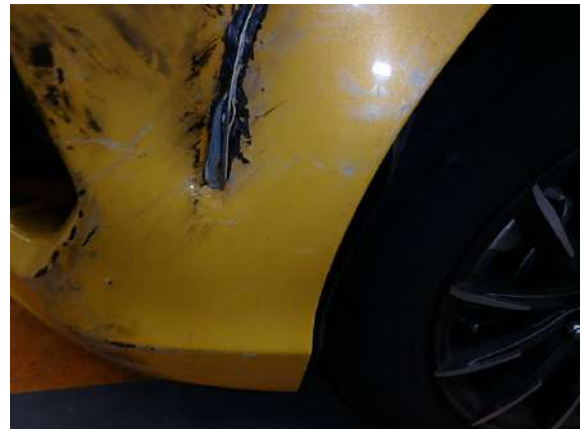
INSPECTION

4. Description of Damages				
THE VEHICLE SUSTAINED DAMAGES AT THE N/S FRONT PORTION. DAMAGES SEE DETAILS.				
5. General Information				
Accident Date	17/10/2020	Inspection Date	28/10/2020	
Survey held at	OPTIMA WERKZ PTE LTD 6, KUNG CHONG ROAD SINGAPORE 159143			
5a. Remarks				
A)THE INSPECTION WAS CONDUCTED ON A"WITHOUT PREJUDICE" BASIS. B)IN ACCORDANCE TO YOUR INSTRUCTIONS, WE HAVE NOT AUTHORISED REPAIRS.				
5b. Estimate Days of Repair				
ESTIMATED NORMAL PERIOD FOR REPAIR:			2 Working Days

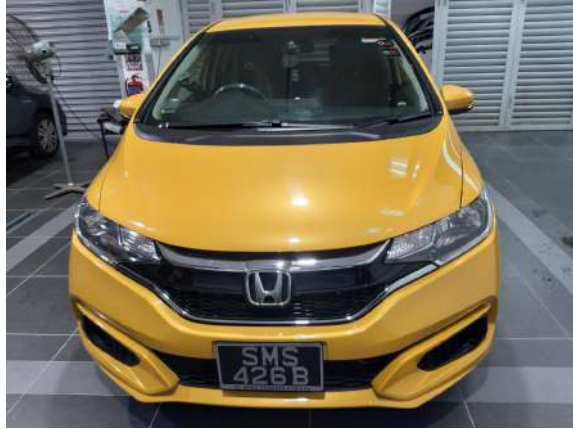
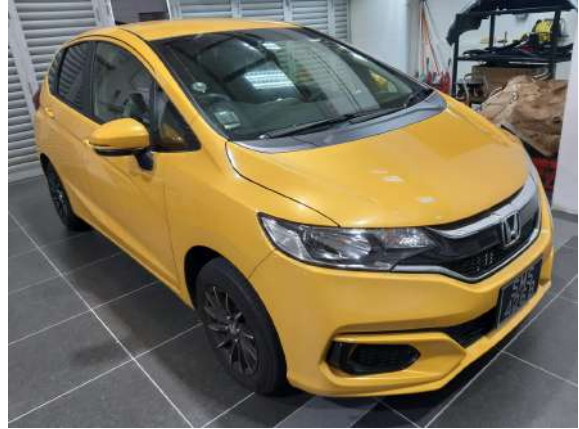
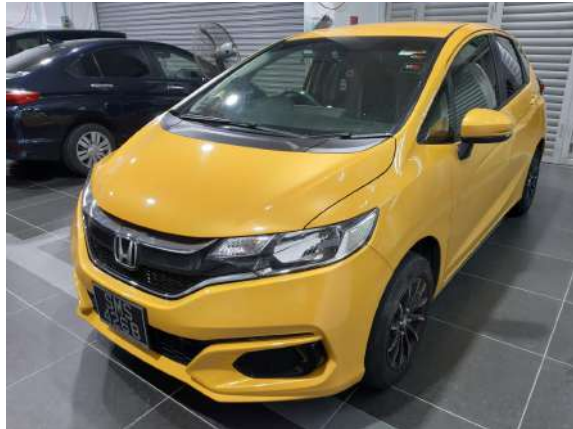
PHOTOGRAPHS FOR VEHICLE NO. SMS 426B

RE-INSPECTION
