## LKK Auto Consultants Pte Ltd

## ADJUSTMENT ON REPAIR COST FOR VEHICLE NO. SKN 9183S

PHOTOGRAPHS FOR VEHICLE NO. SKN 9183S

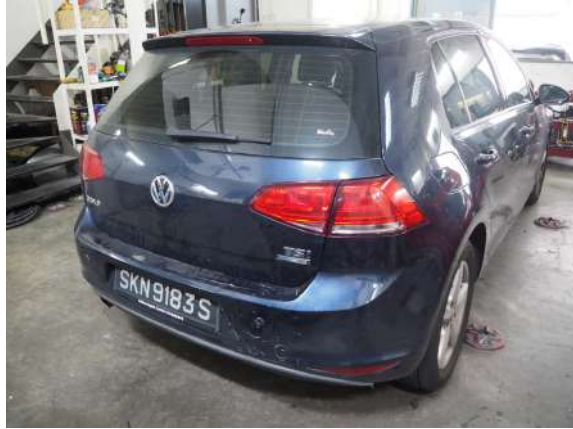
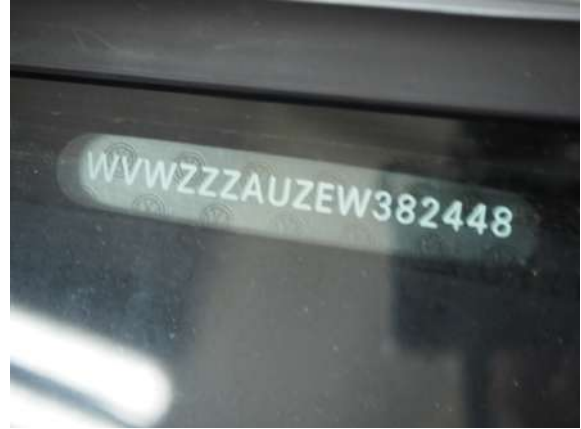
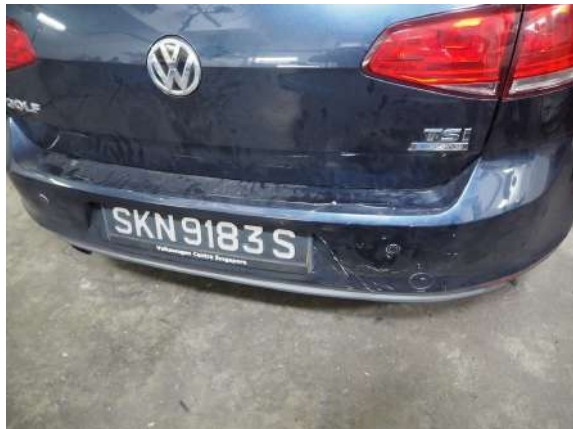
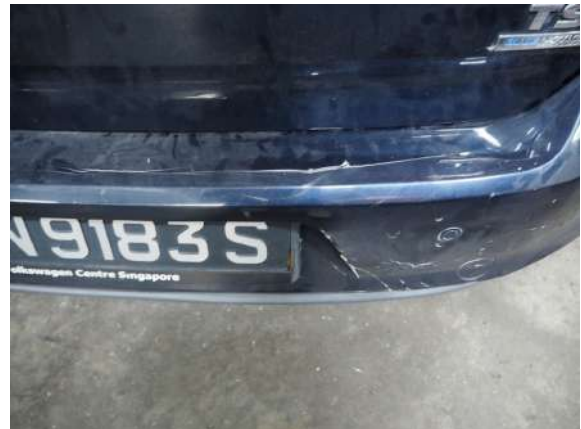
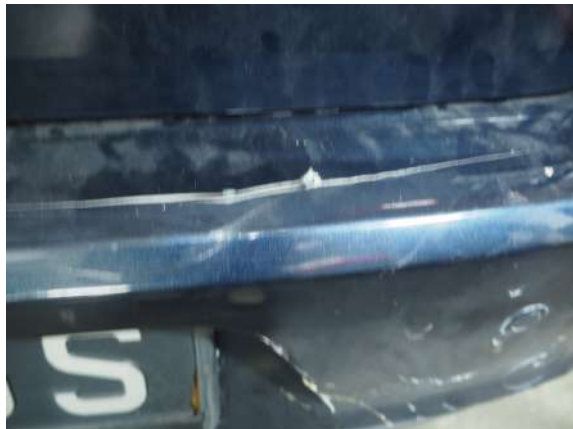
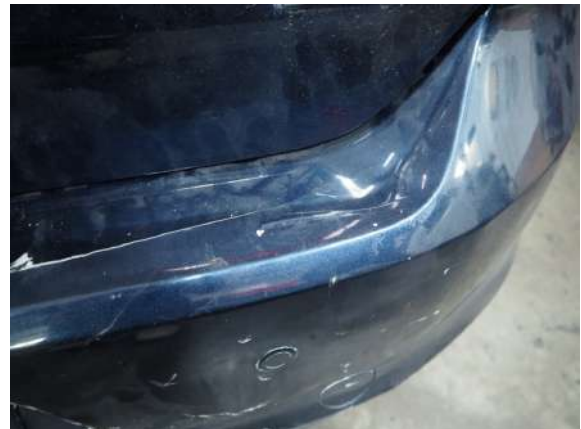
INSPECTION

| Affiliated to Federation Internationale Des Experts En Automobile | | | | |
|---|---|---|---|---|
| | THE VEHICLE SUSTAINED DAMAGES AT THE REAR PORTION.<br><br>DAMAGES SEE DETAILS. | | | |

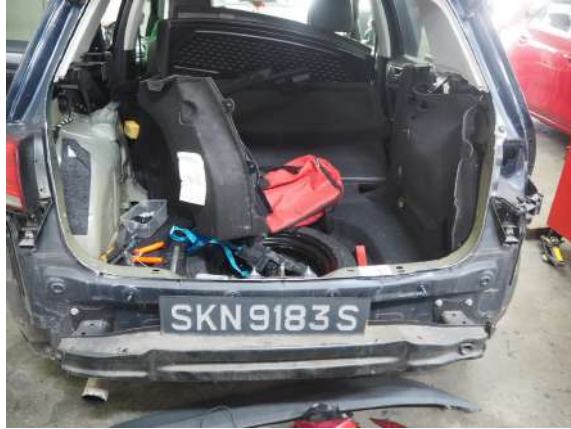
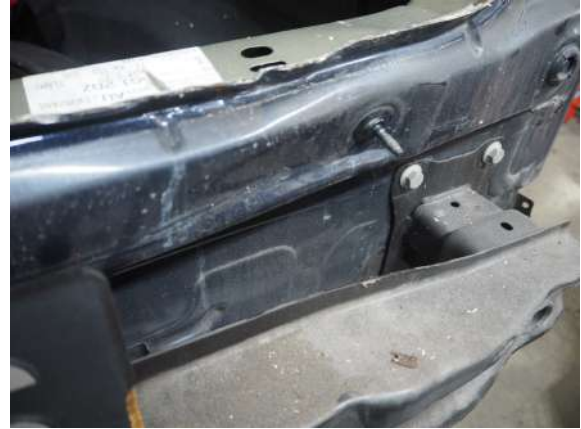
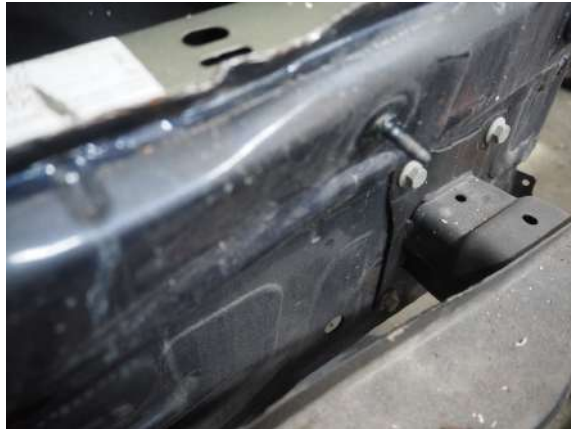
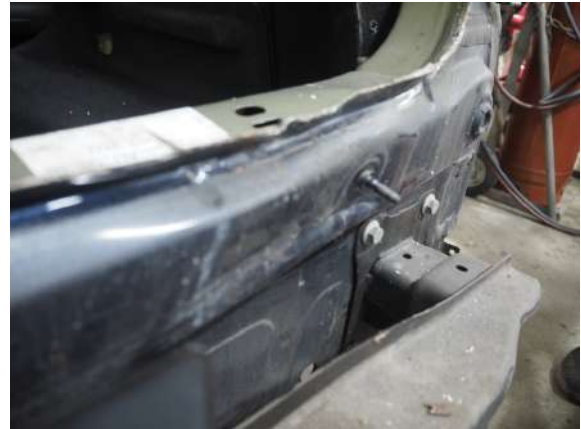
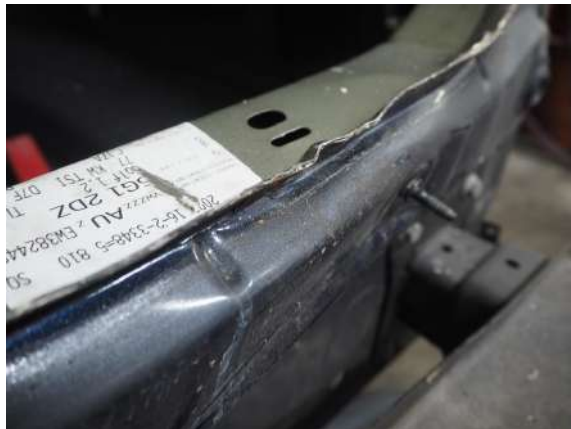
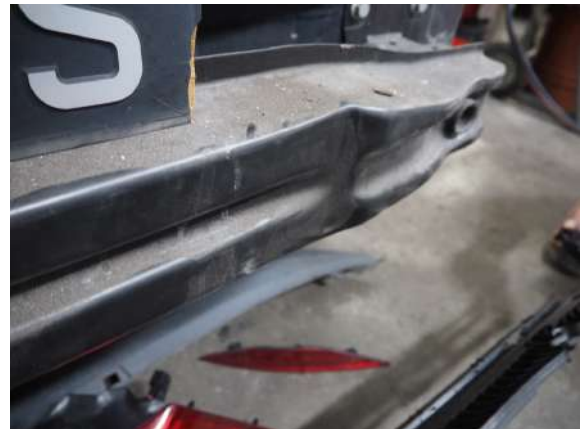
RE-INSPECTION

PHOTOGRAPHS FOR VEHICLE NO. SKN 9183S
