TAX INVOICE

PROFESSIONAL SERVICE FEE

ADJUSTMENT ON REPAIR COST FOR VEHICLE NO. SHD 613R

PHOTOGRAPHS FOR VEHICLE NO. SHD 613R

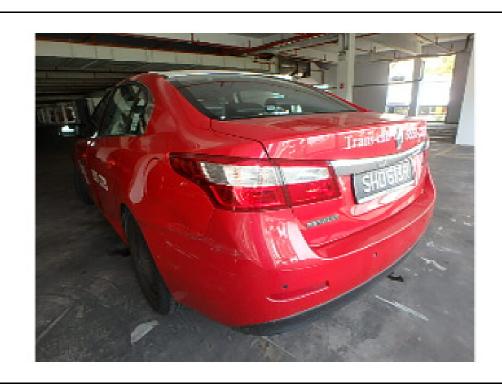
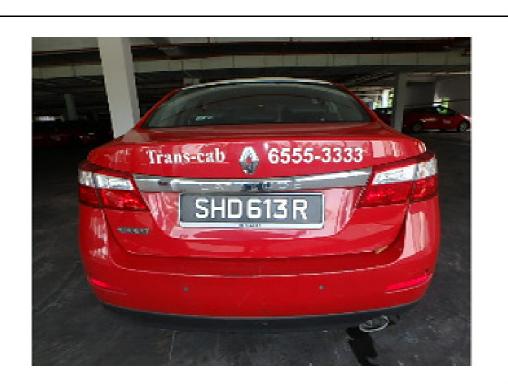
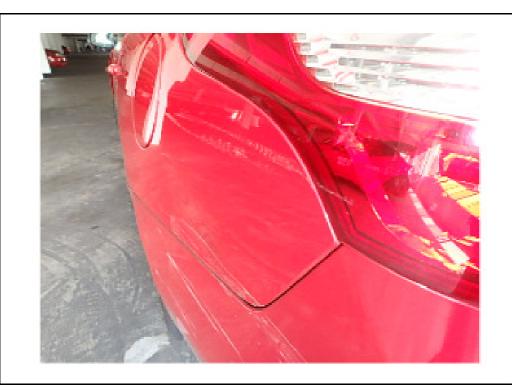
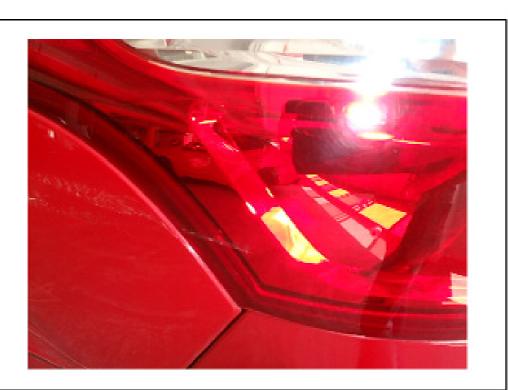
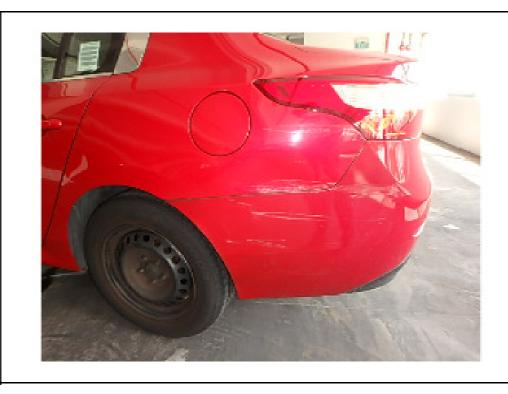
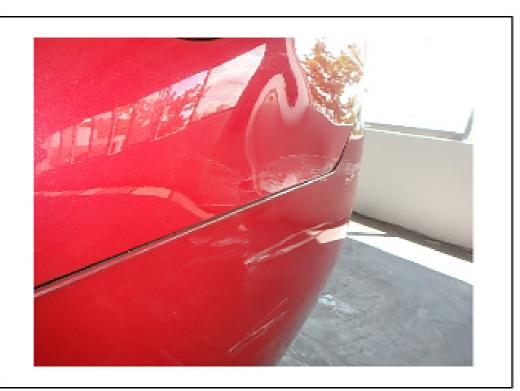
4.		Description	on of Damages	
	THE VEHICLE SU	STAINED DAMAGES AT THE N/S	REAR PORTION.	
	DAMAGES SEE D	ETAILS.		
5.		General	Information	
	Accident Date	23/10/2020	Inspection Date	27/10/2020
	Survey held at	TRANS-CAB AUTO SERVICES	PTE LTD	
		NO.2 ANG MO KIO ST 63 SINGAPORE 569111		
5a.		Re	emarks	
		ON WAS CONDUCTED ON A"WIT CE TO YOUR INSTRUCTIONS, W		
5b.				
	ESTIMATED NORI	MAL PERIOD FOR REPAIR:	2 Working Days

INSPECTION
