## LKK Auto Consultants Pte Ltd

### PROFESSIONAL SERVICE FEE

Vehicle No. SLN 6702C

**ADJUSTMENT ON REPAIR COST FOR VEHICLE NO. SLN 6702C**

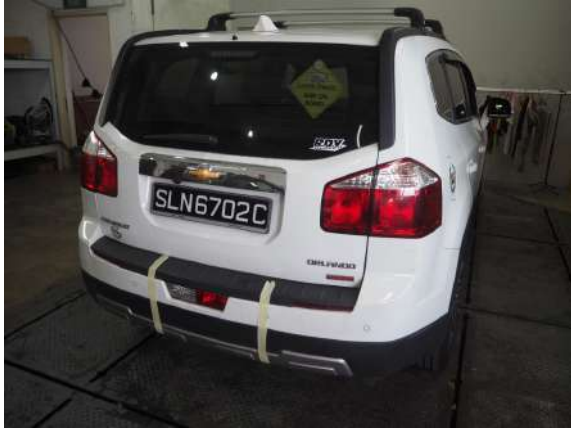
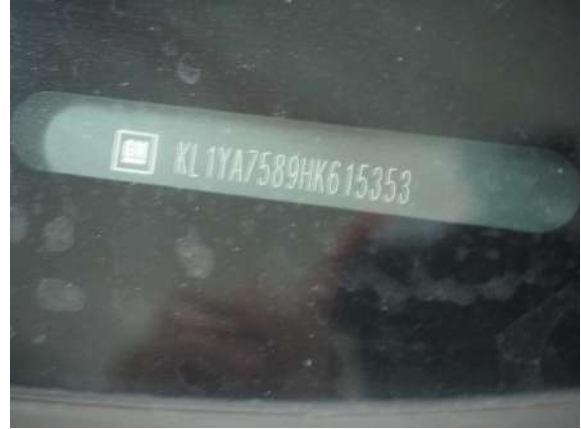
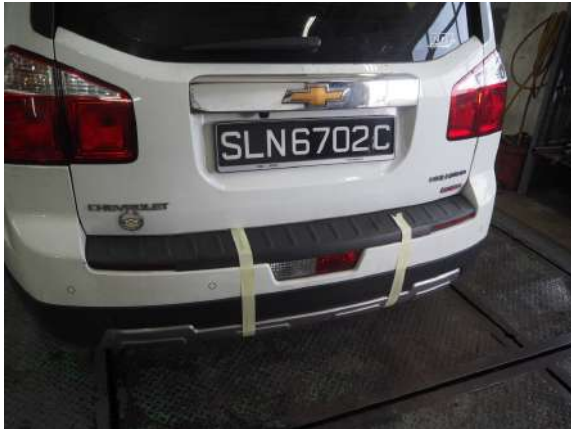
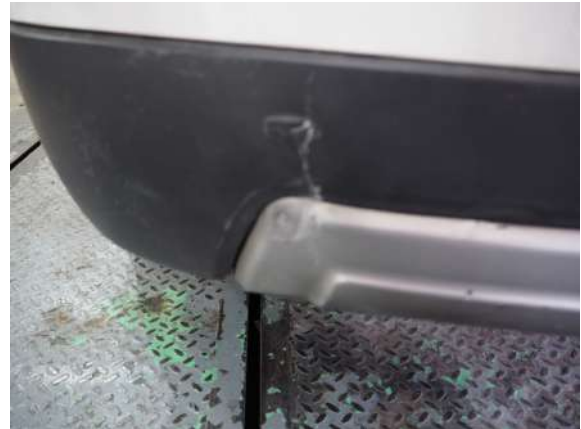
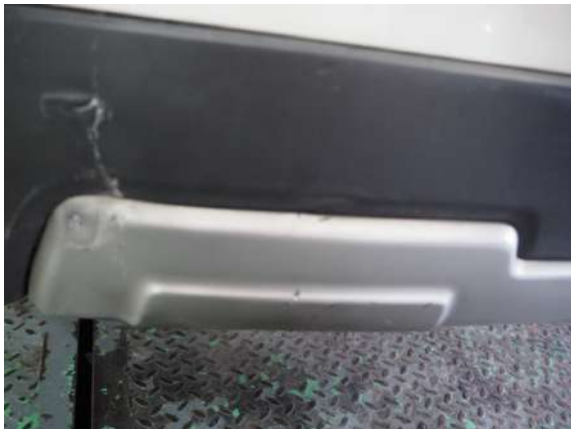
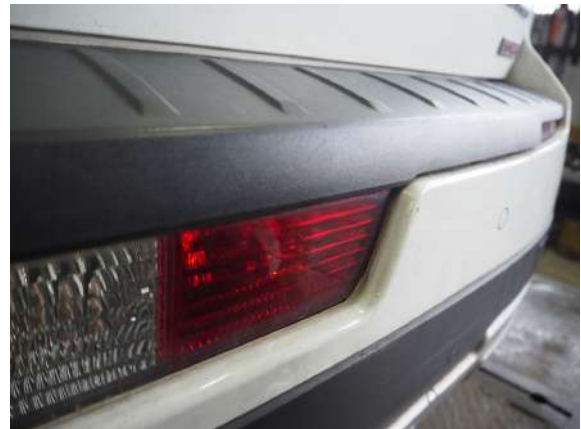
### INSPECTION

| Affiliated to Federation Internationale Des Experts En Automobile | | | | |
|---|---|---|---|---|
| THE VEHICLE SUSTAINED DAMAGES AT THE REAR PORTION.<br>DAMAGES SEE DETAILS. | | | | |

### PHOTOGRAPHS FOR VEHICLE NO. SLN 6702C

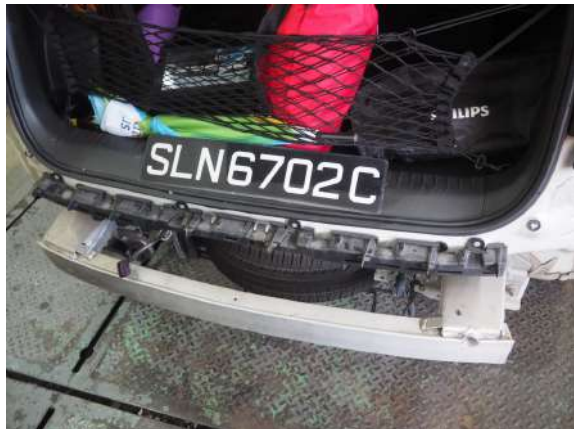
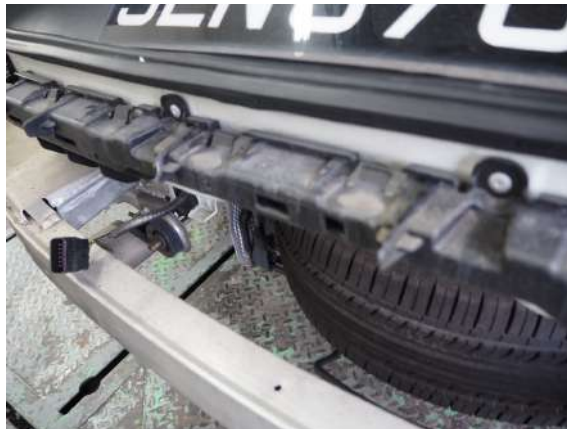
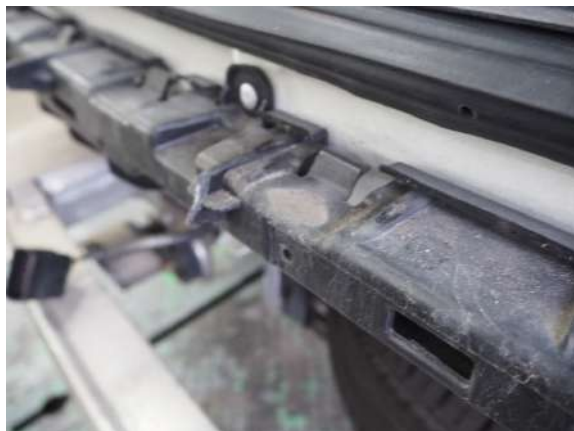
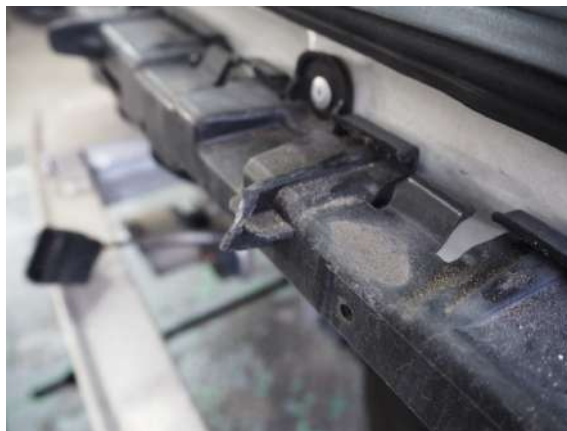
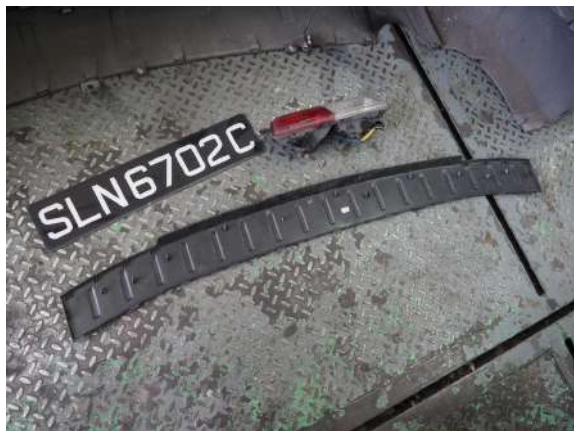
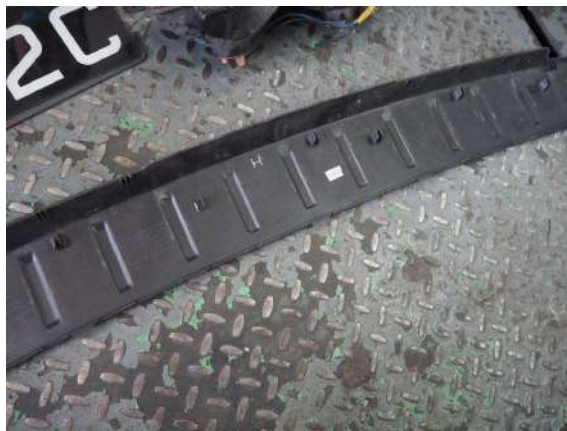
RE-INSPECTION

PHOTOGRAPHS FOR VEHICLE NO. SLN 6702C
