Vehicle No. SLN 9527Y  
Insured Veh. SHA 771H  
Claim No. D20004454MFSH  
Policy No. D-18088937MFSH  
Accident Date 30/10/2020  
Inspection Date 24/11/2020

## ADJUSTMENT ON REPAIR COST FOR VEHICLE NO. SLN 9527Y

**PHOTOGRAPHS FOR VEHICLE NO. SLN 9527Y**

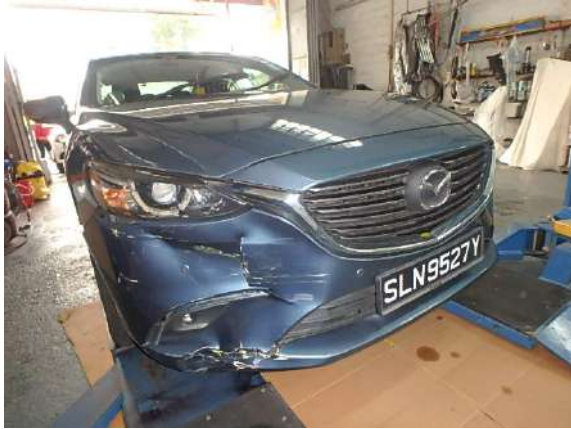
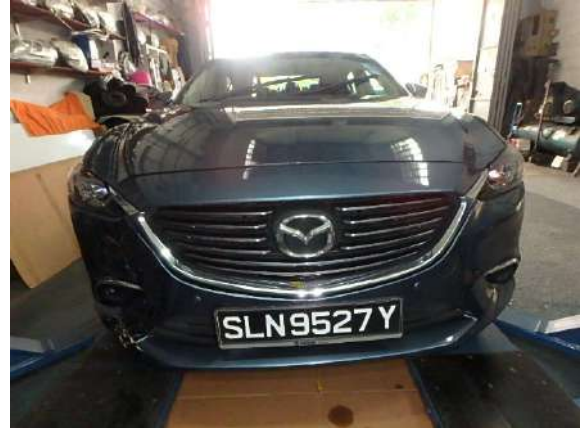
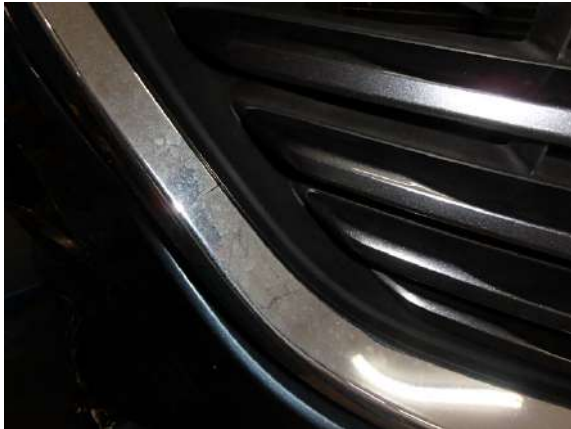
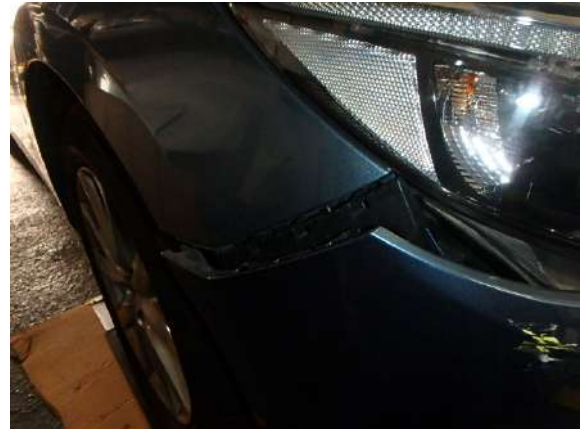
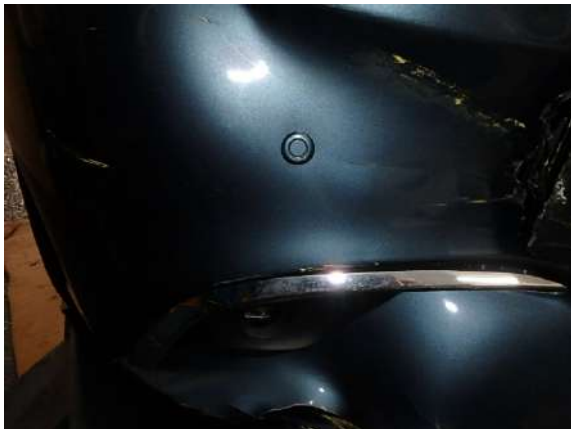
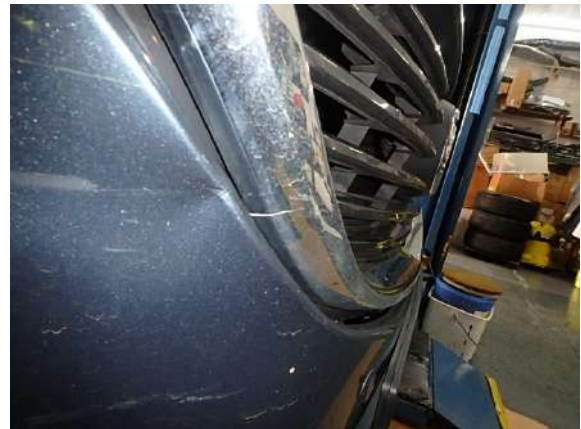
**INSPECTION**

| Affiliated to Federation Internationale Des Experts En Automobile | | | | |
|---|---|---|---|--|
| THE VEHICLE SUSTAINED DAMAGES AT THE FRONT O/S PORTION.<br>DAMAGES SEE DETAILS. | | | | |

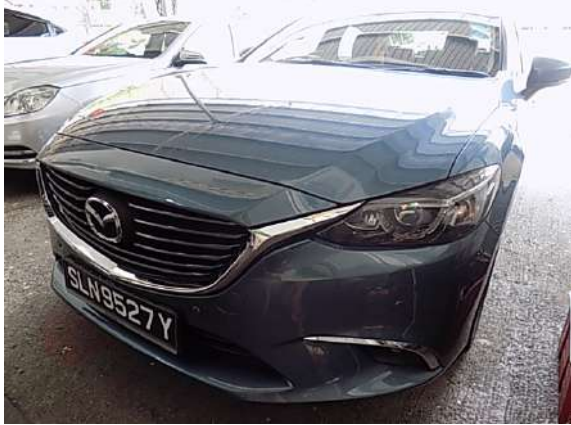
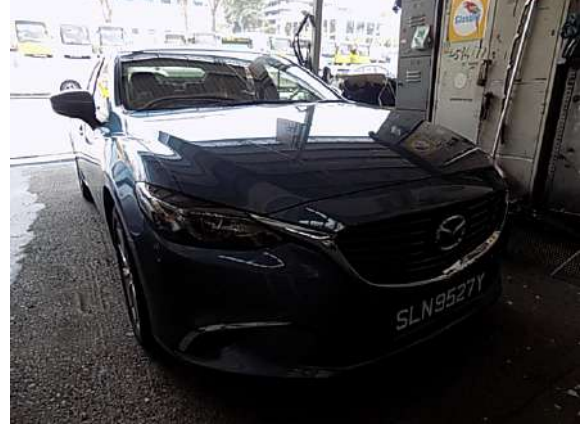
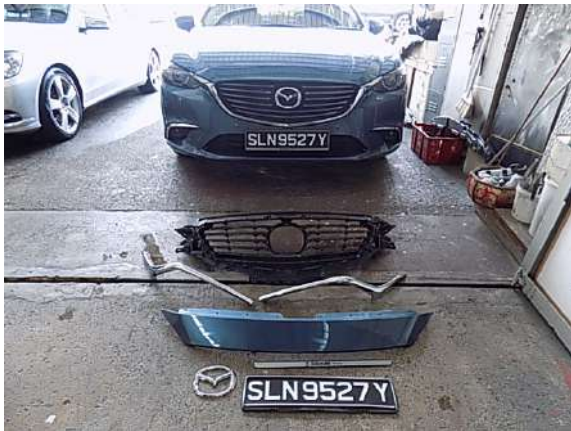
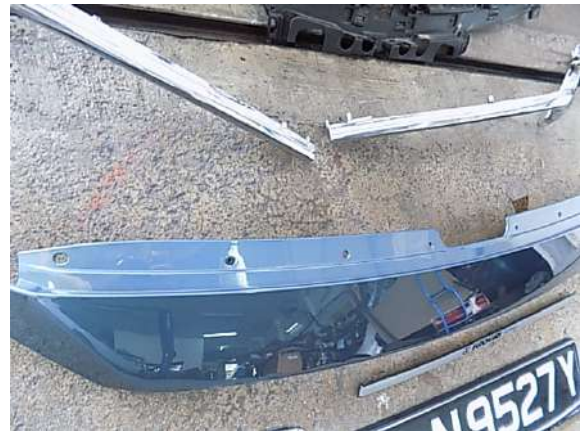
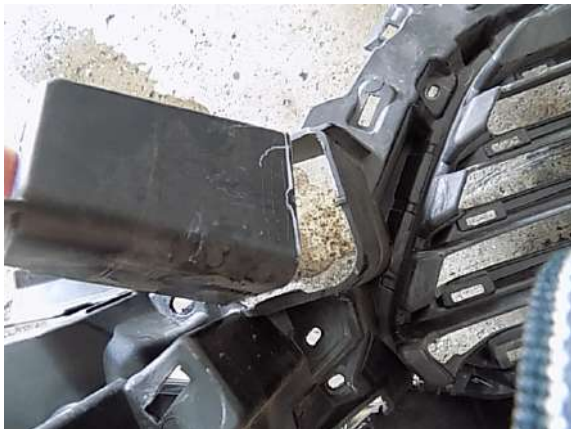
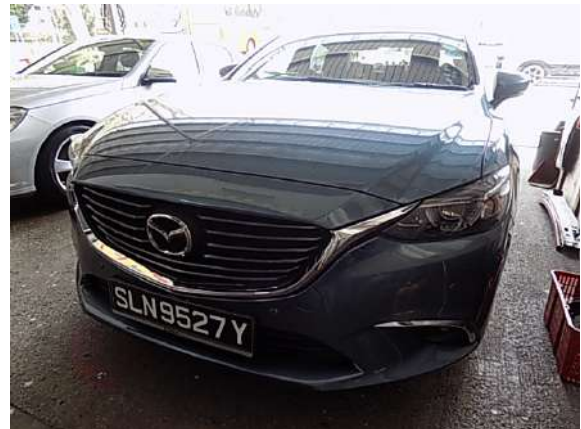
PHOTOGRAPHS FOR VEHICLE NO. SLN 9527Y

RE-INSPECTION
