# PAR Automotive Consultancy

Report No: 0124-20-TCA

## ACCIDENT VEHICLE SURVEY REPORT

| Make & Model: | Nissan Cabstar 3/0 5M/T | Colour: | White |

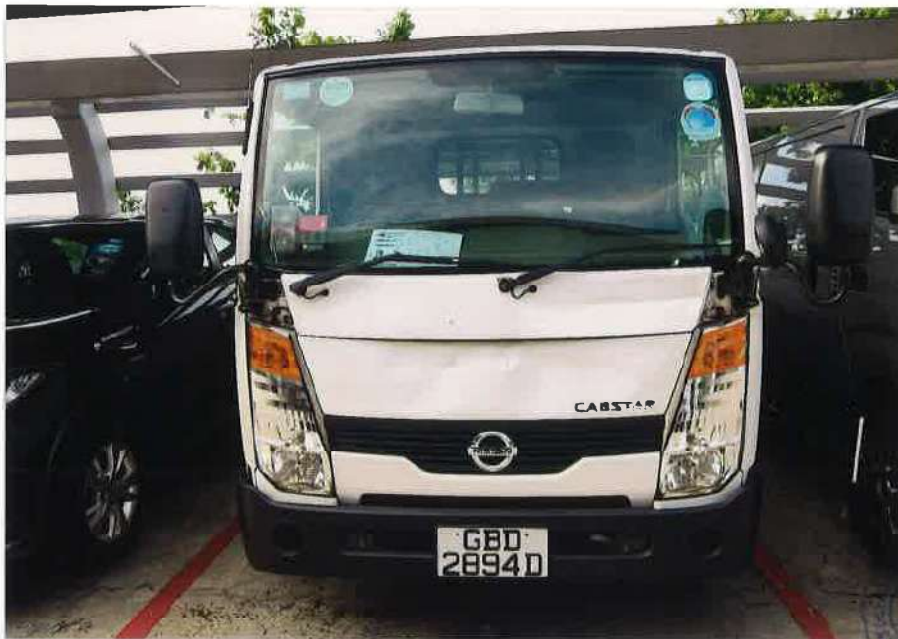
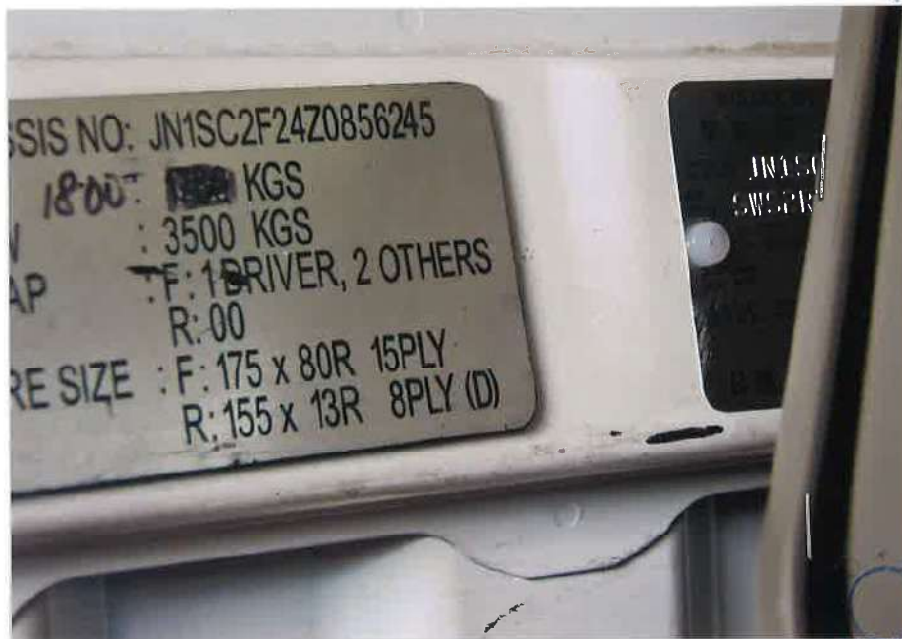
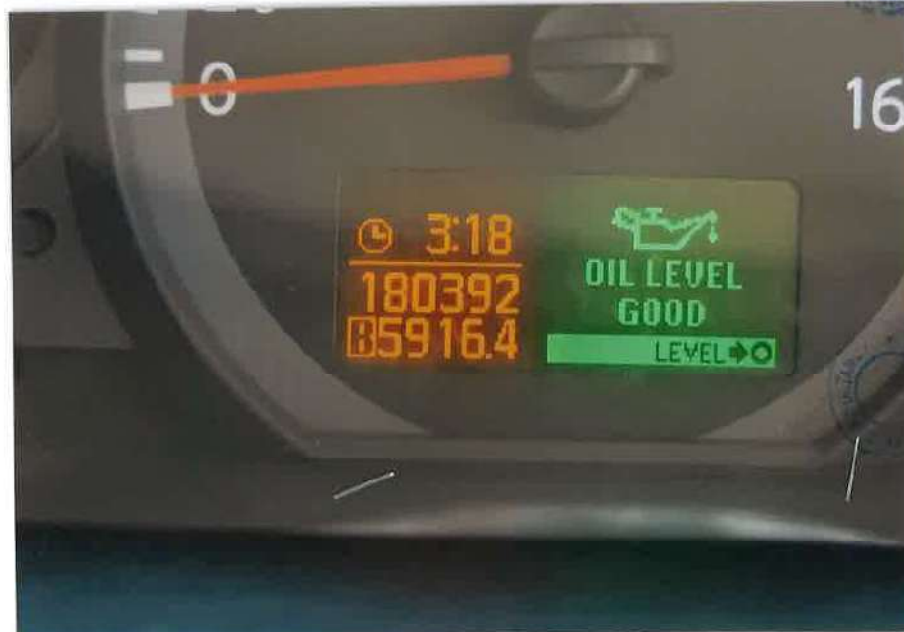
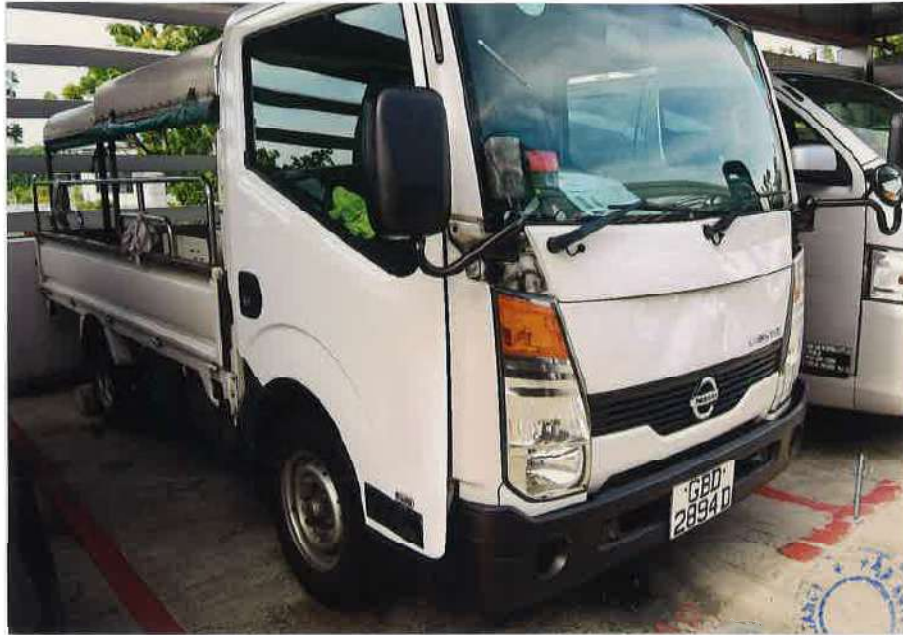
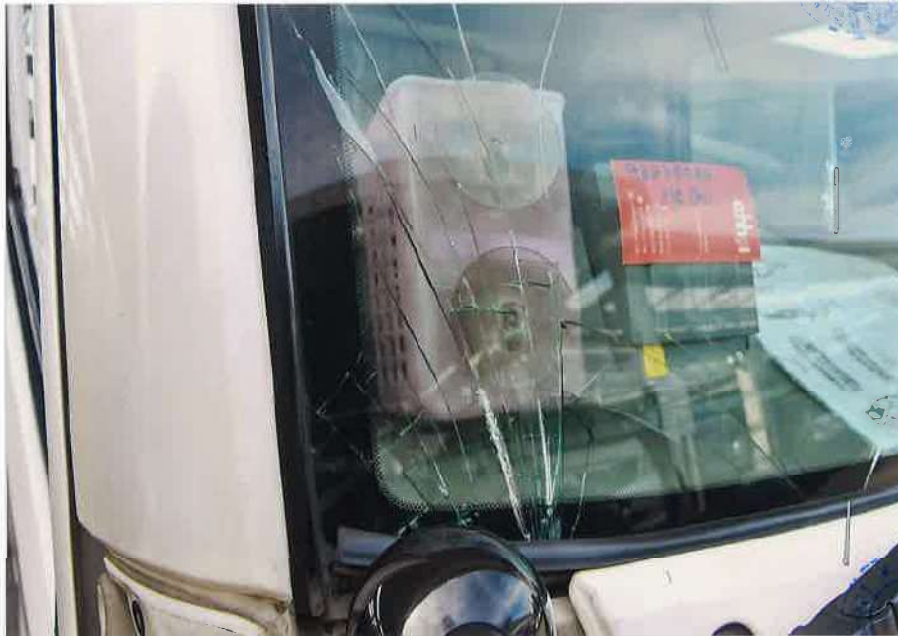
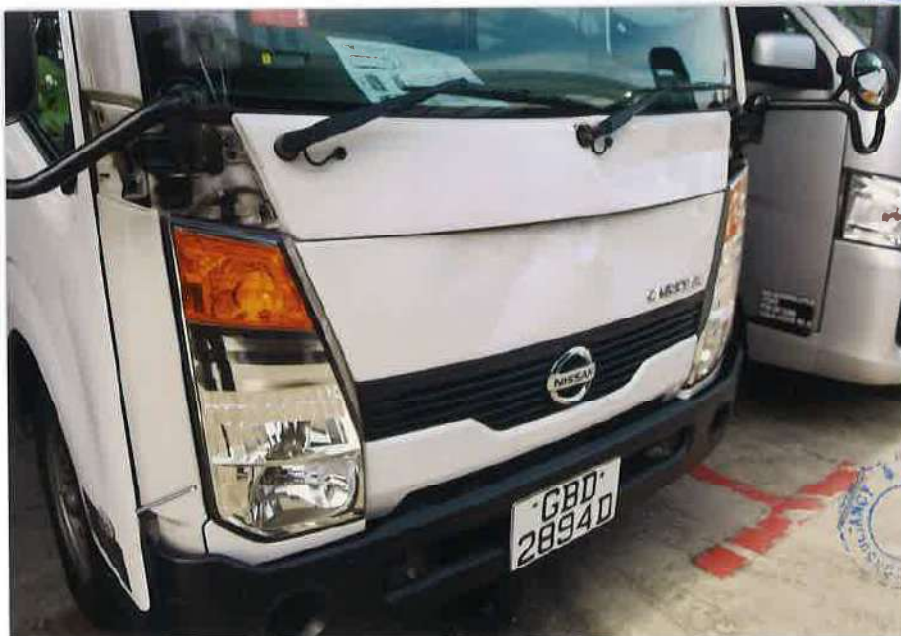
Impact on the front portion.  
Please see details as described in the Annex for parts and labour.

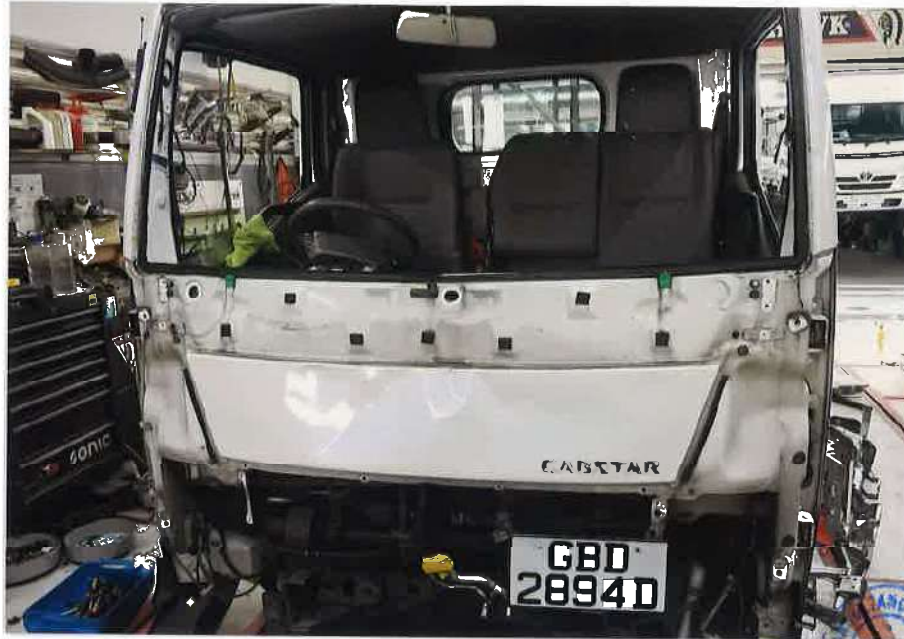
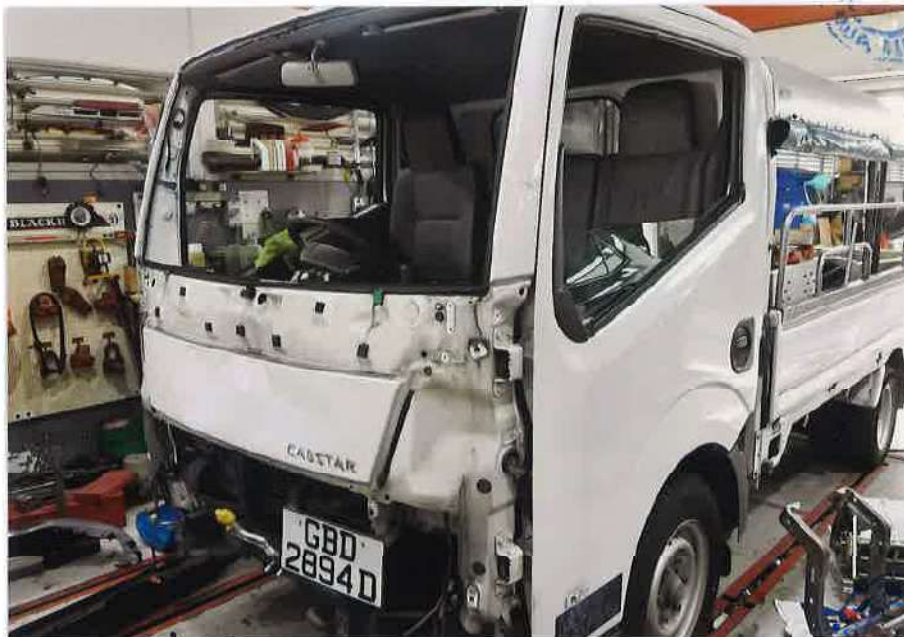
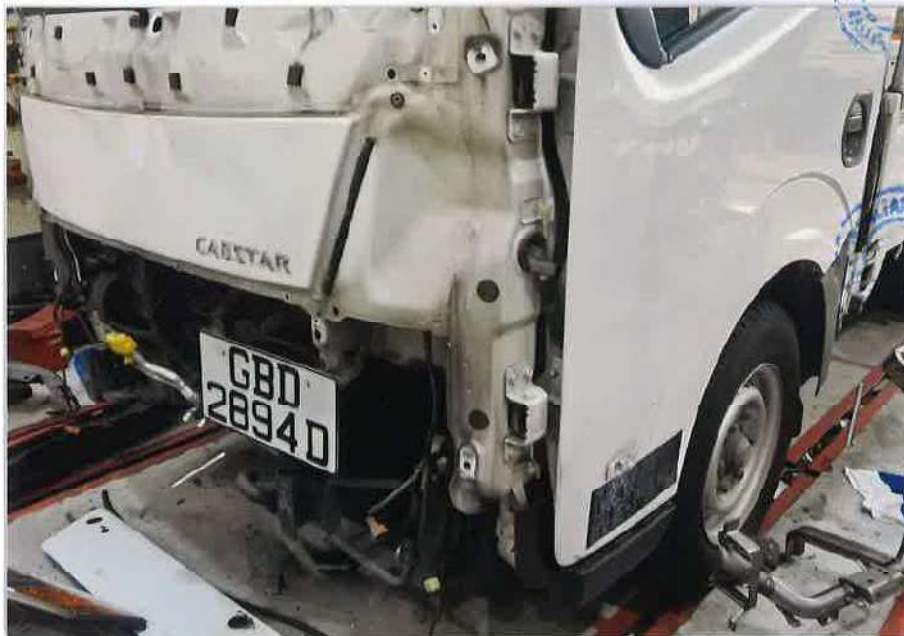
We had carried out re-inspection during works in progress and post repair inspection on the above vehicle. Attached in Annex B are the re-inspection photos, showing the work in progress and our re-inspection to the hidden part that were damaged.
