Report Reference : **TP / 19019-10/AY / 2019**
Date of Report : **31 Oct 2019**

THIRD PARTY SURVEY
ACCIDENT HAPPENED ON 14 Oct 2019

Registration No	: SKP 3560 R	Engine No	: 27186030291176
Model	: Mercedes Benz E250	Mileage	: 126140
Year / Capacity	: 2013/1796	Colour	: Black
Chassis No	: WDD2120472A482136

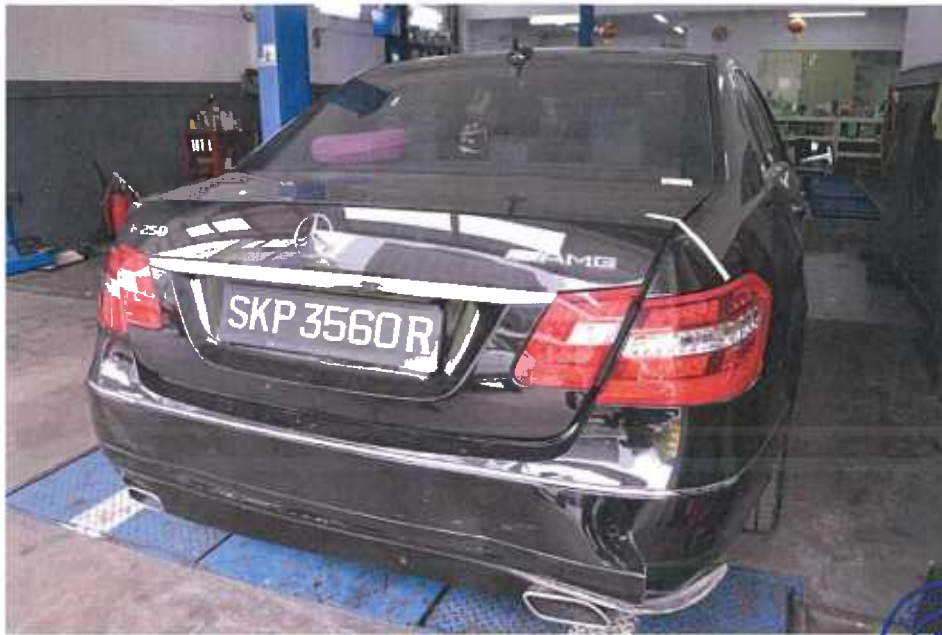
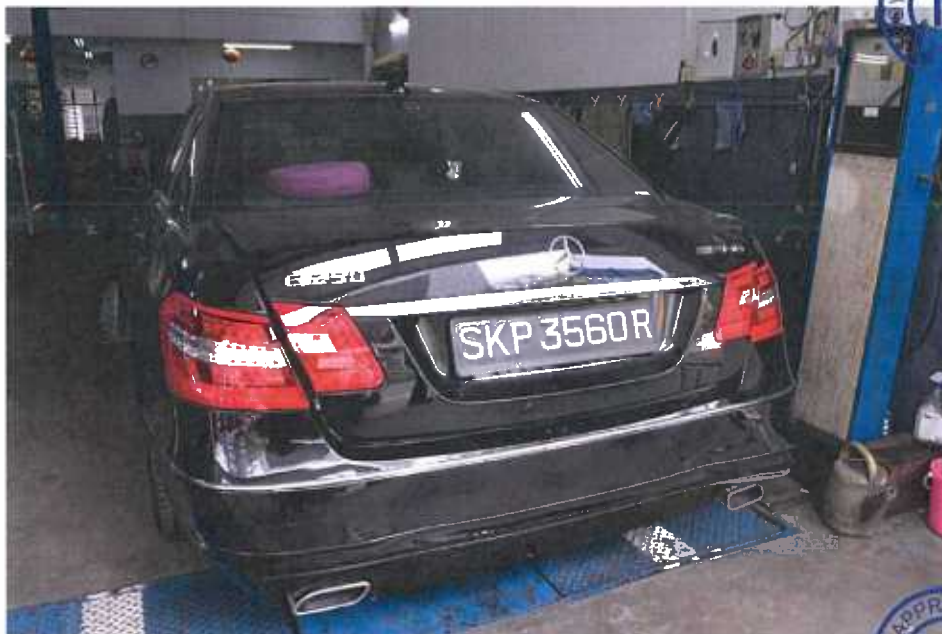
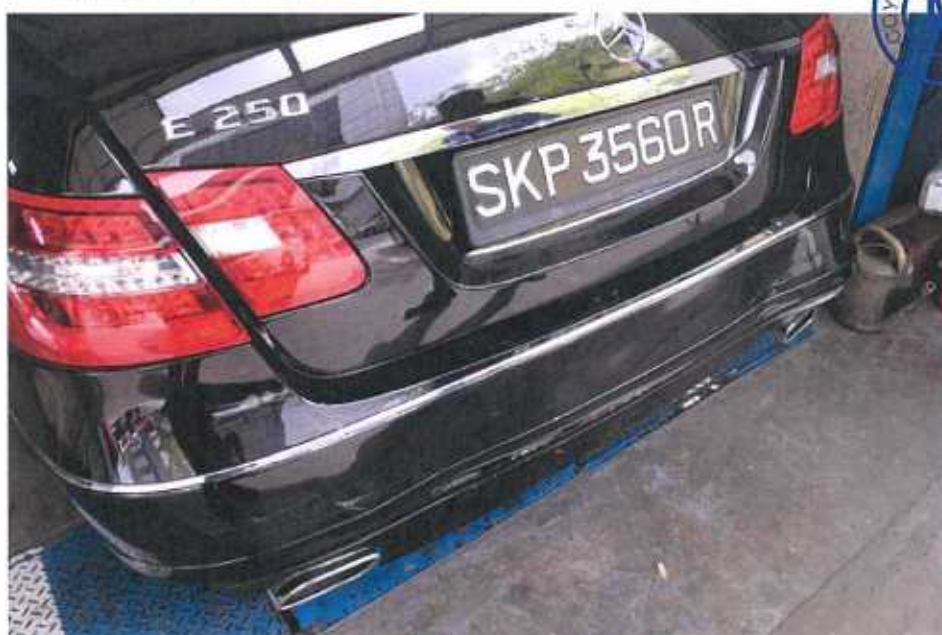
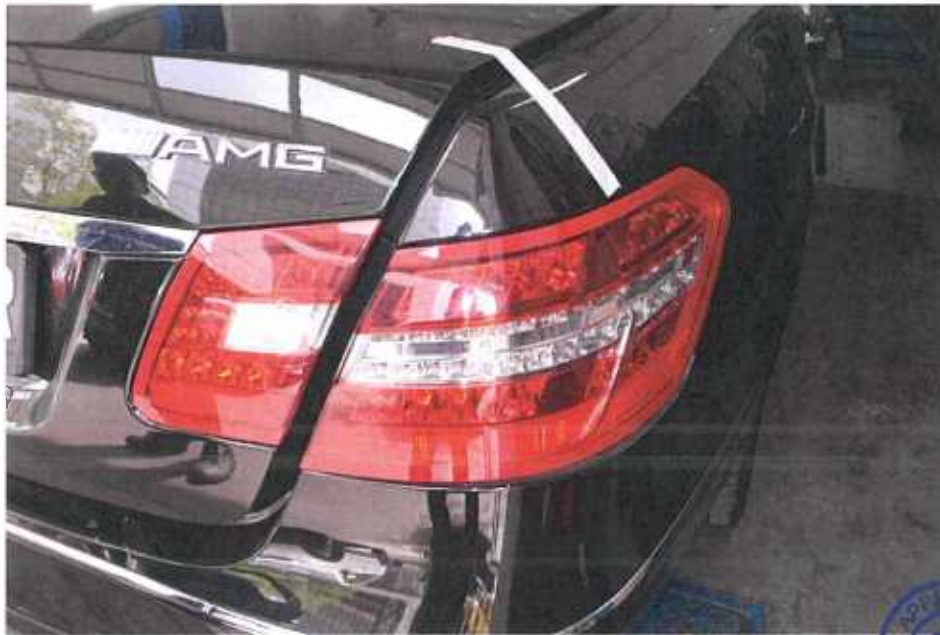
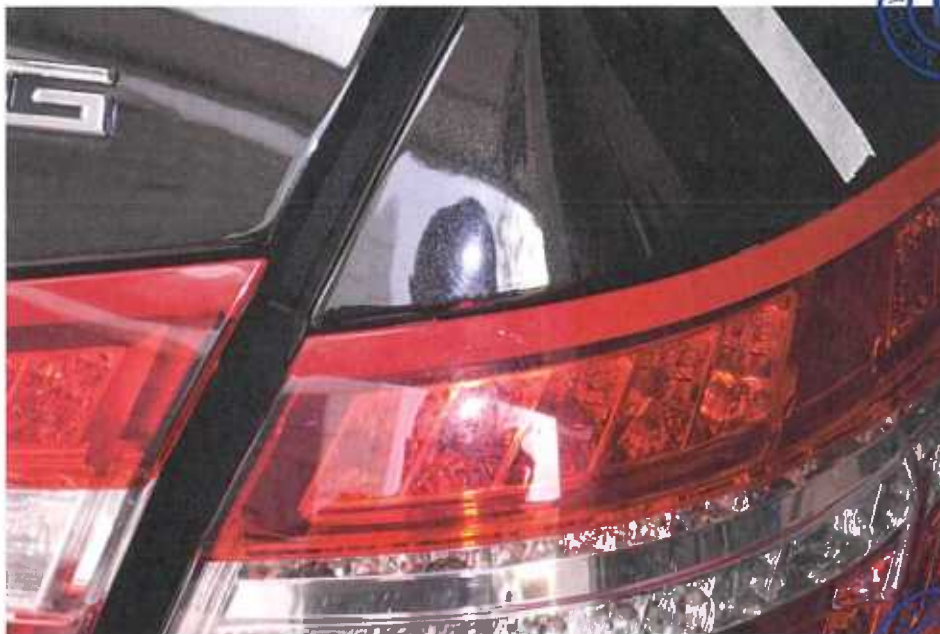
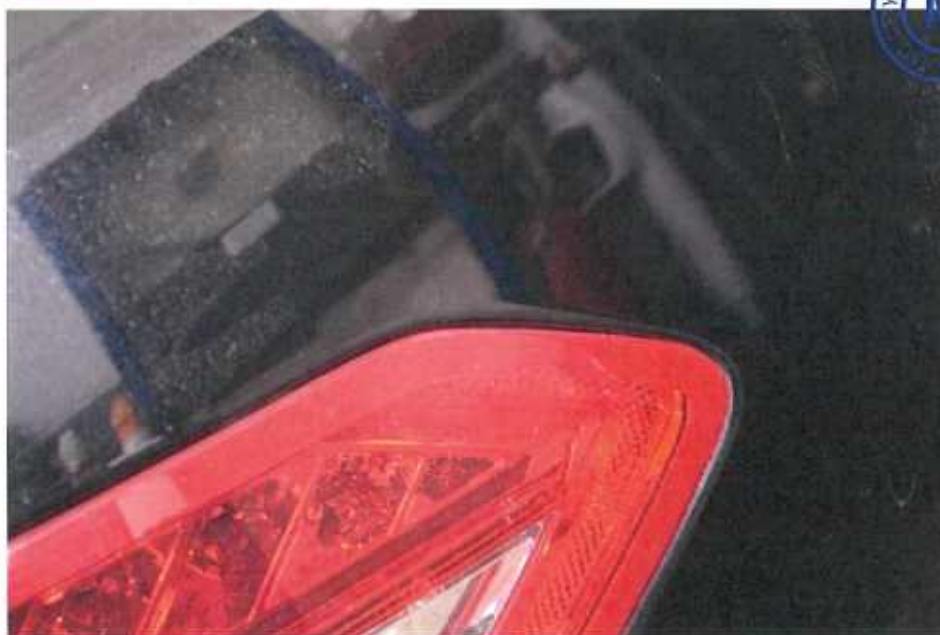
At the time of inspection, we noted that the vehicle has sustained an impact damages on the rear portion(s). For more detail of the damages, please see photograph attached.
