Code: AGI		
1.	Policy Particulars :- THIRD PARTY CLAIM				
	Insured Veh.	SMT 3958H	Veh. Inspected	SKU 1163R	
	Policy No.		Coverage (\$)	0.00	
	Claim No.	C10008056/ST	Excess (\$)	0.00	
	Assign From	IVY RATILLA	Assign Date	24/11/2020	
2.		Vehicle Partic	culars & Condition		
	Make & Model	TOYOTA ALPHARD (A)	c.c	2494	
	Engine No.	HIDDEN	Year of Reg.	2015	
	Chassis No.	JTNGF3DH808000226	Colour	WHITE	
	Odometer	254021	Steering	IN ORDER	
	Brakes	IN ORDER	Modification	SPORTS RIM	
	General	GOOD			
3.		Conditi	ons of Tyres		
		Size	Make	Balance	
	R/H Front Tyre	235/50 R18	MICHELIN	6 mm	
	L/H Front Tyre	235/50 R18	MICHELIN	6 mm	
	R/H Rear Tyre	235/50 R18	MICHELIN	6 mm	
	L/H Rear Tyre	235/50 R18	MICHELIN	6 mm	
4.	Description of Damages				
	THE VEHICLE SUSTAINED DAMAGES AT THE FRONT O/S PORTION.

### ADJUSTMENT ON REPAIR COST FOR VEHICLE NO. SKU 1163R

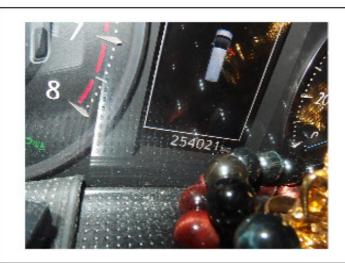
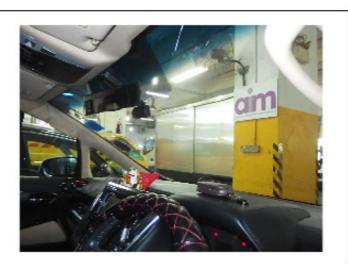
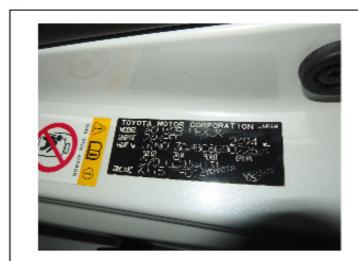
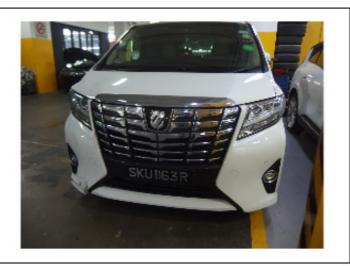
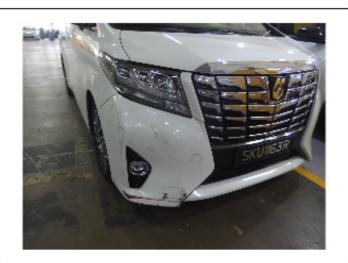
### PHOTOGRAPHS FOR VEHICLE NO. SKU 1163R

DAMAGES SEE DETAILS.

INSPECTION

Qty	Description of Parts	Condition	Estimate By Workshop (\$))	Our Adjusted (\$)
	REPLACEMENT OF PARTS			
1	FRONT BUMPER	DEFORMED / DISTORTED	1,381.45	1,381.45
1	FRONT BUMPER PDC SENSOR-RH	SHORTED	414.75	414.75
1	FRONT BUMPER FOG LAMP-RH	SERVICEABLE	481.35	-
1	FRONT BUMPER FOG LAMP COVER	TWISTED	121.50	121.50
1	FRONT BUMPER TOW COVER	NOT NECESSARY	58.85	-
1	FRONT BUMPER SPONGE	NOT NECESSARY	180.63	-
1	FRONT BUMPER REINFORCEMENT	NOT NECESSARY	501.60	-
2	FRONT BUMPER SIDE RETAINERS-L/R @\$89.55	O/S BENT	179.10	89.55
1	FRONT FENDER-RH	TO REPAIR SEE LABOUR	899.60	-
1	FRONT HEADLAMP-RH	CRACKED	4,249.36	3,606.90
1	FRONT HEADLAMP SIDE MOULDING-RH	NOT NECESSARY	181.93	-
1	FRONT GRILLE ASSY	NOT NECESSARY	1,330.50	-
1	WASHER TANK	NOT NECESSARY	241.60	-
	LESS 25% DISCOUNT		-2,555.55	-1,403.54
			7,666.67	4,210.61
	SPECIAL NETT ITEMS			
1	SET FRONT BUMPER CLIP (SN)	NECESSARY	45.00	45.00
1	FRONT SPORT WHEEL (SN)	NOT NECESSARY	650.00	-
