# AUTOMAX SURVEY

## THIRD PARTY SURVEY ACCIDENT OCCURED ON 27 JAN 2020

### 1. VEHICLE PARTICULARS

Registration No : SMK2743P  
Model : TOYOTA ALLION A15 A  
Year / Capacity : Apr 2009 / 1598 cc  
Chassis No : NZT2603042958

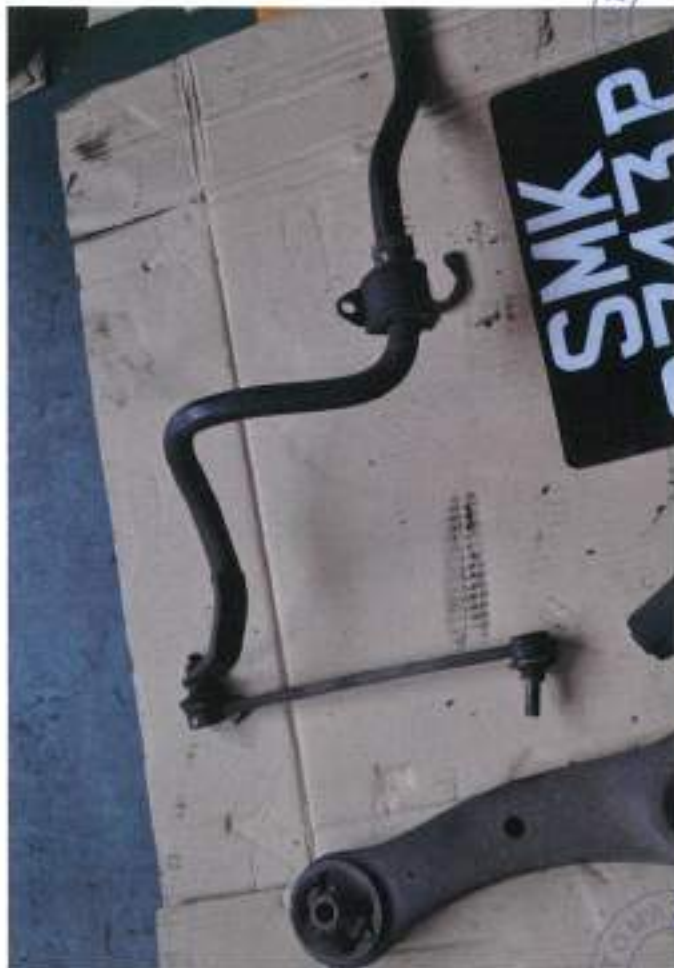
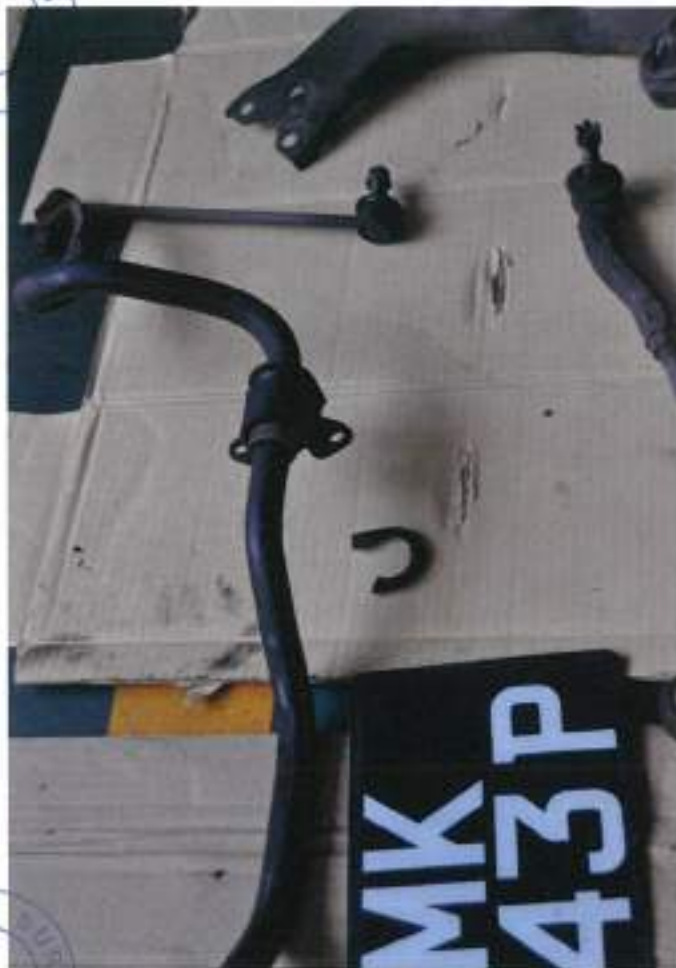
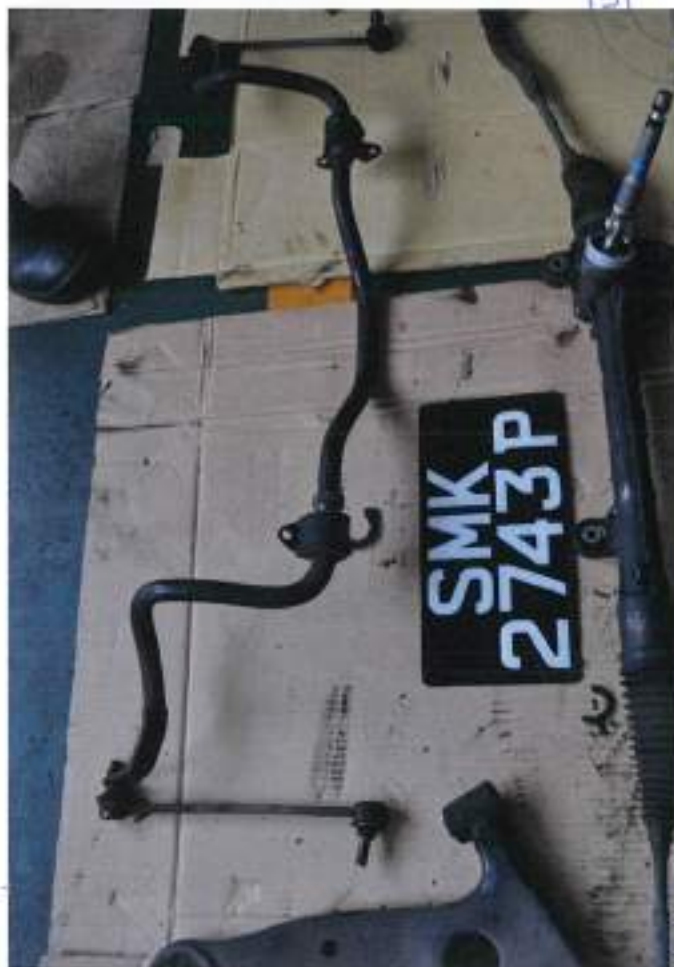
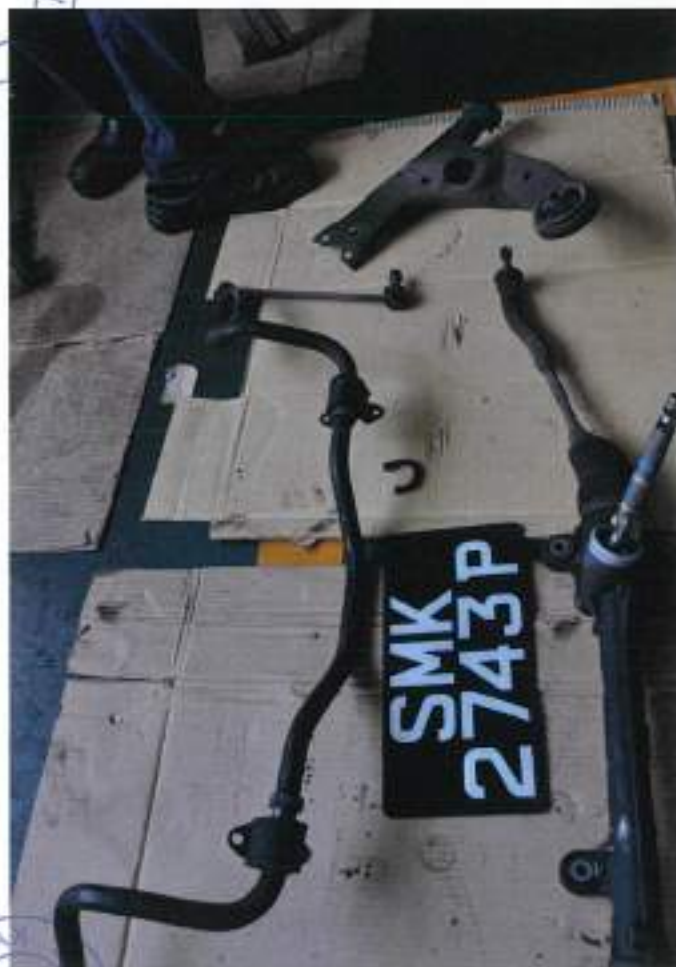
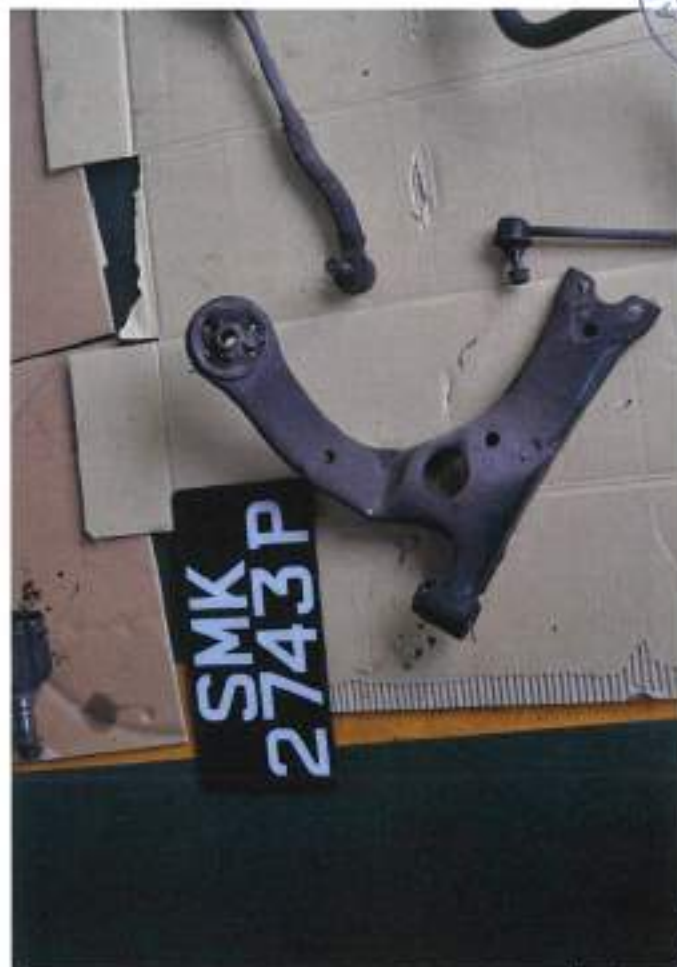
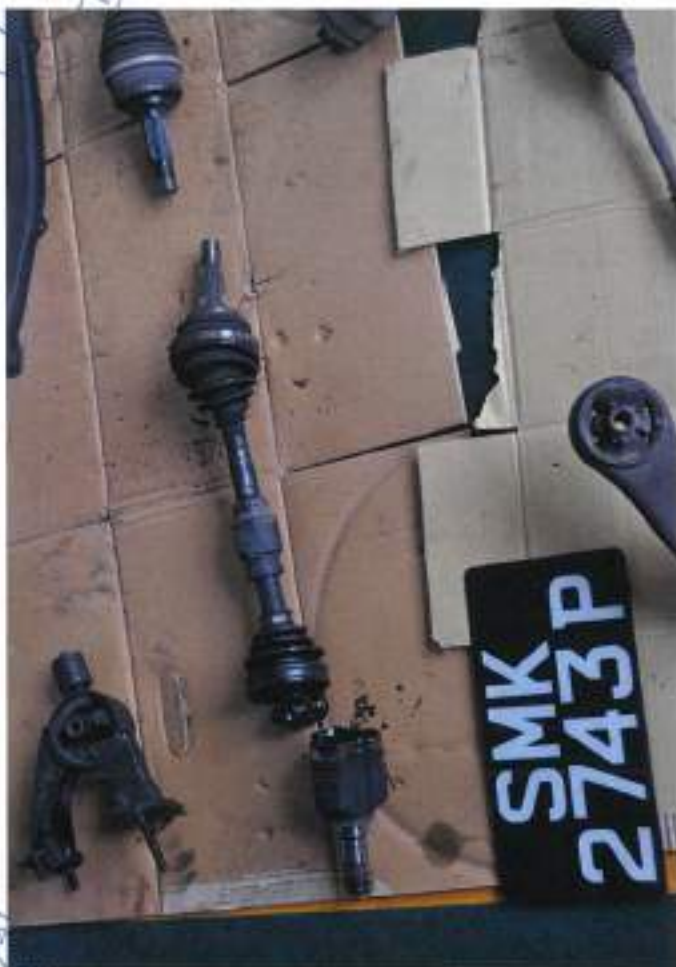
At the time of inspection, we noted that the vehicle has sustained an impact damages on the side portion(s). For more detail of the damages, please see photograph attached.
