Vehicle No. SMQ 6298A  
Insured Veh. GBE 858S  
Claim No. VC014132  
Policy No. 8-V0014300-MVA-R003  
Accident Date 26/11/2020  
Inspection Date 26/11/2020

### ADJUSTMENT ON REPAIR COST FOR VEHICLE NO. SMQ 6298A

PHOTOGRAPHS FOR VEHICLE NO. SMQ 6298A

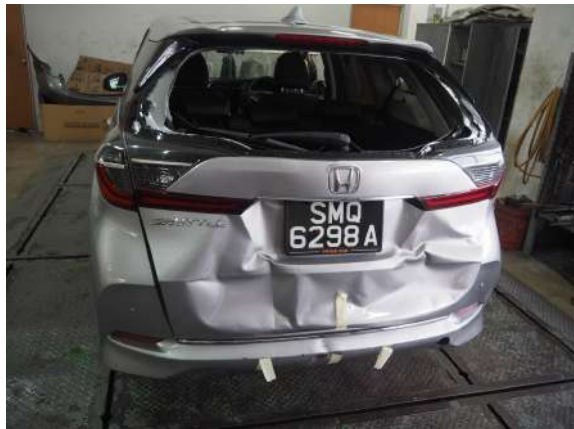
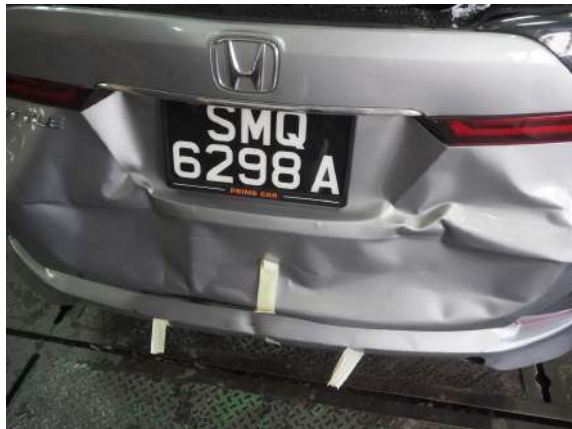
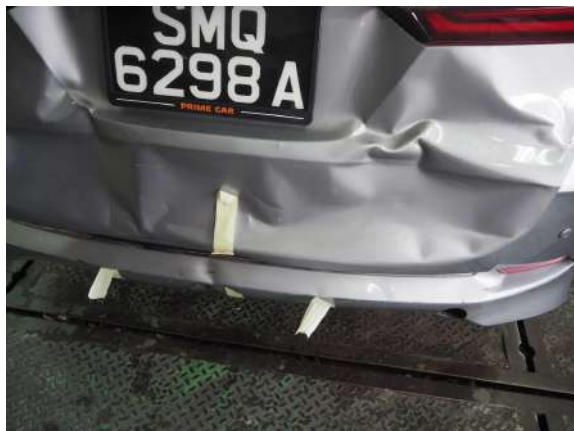
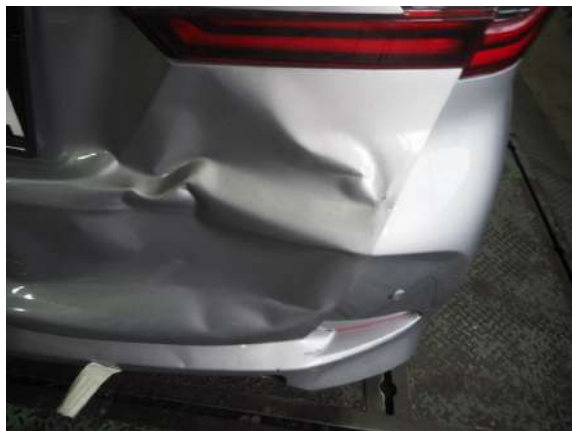
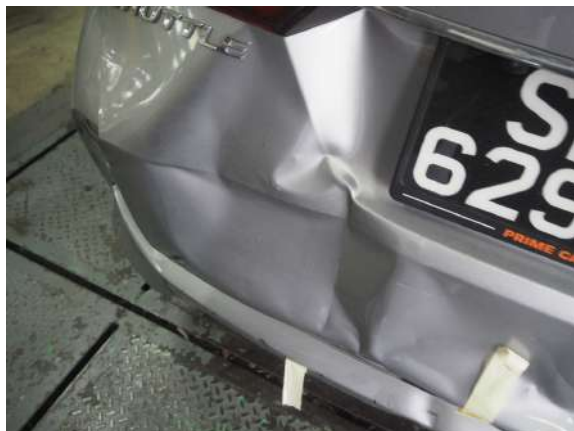
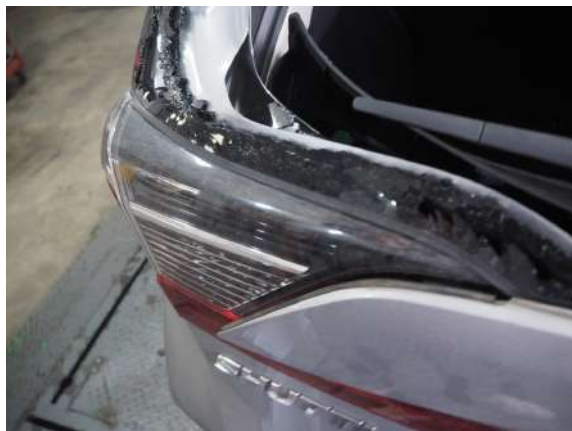
| Affiliated to Federation Internationale Des Experts En Automobile | | | | |
|---|---|---|---|---|
| THE VEHICLE SUSTAINED DAMAGES AT THE REAR PORTION.<br><br>DAMAGES SEE DETAILS. | | | | |

INSPECTION

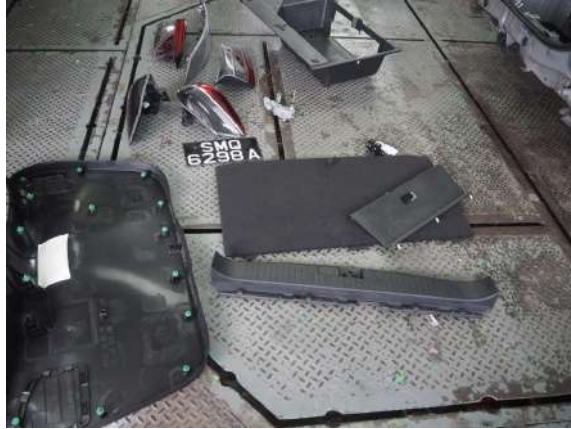
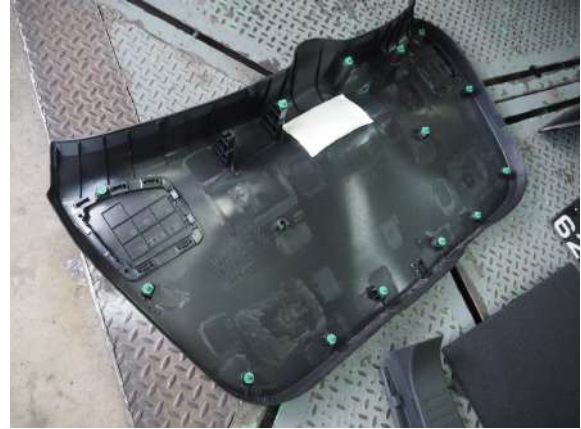
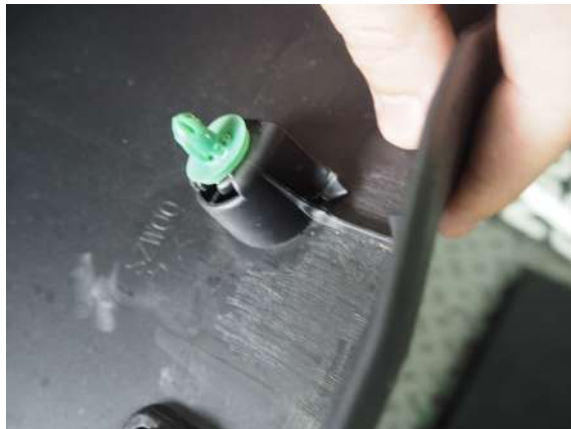
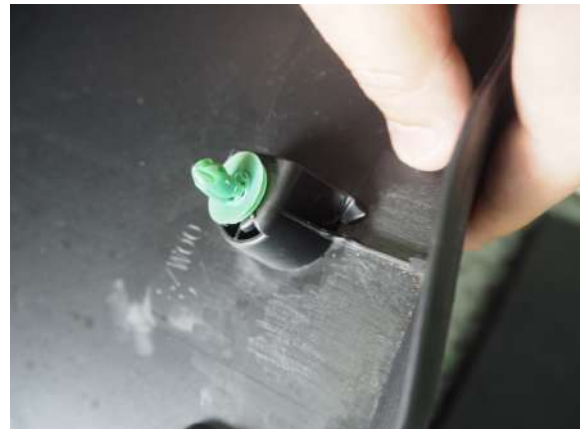
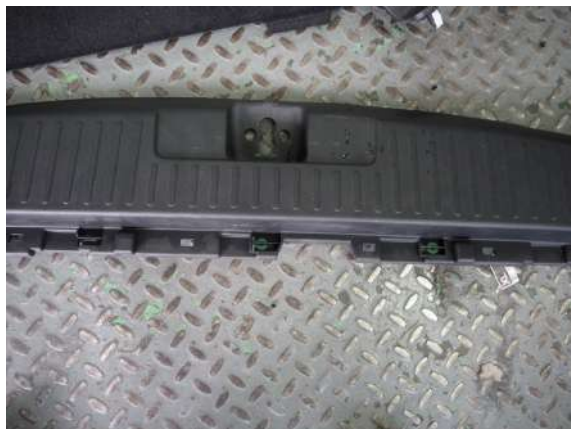
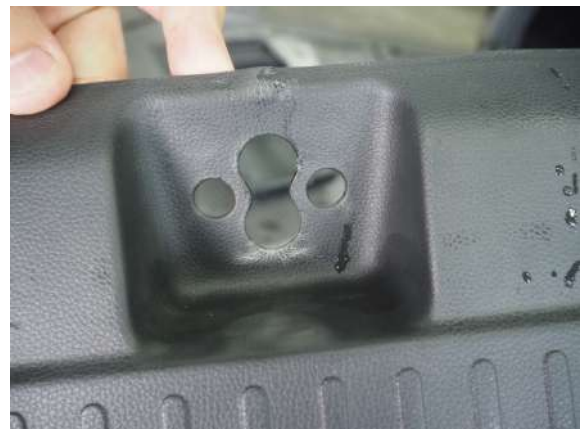
PHOTOGRAPHS FOR VEHICLE NO. SMQ 6298A

RE-INSPECTION
