## LKK Auto Consultants Pte Ltd

### PROFESSIONAL SERVICE FEE

Vehicle No. SMT 2326M  
Insured Veh. SHD 3829R  
Claim No. D20004938MFSH  
Policy No. D-20094922MFSH  
Accident Date 03/12/2020  
Inspection Date 08/12/2020

## ADJUSTMENT ON REPAIR COST FOR VEHICLE NO. SMT 2326M

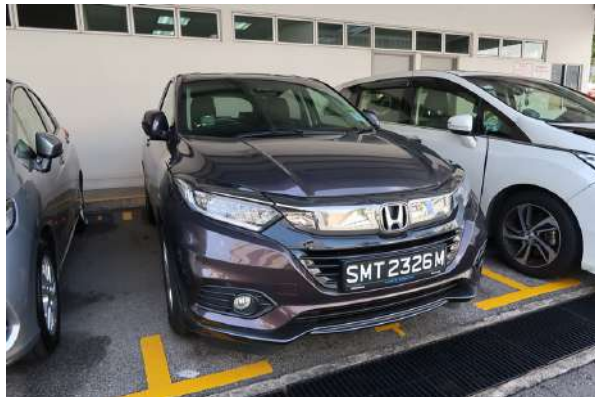
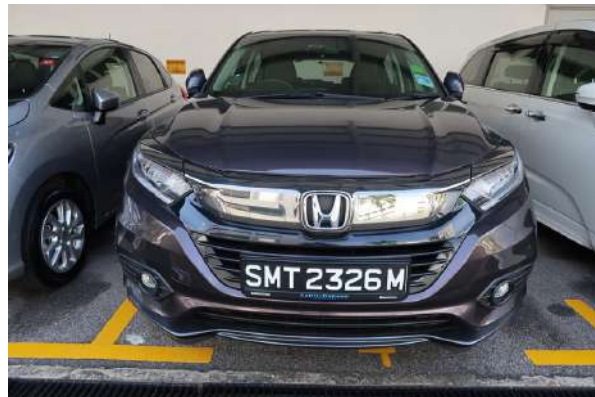
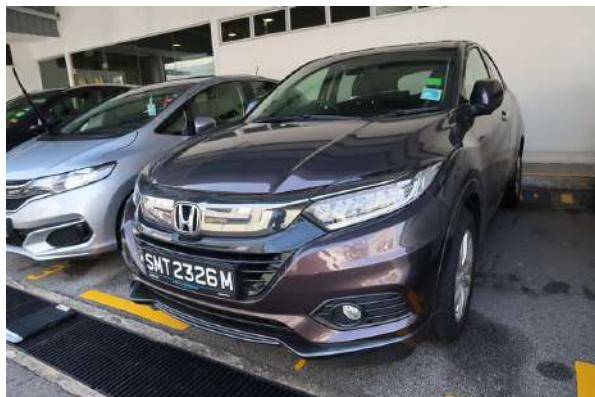
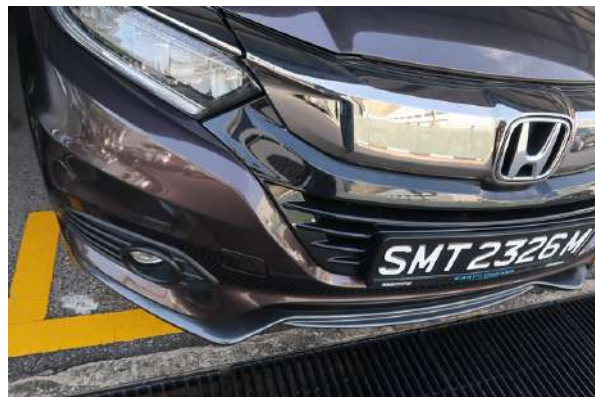
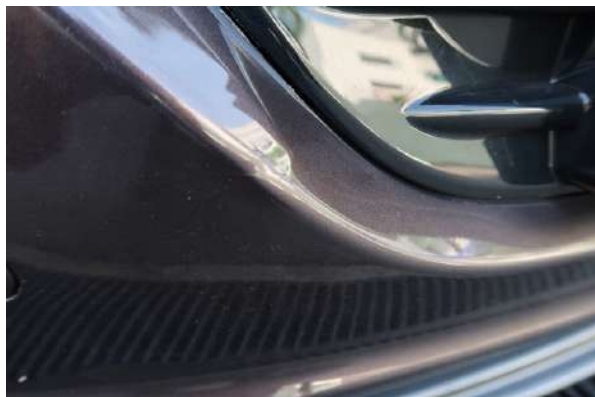
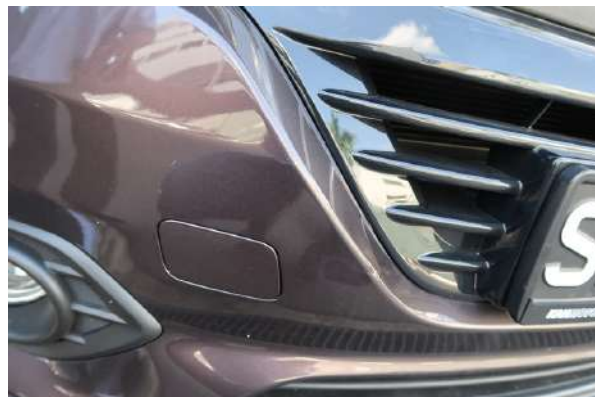
### INSPECTION

| Affiliated to Federation Internationale Des Experts En Automobile | | | | |
|---|---|---|---|--|
| THE VEHICLE SUSTAINED DAMAGES AT THE FRONT PORTION.<br>DAMAGES SEE DETAILS. | | | | |

### PHOTOGRAPHS FOR VEHICLE NO. SMT 2326M

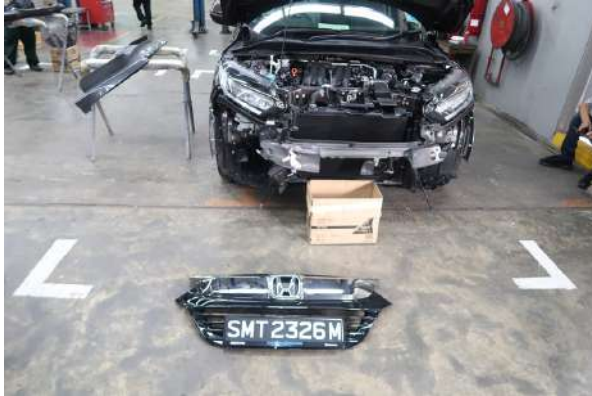
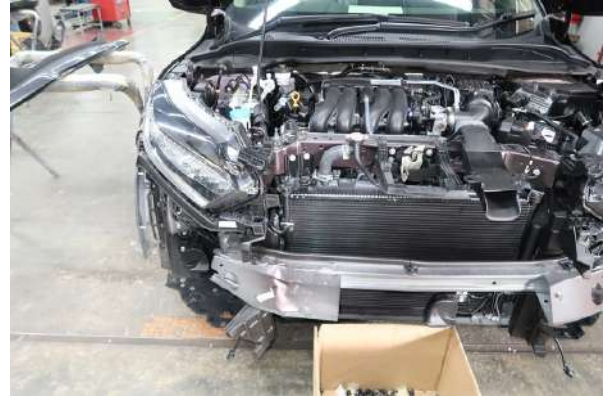
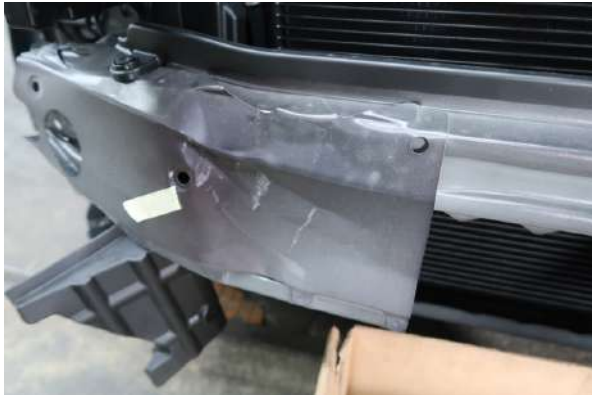
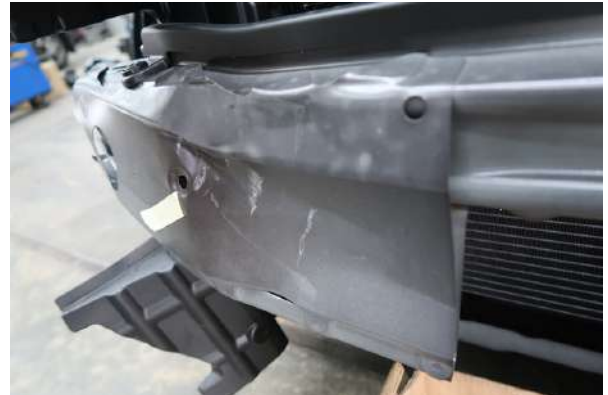
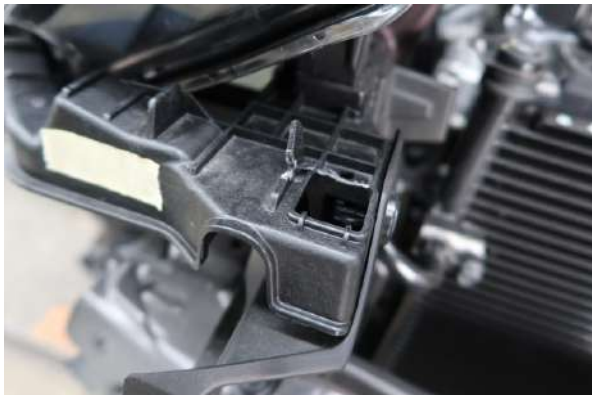
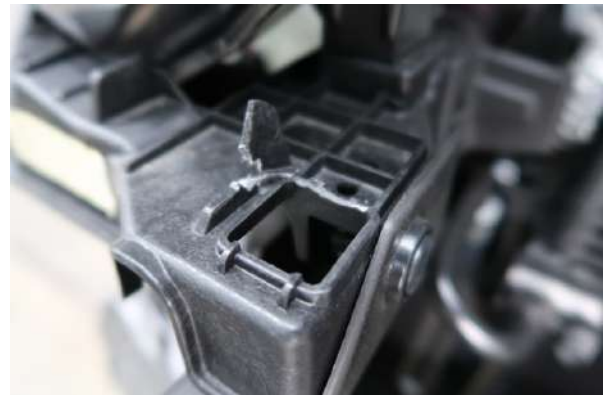
RE-INSPECTION

PHOTOGRAPHS FOR VEHICLE NO. SMT 2326M
