## LKK Auto Consultants Pte Ltd

## ADJUSTMENT ON REPAIR COST FOR VEHICLE NO. SHB 5218B

### PHOTOGRAPHS FOR VEHICLE NO. SHB 5218B

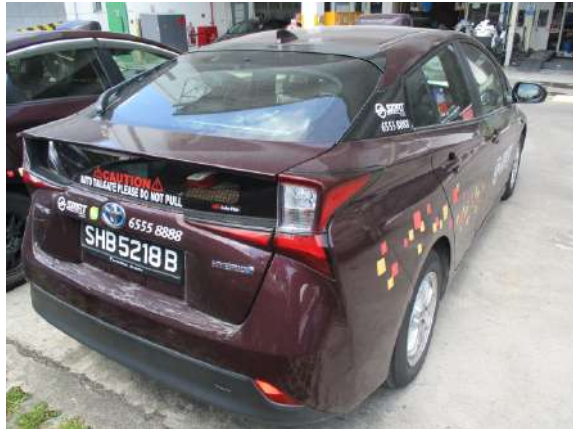
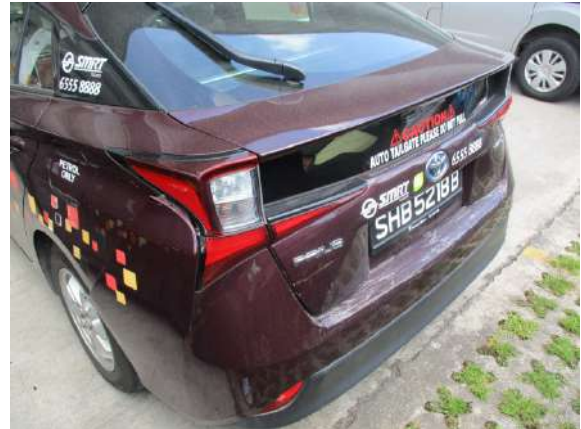
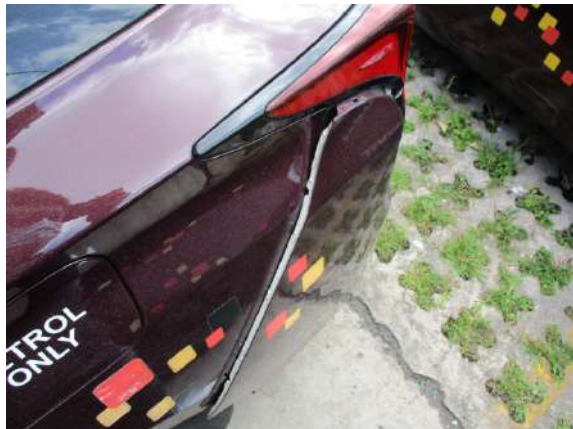
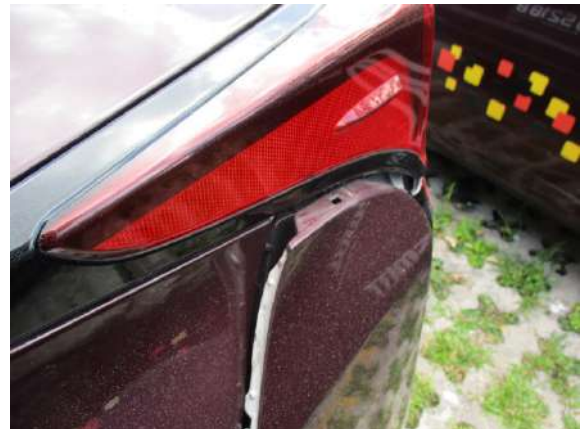
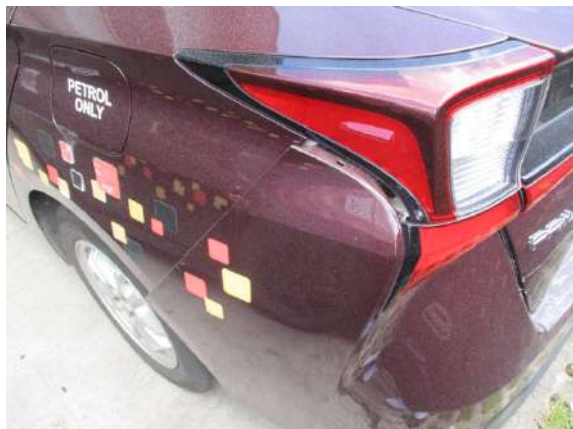
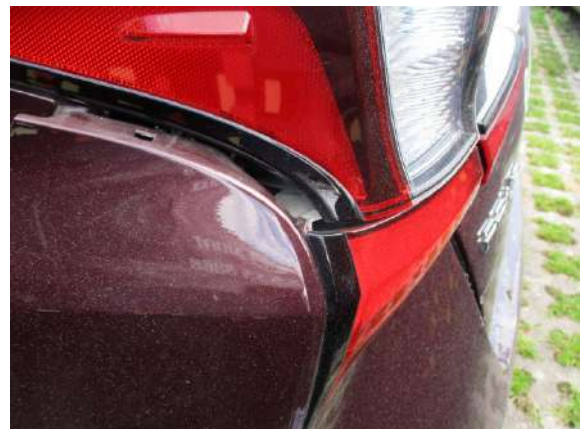
### INSPECTION

| Affiliated to Federation Internationale Des Experts En Automobile | | | | |
|---|---|---|---|---|
| | THE VEHICLE SUSTAINED DAMAGES AT THE REAR PORTION.<br>DAMAGES SEE DETAILS. | | | |

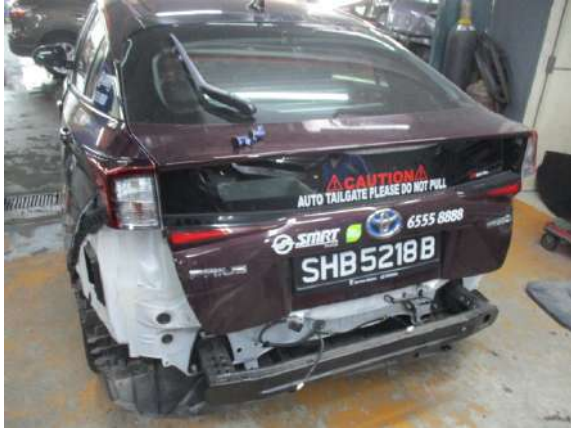
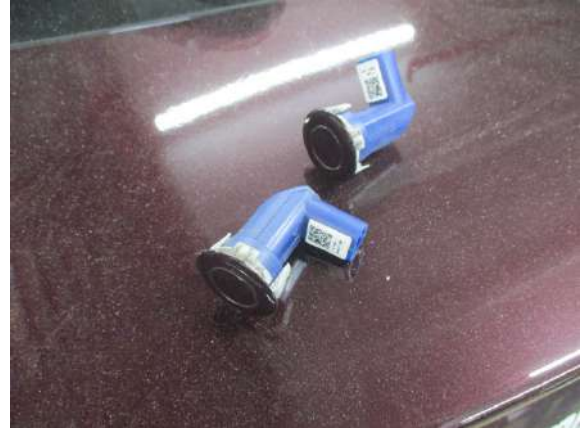
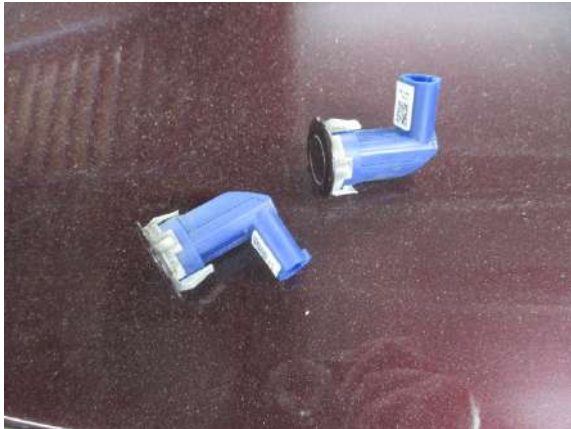
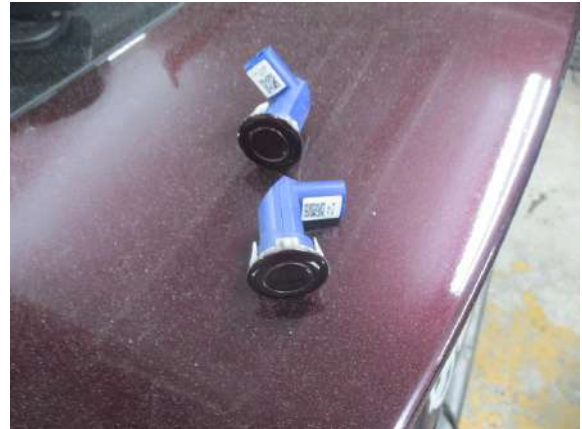
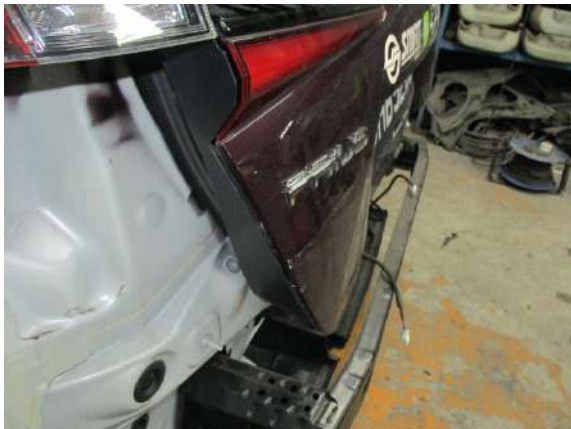
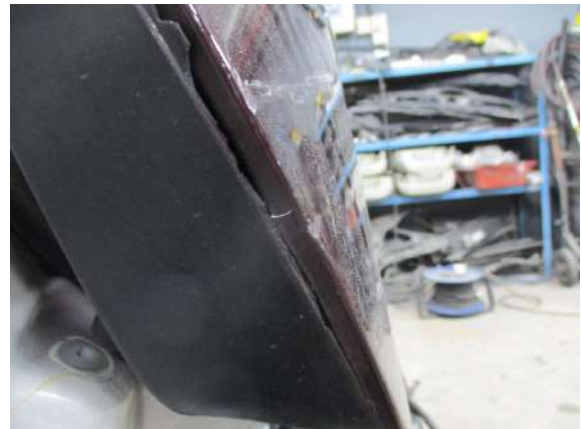
### RE-INSPECTION

### PHOTOGRAPHS FOR VEHICLE NO. SHB 5218B
