### PROFESSIONAL SERVICE FEE

Vehicle No. SMC 2082E  
Insured Veh. SKV 7129X  
Claim No. 20/20/20/VP05/023993  
Policy No. Z20VP05027548  
Accident Date 08/12/2020  
Inspection Date 11/12/2020

### ADJUSTMENT ON REPAIR COST FOR VEHICLE NO. SMC 2082E

### PHOTOGRAPHS FOR VEHICLE NO. SMC 2082E

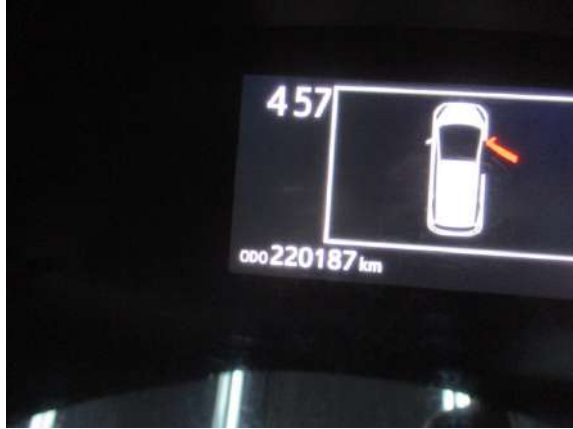
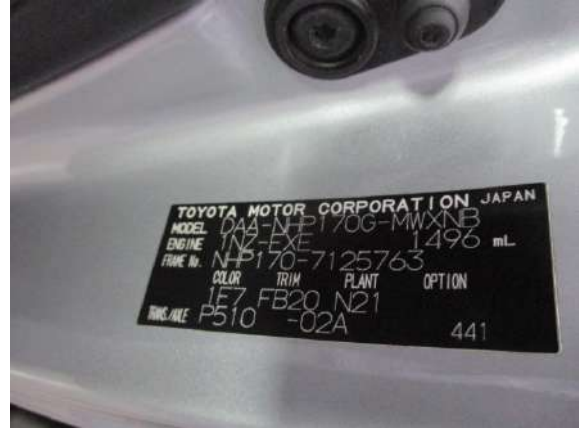
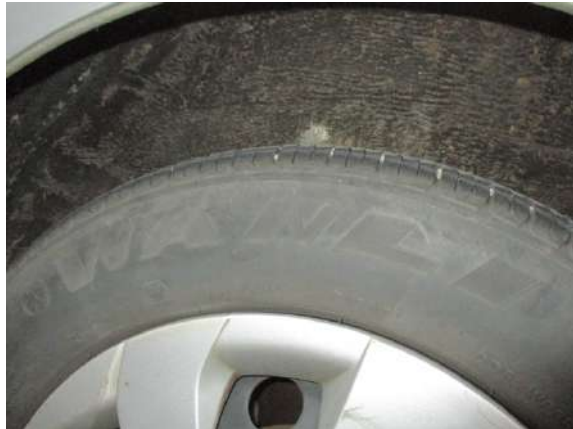
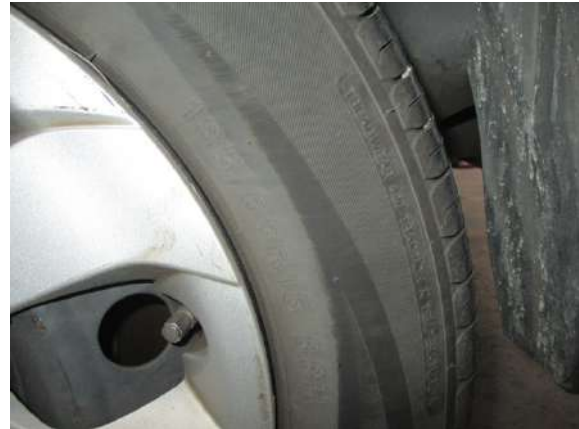
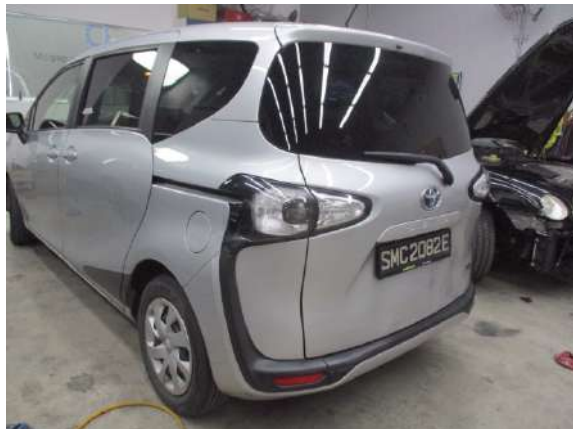
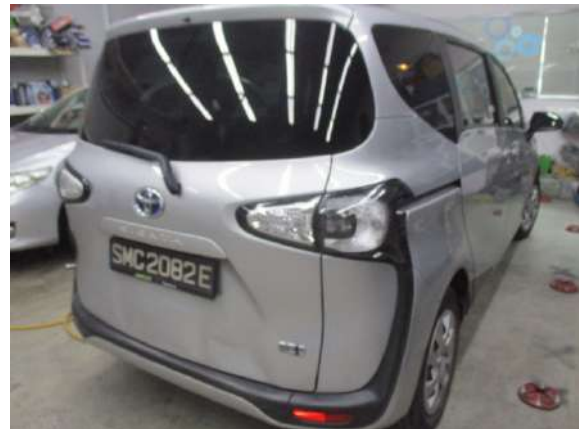
### INSPECTION

| Affiliated to Federation Internationale Des Experts En Automobile | | | | |
|---|---|---|---|--|
| THE VEHICLE SUSTAINED DAMAGES AT THE REAR PORTION.<br>DAMAGES SEE DETAILS. | | | | |
