## LKK Auto Consultants Pte Ltd

### PROFESSIONAL SERVICE FEE

Vehicle No. SLG 6352R  
Insured Veh. SHC 7578T  
Claim No. D20005136MFSH  
Policy No. D-20094921MFSH  
Accident Date 14/12/2020  
Inspection Date 18/12/2020

### PHOTOGRAPHS FOR VEHICLE NO. SLG 6352R

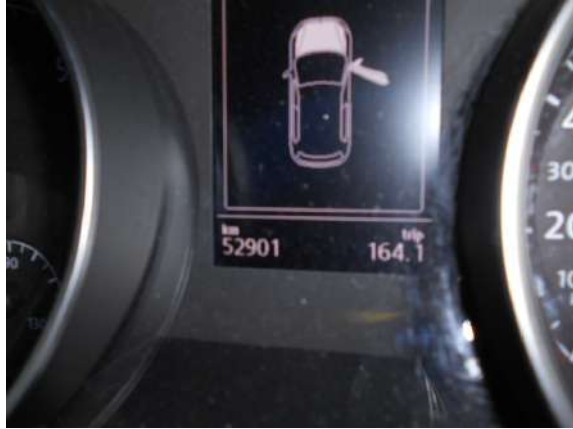
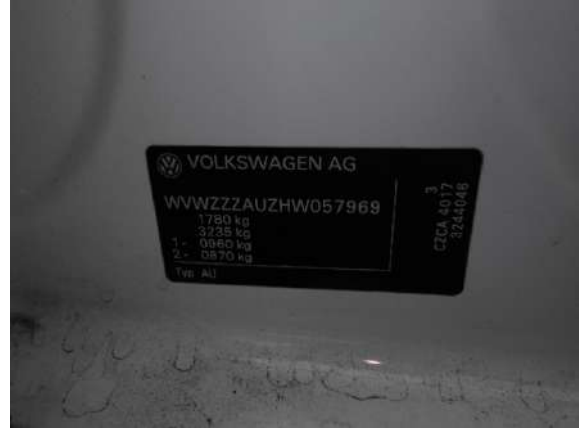
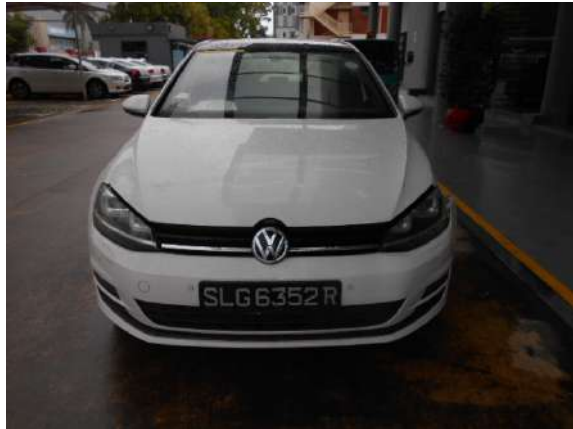
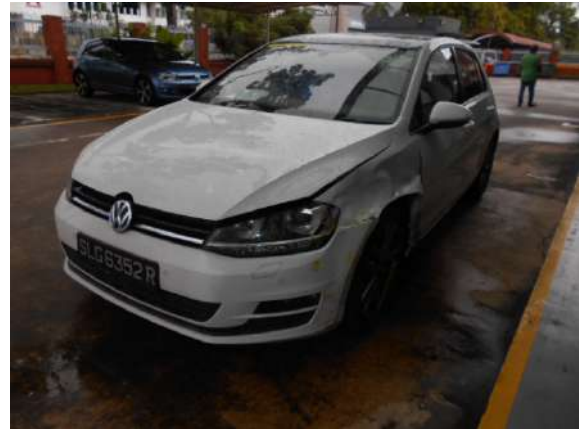
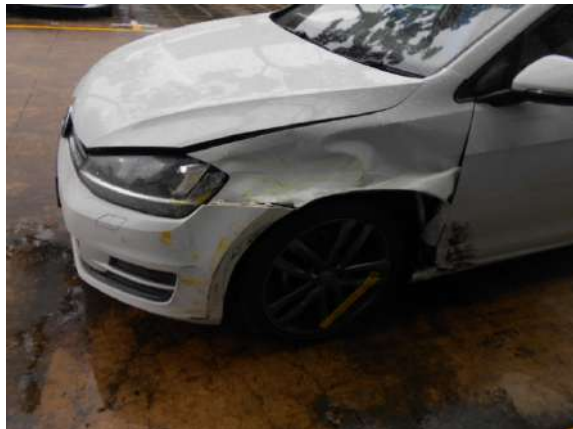
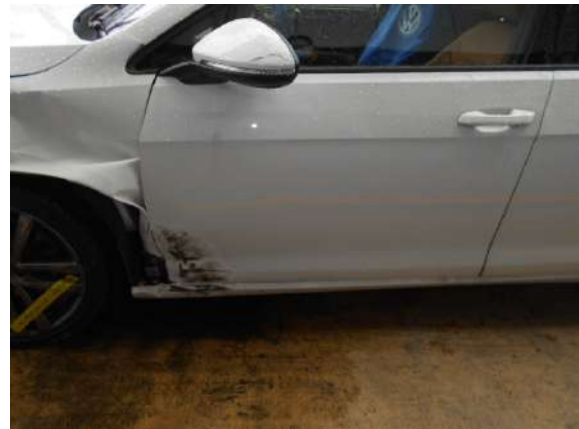
### INSPECTION

| Affiliated to Federation Internationale Des Experts En Automobile | | | | |
|---|---|---|---|--|
| THE VEHICLE SUSTAINED DAMAGES AT THE N/S FRONT AND N/S REAR PORTION.<br>DAMAGES SEE DETAILS. | | | | |

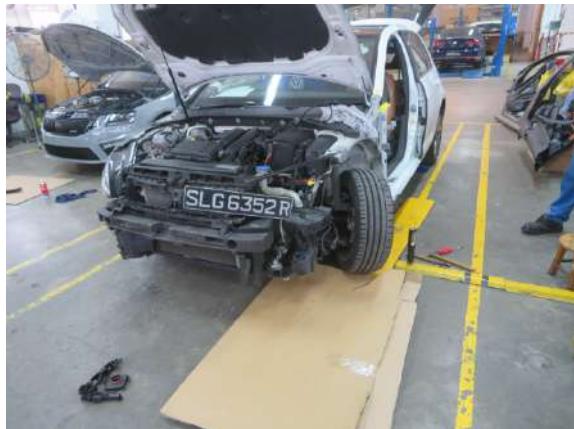
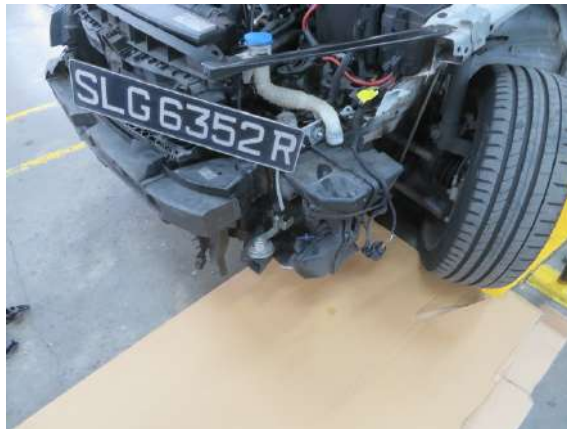
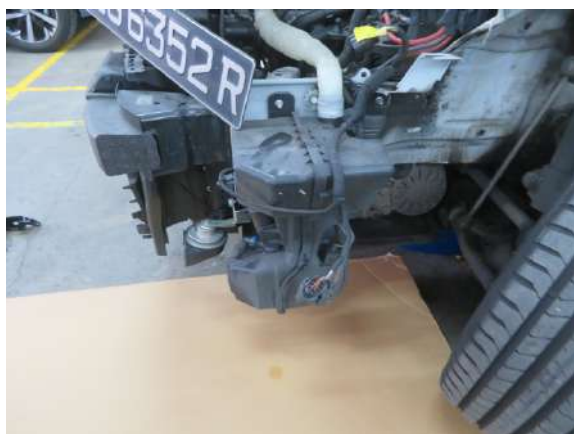
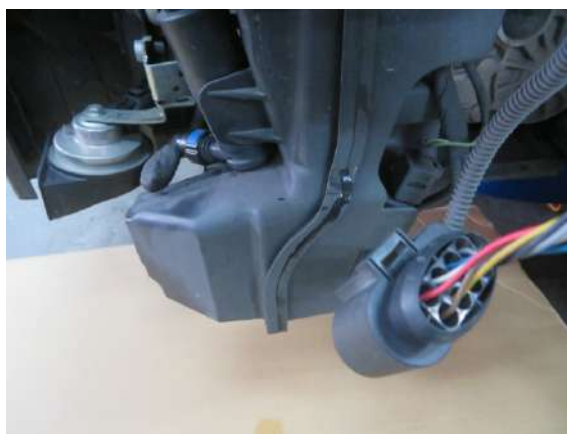
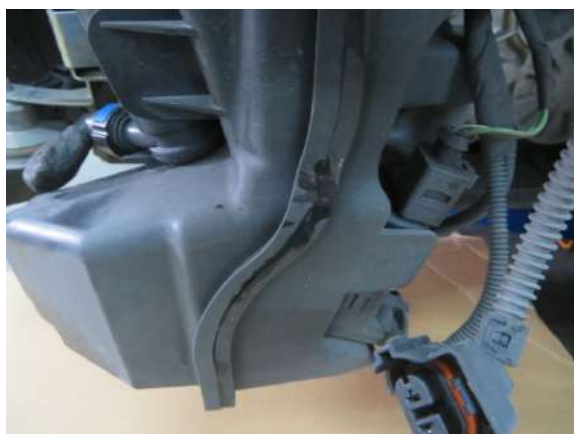
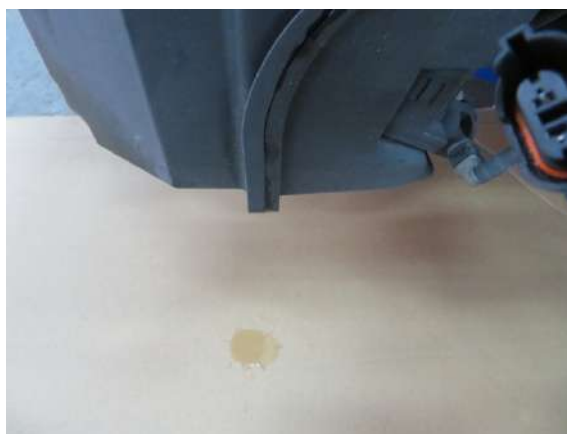
PHOTOGRAPHS FOR VEHICLE NO. SLG 6352R

RE-INSPECTION
