# UNITED Appraisal And Management Pte Ltd

Our ref. : UAM20.07.16-AK-STP-LKT-FU396B

**Re : Third Party Claim For Vehicle Registration No. FU396B**

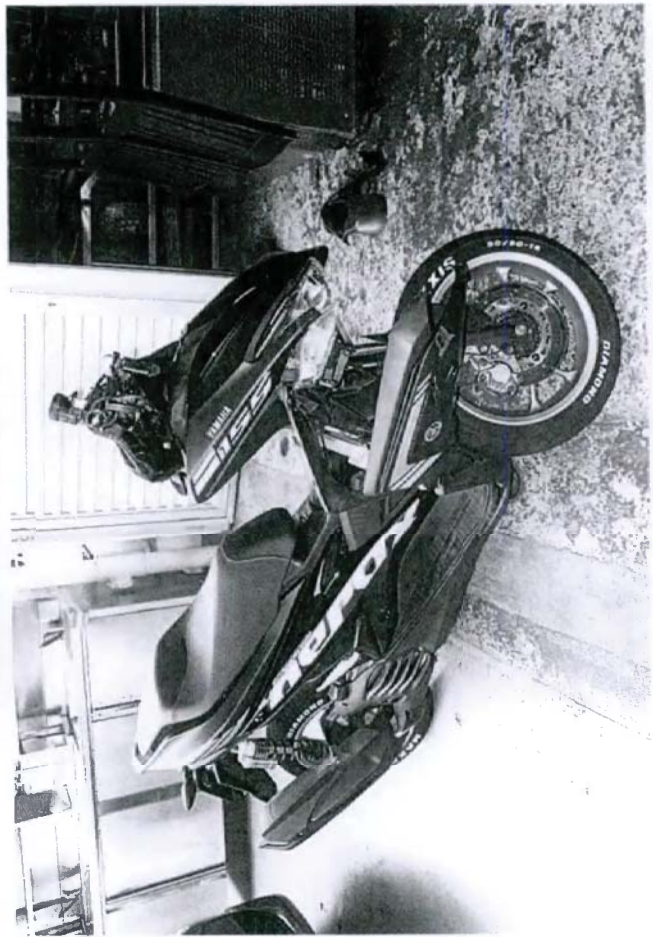
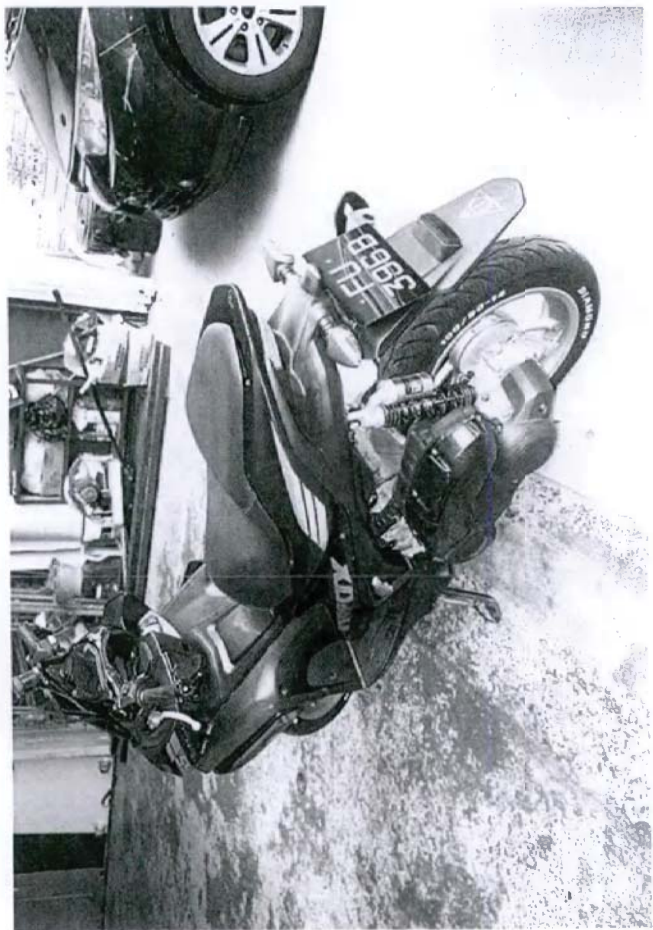
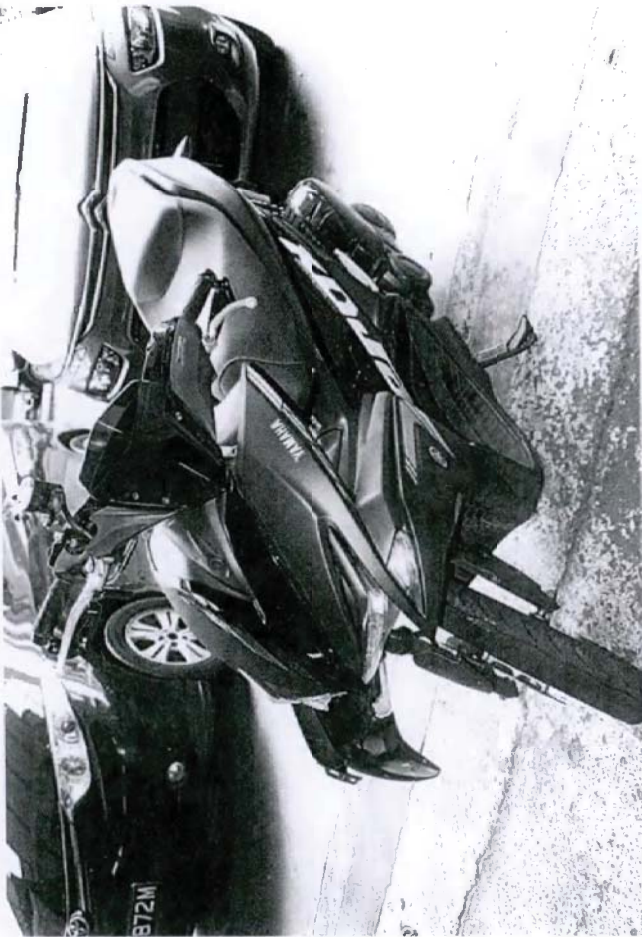
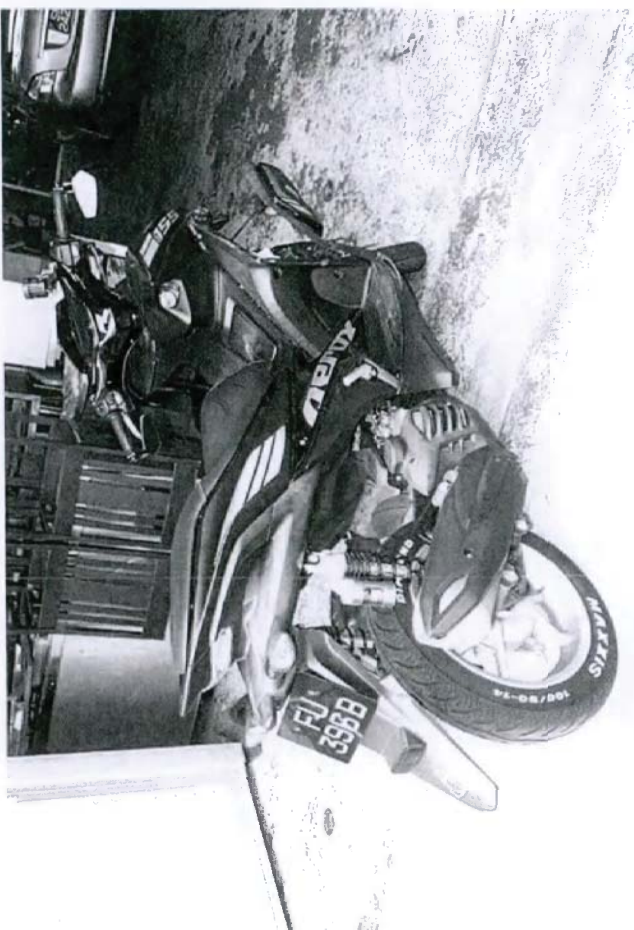
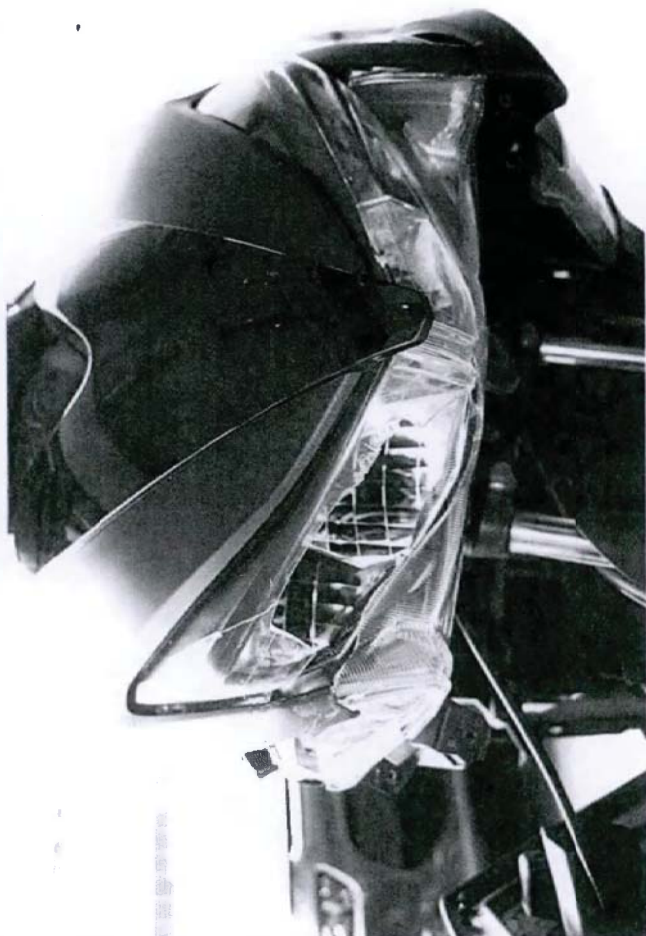
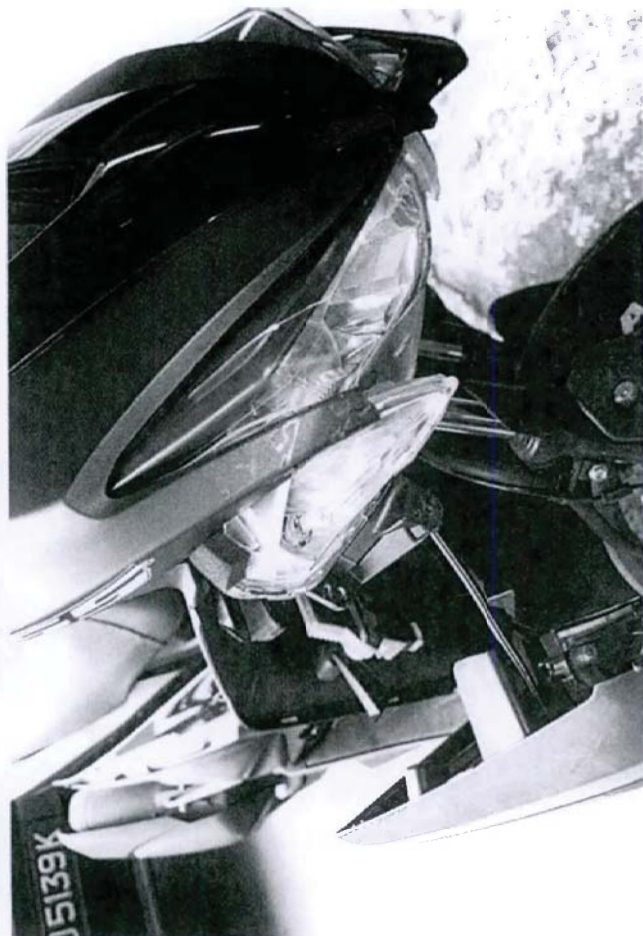
The impact of the collision has damaged / affected the front fairing, front cowling, headlight, handle bar, front fork, side board, tailboard and etc...

Please refer to Annex A (Appraisement Schedule) for a detailed account of the damages and photographs taken.
