**AUTOMOBILE
INSPECTION REPORT
NO. 20/3/TP004**

Reg. No.	SFA 833 L	Make/Model	HONDA HRV 1.5 DX CVT AUTO	Year	2016
Engine No.	L15B4530371	Chassis No.	JHMRU1810GX200370	Colour	White
Condition of Tyres			Speedometer Reading - Km 039679		
Front N/S	DUNLOP 215/60R16	worn	30 %	Front O/S	DUNLOP 215/60R16 worn 30 %
Rear N/S	DUNLOP 215/60R16	worn	30 %	Rear O/S	DUNLOP 215/60R16 worn 30 %
As Requested By		YOURSELF		On	11-Mar-20 The Above Vehicle

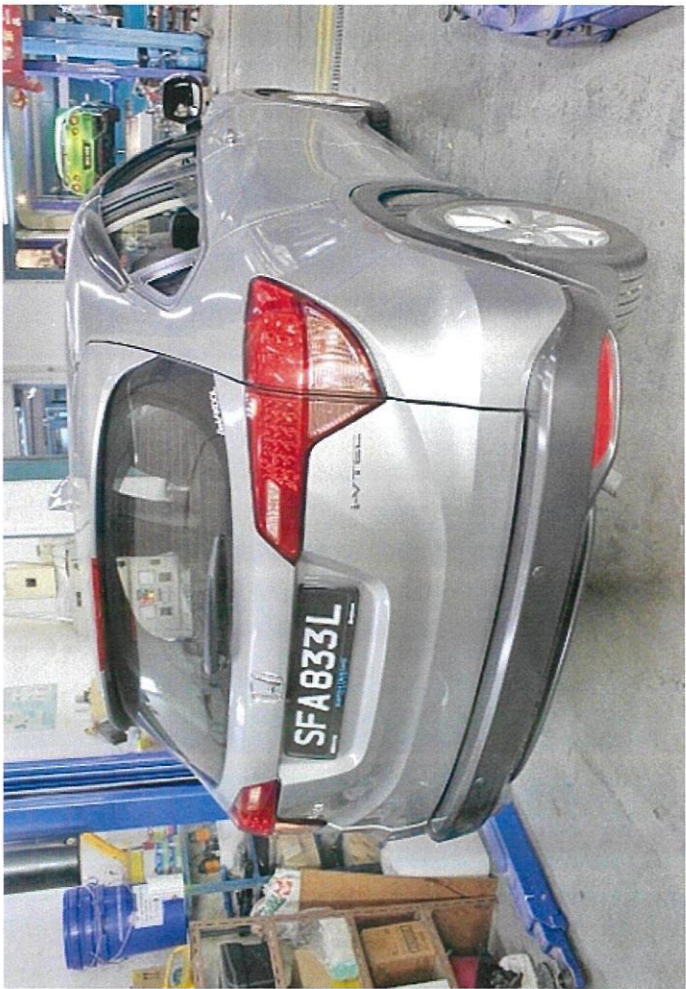
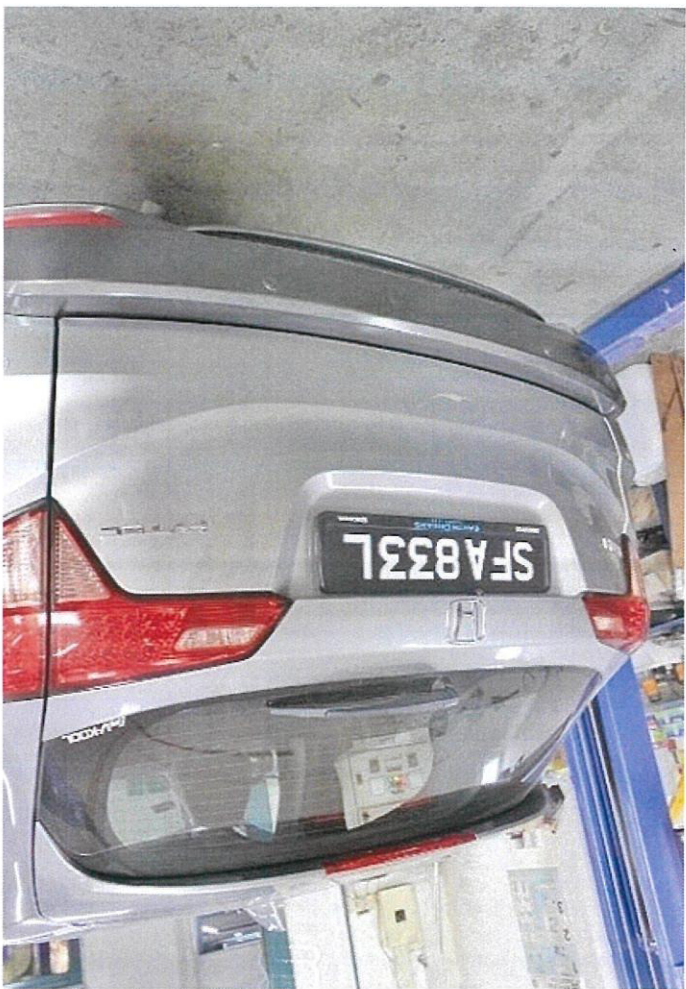
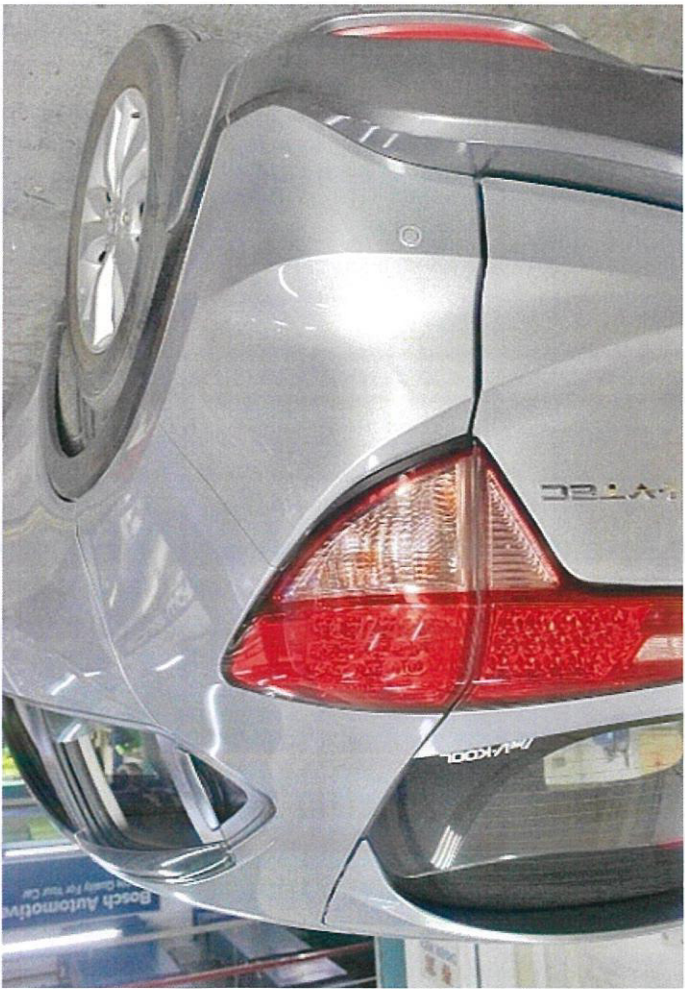
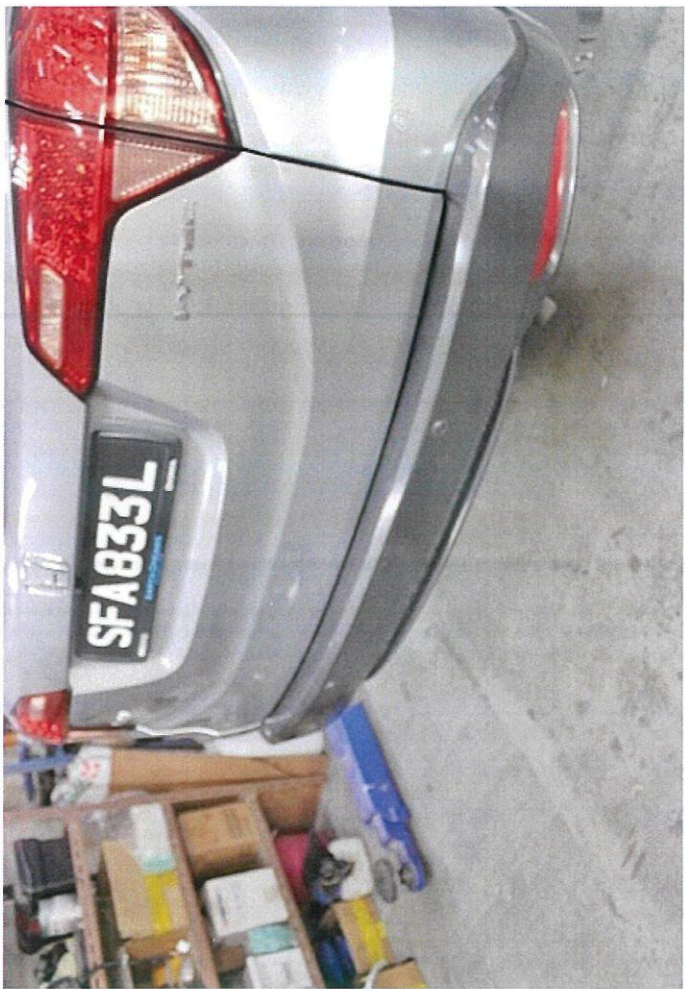
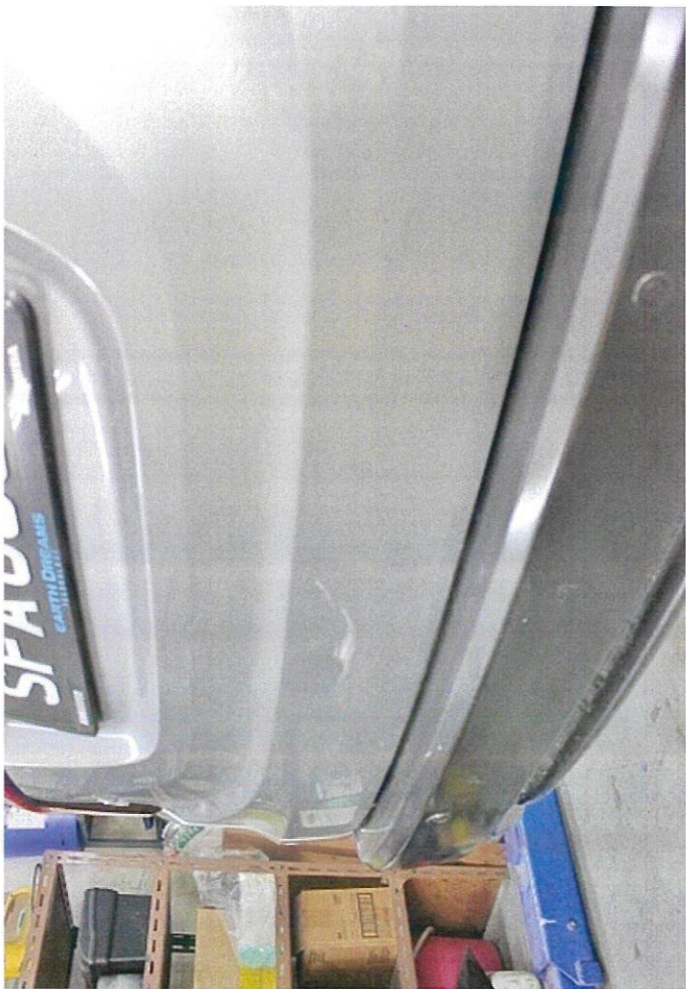
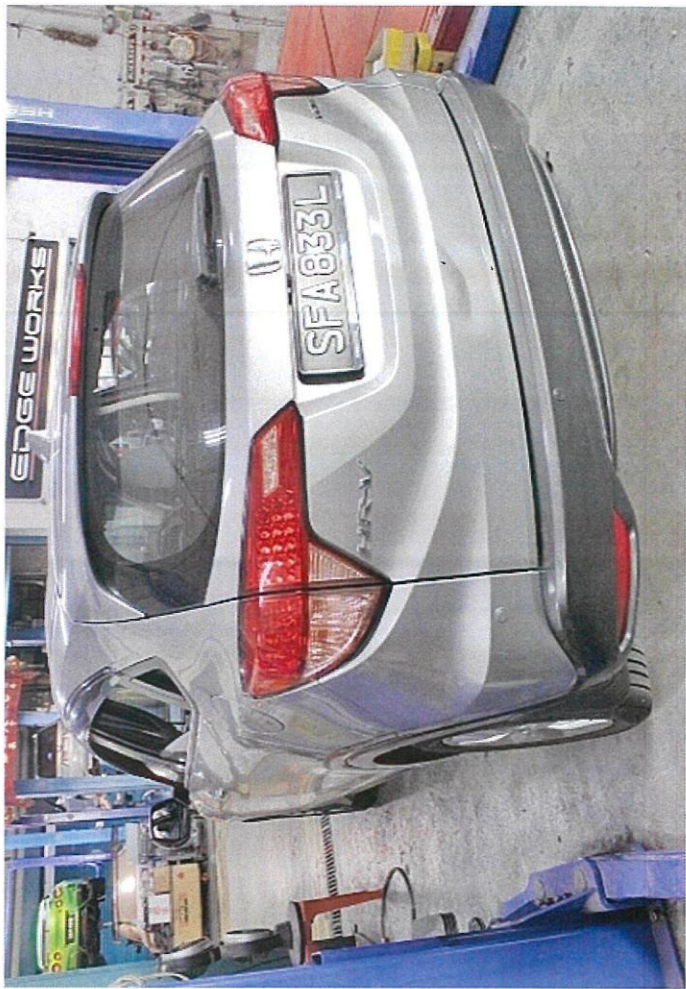
TO REPORT NO: 20/3/TP004
REGN. NO: SFA 833 L

Tailgate dented and bent, inner frame bent, lock assy. bent and jammed, rubber twisted, kinked, deformed, rear panel dented and bent, bumper assy. grazed, dented, kinked and deformed, fastener torn, fenders bent and distorted, boot floor panel bent.

Photographs:-	83 Copies	were taken at time of inspection and are attached .
The Repairers estimate was for a total amount of	\$	8,151.10
After adjustment the estimate was revised and agreed at	\$	5,749.04
