## LKK Auto Consultants Pte Ltd

## ADJUSTMENT ON REPAIR COST FOR VEHICLE NO. SMP 9017E

PHOTOGRAPHS FOR VEHICLE NO. SMP 9017E

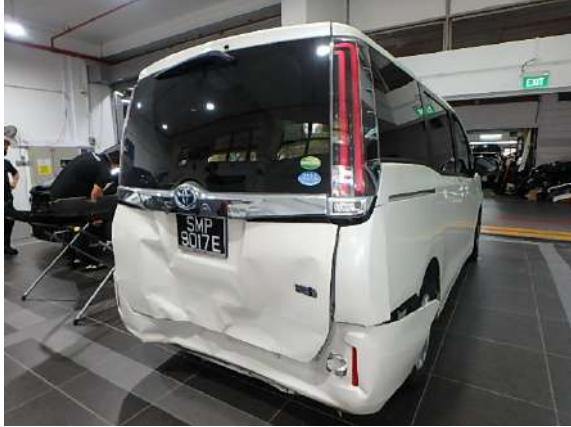
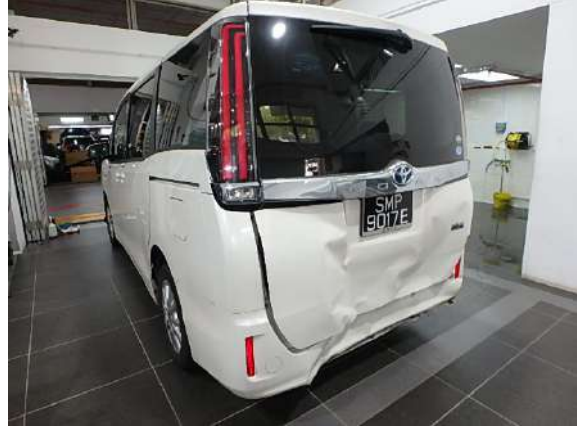
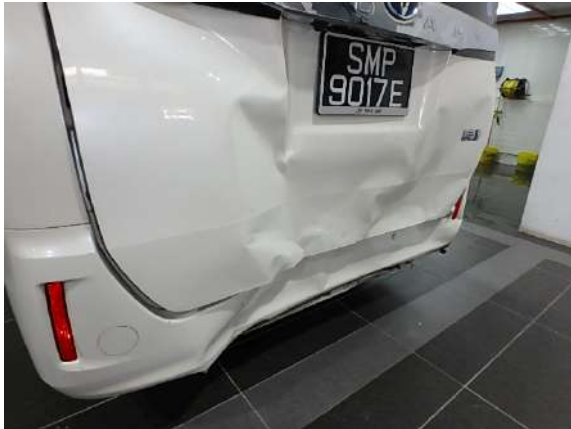
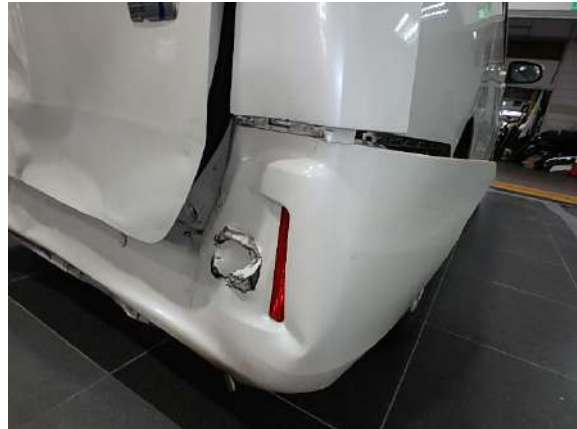
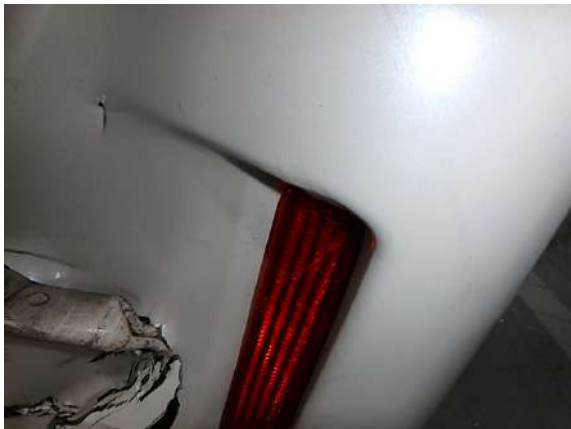
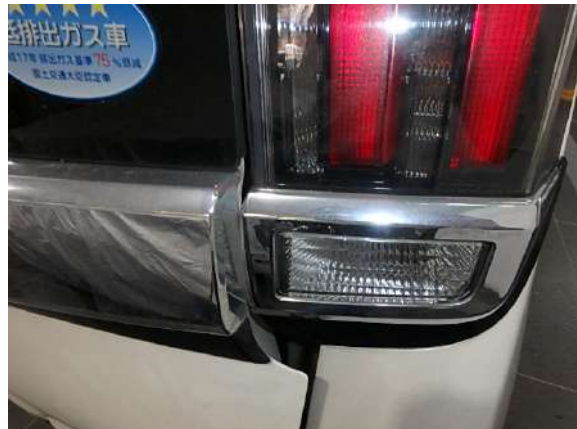
| Affiliated to Federation Internationale Des Experts En Automobile | | | | |
|---|---|---|---|--|
| THE VEHICLE SUSTAINED DAMAGES AT THE REAR & FRONT PORTION.<br><br>DAMAGES SEE DETAILS. | | | | |

INSPECTION
