Vehicle No. GBG 9001C  
Insured Veh. SHB 6608C  
Claim No. D20005236MFSH  
Policy No. D-20094922MFSH  
Accident Date 21/12/2020  
Inspection Date 24/12/2020

## ADJUSTMENT ON REPAIR COST FOR VEHICLE NO. GBG 9001C

### PHOTOGRAPHS FOR VEHICLE NO. GBG 9001C

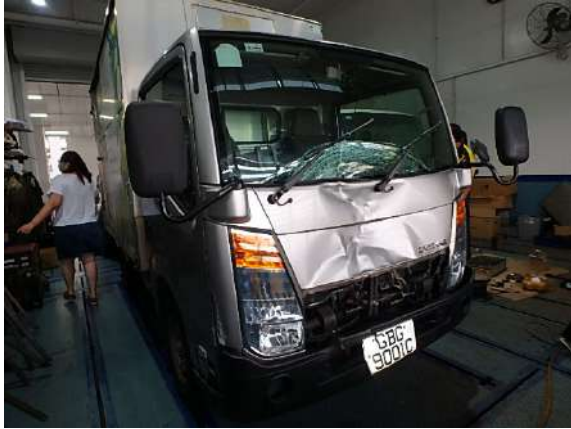
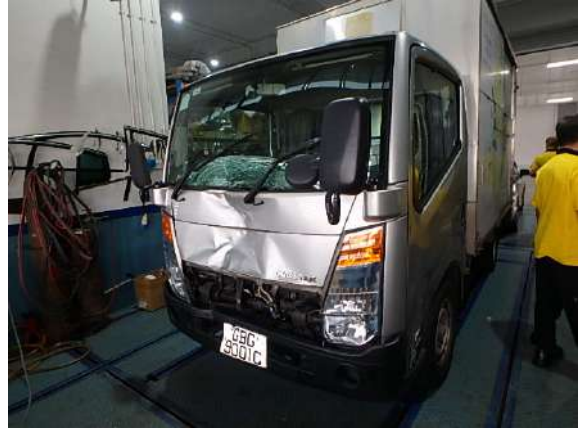
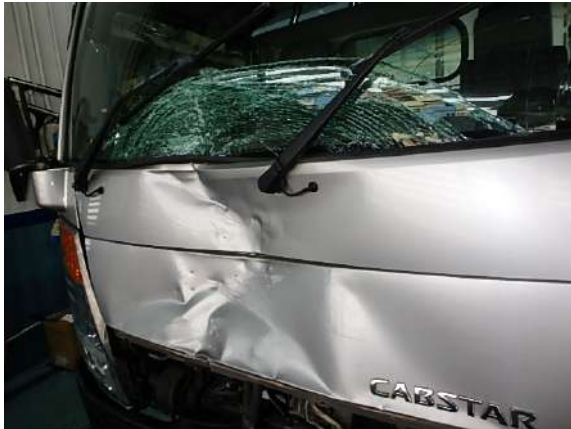
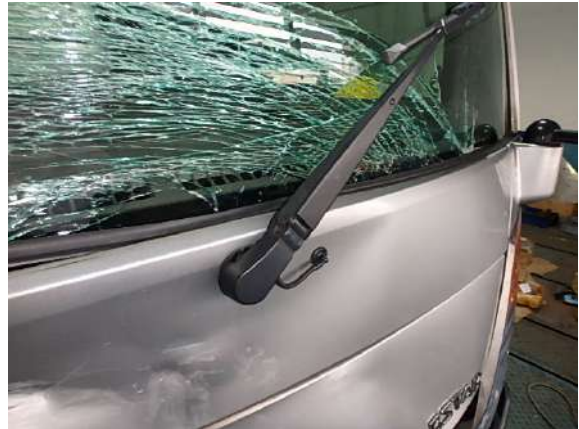
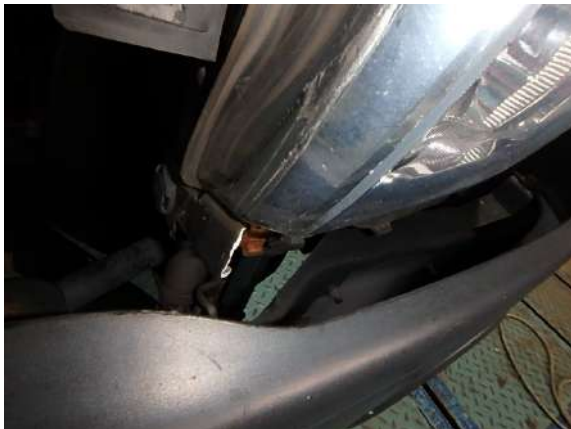
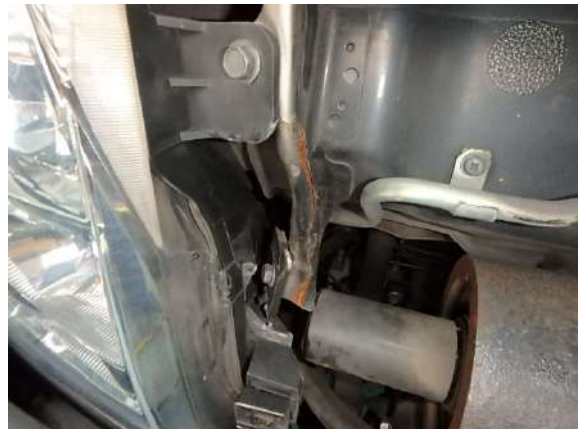
### INSPECTION

| Affiliated to Federation Internationale Des Experts En Automobile | | | | |
|---|---|---|---|--|
| THE VEHICLE SUSTAINED DAMAGES AT THE FRONT PORTION.<br><br>DAMAGES SEE DETAILS. | | | | |

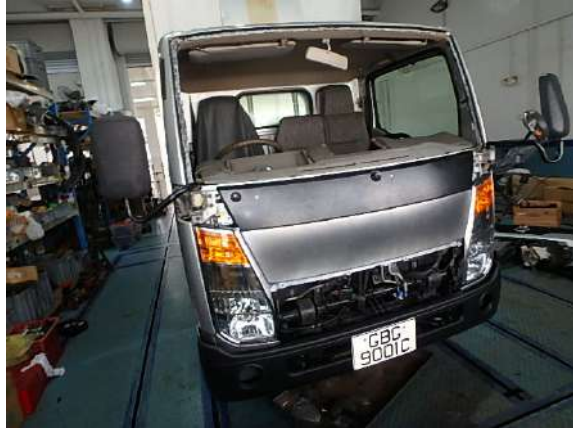
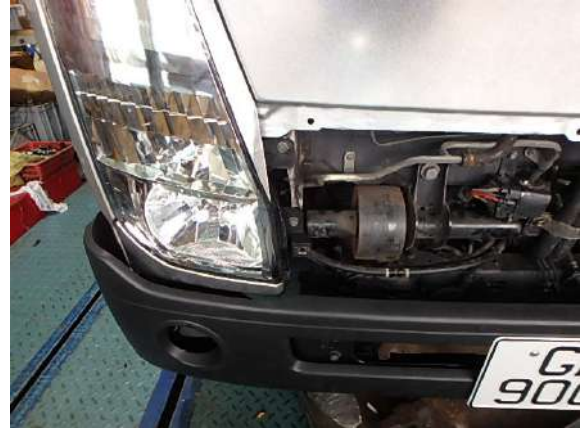
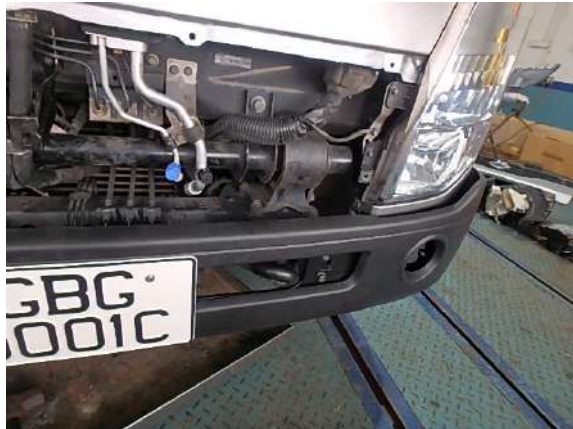
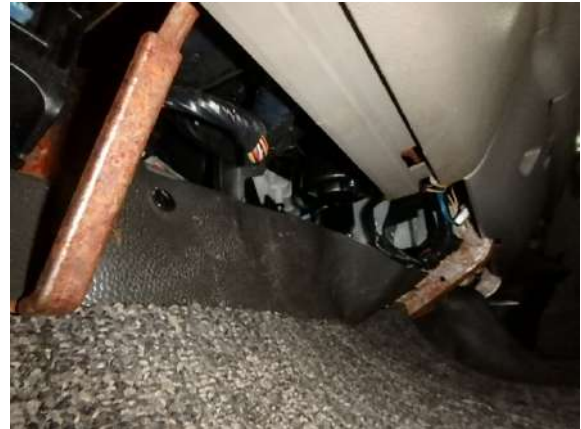
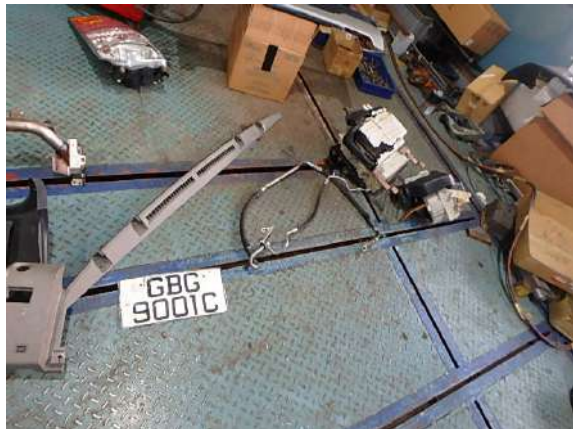
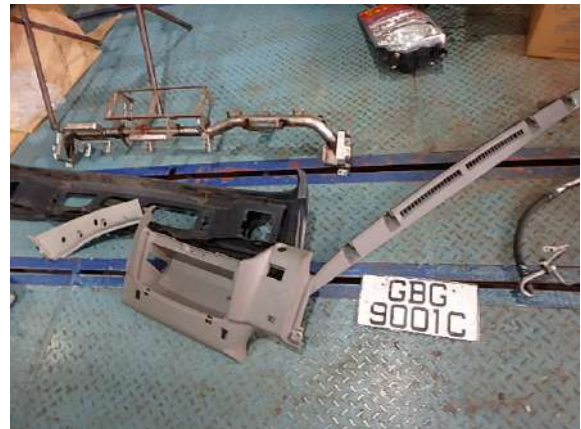
RE-INSPECTION

PHOTOGRAPHS FOR VEHICLE NO. GBG 9001C
