## LKK Auto Consultants Pte Ltd

Vehicle No. SHD 9035A  
Insured Veh. SHC 7809C  
Claim No. D20005252MFSH  
Policy No. D-18088937MFSH  
Accident Date 21/12/2020  
Inspection Date 22/12/2020

## ADJUSTMENT ON REPAIR COST FOR VEHICLE NO. SHD 9035A

**PHOTOGRAPHS FOR VEHICLE NO. SHD 9035A**

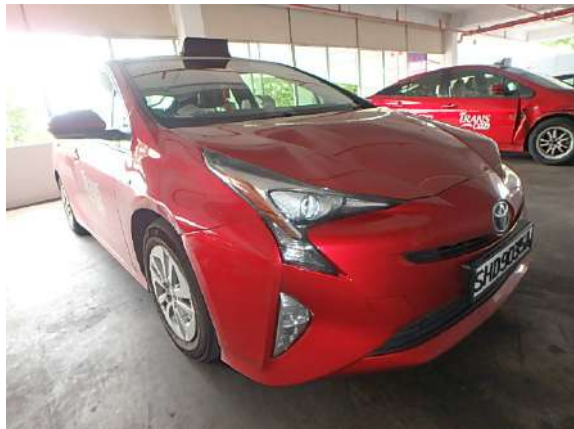
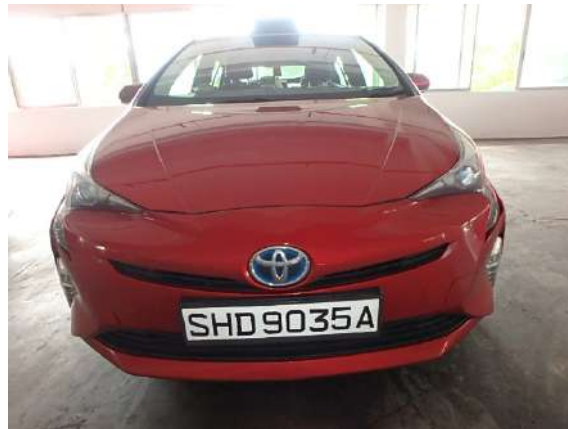
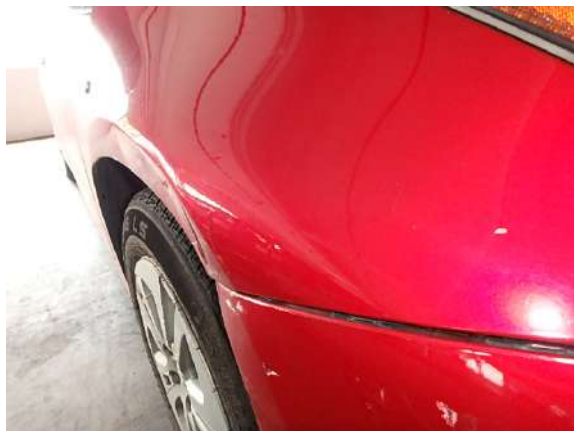
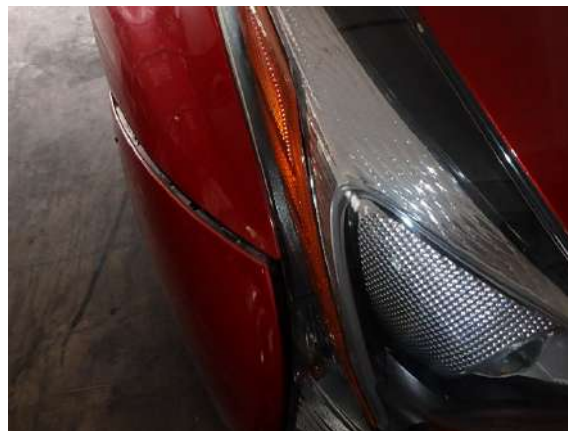
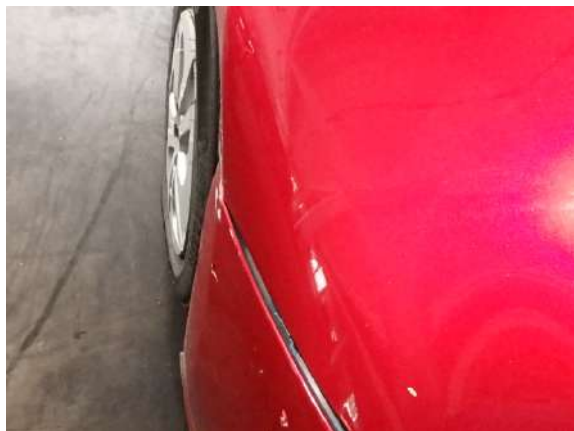
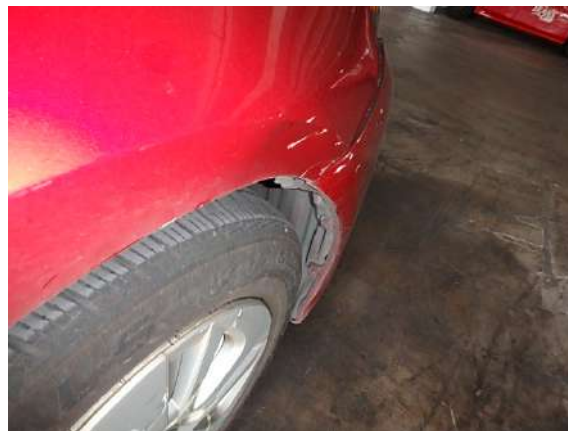
| Affiliated to Federation Internationale Des Experts En Automobile | | | | |
|---|---|---|---|--|
| THE VEHICLE SUSTAINED DAMAGES AT THE O/S FRONT PORTION.<br><br>DAMAGES SEE DETAILS. | | | | |

**INSPECTION**
