## LKK Auto Consultants Pte Ltd

## ADJUSTMENT ON REPAIR COST FOR VEHICLE NO. SMW 2414B

### PHOTOGRAPHS FOR VEHICLE NO. SMW 2414B

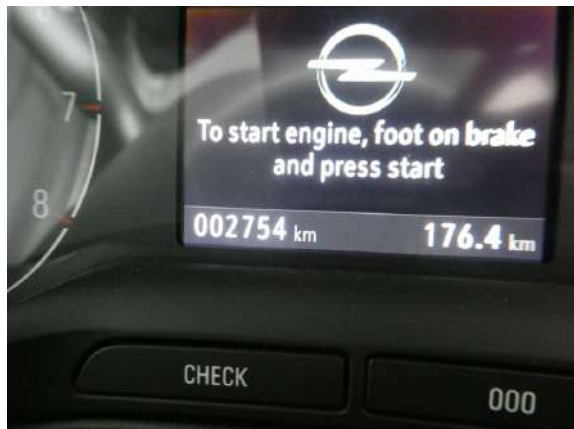
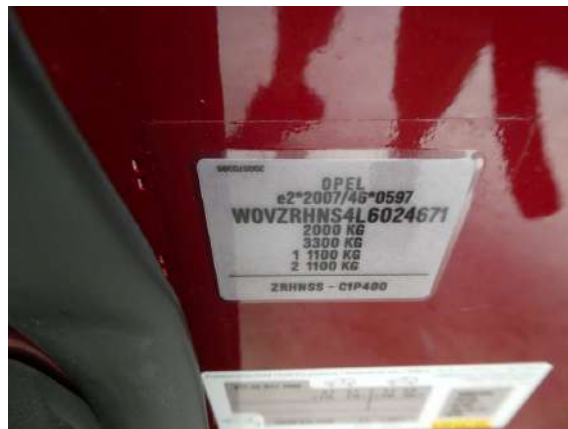
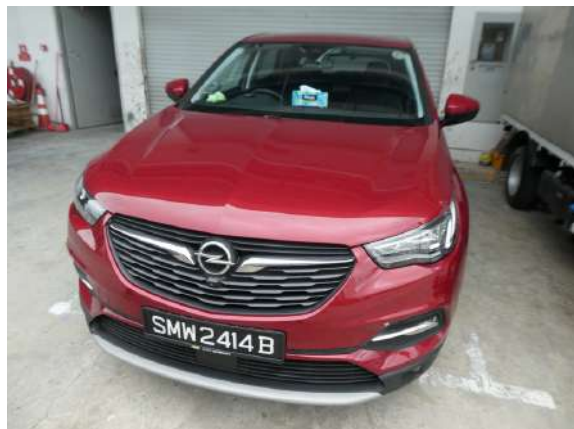
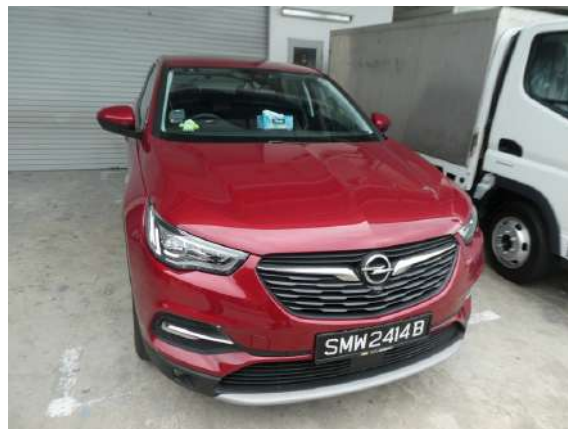
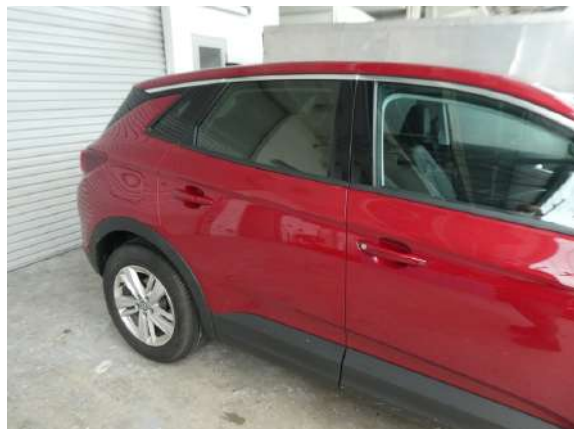
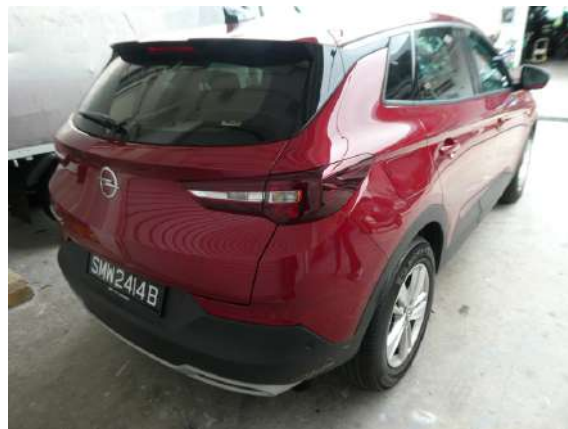
### INSPECTION

| Affiliated to Federation Internationale Des Experts En Automobile | | | | |
|---|---|---|---|--|
| THE VEHICLE SUSTAINED DAMAGES AT THE O/S REAR PORTION.<br>DAMAGES SEE DETAILS. | | | | |

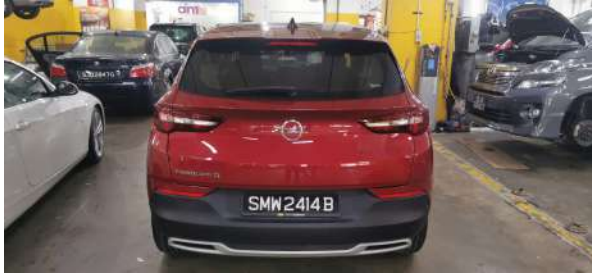
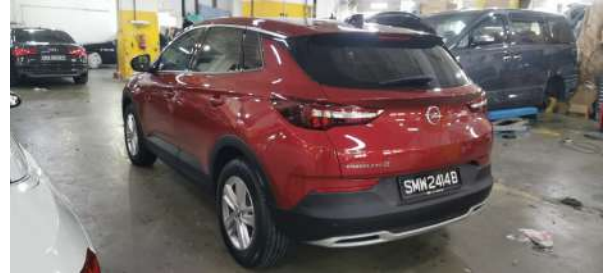
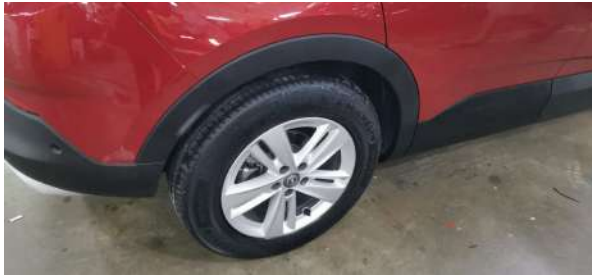
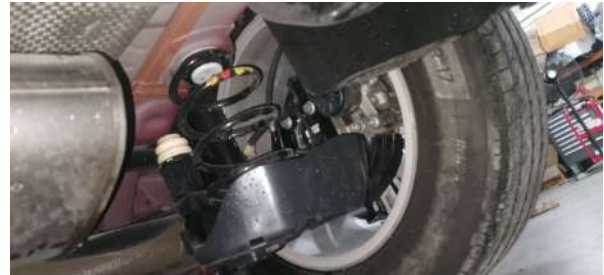
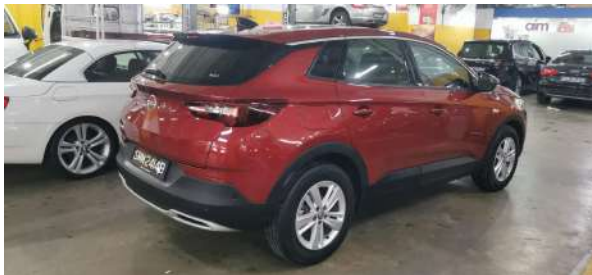
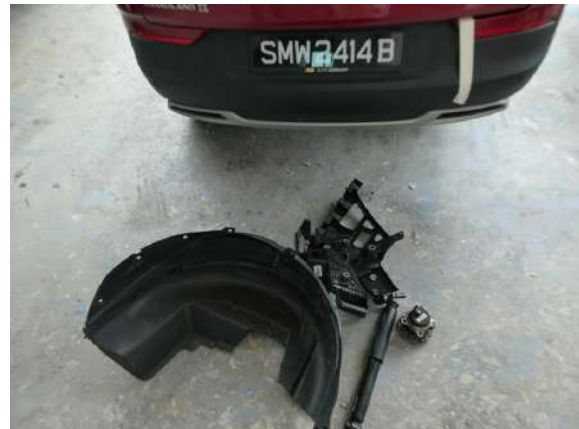
### PHOTOGRAPHS FOR VEHICLE NO. SMW 2414B

### RE-INSPECTION
