## LKK Auto Consultants Pte Ltd

### PROFESSIONAL SERVICE FEE

### ADJUSTMENT ON REPAIR COST FOR VEHICLE NO. GBK 3922M

### PHOTOGRAPHS FOR VEHICLE NO. GBK 3922M

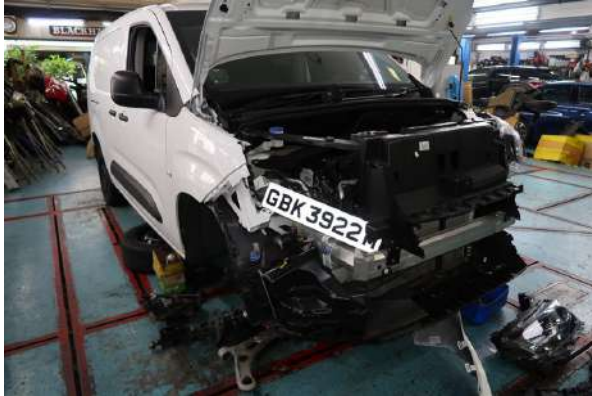
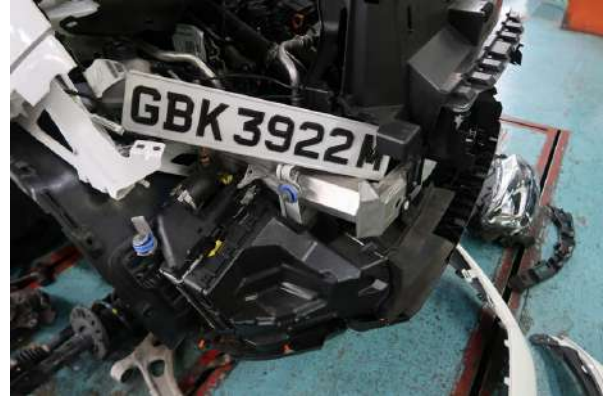
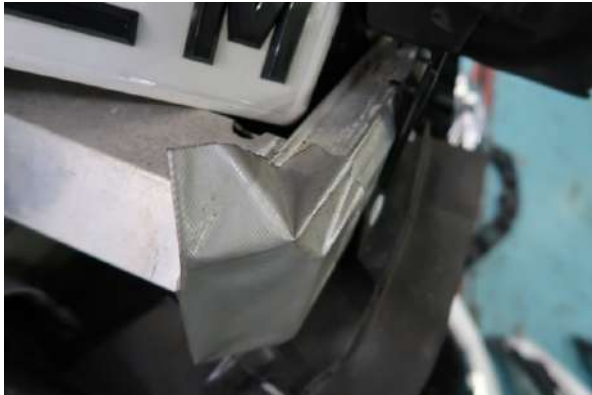
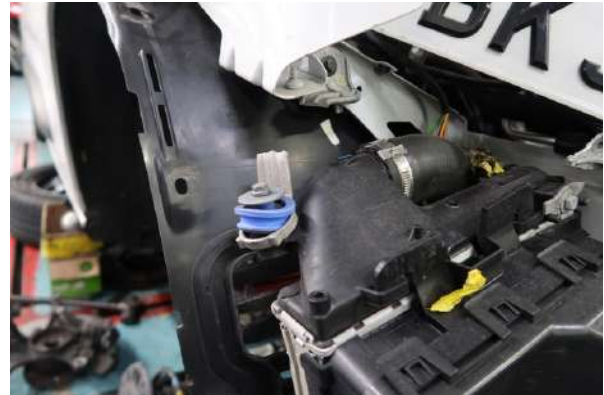
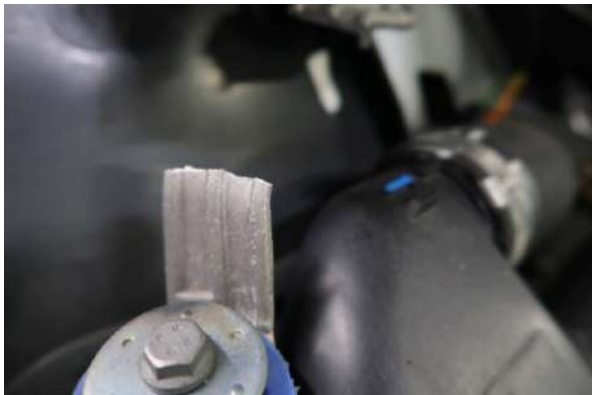
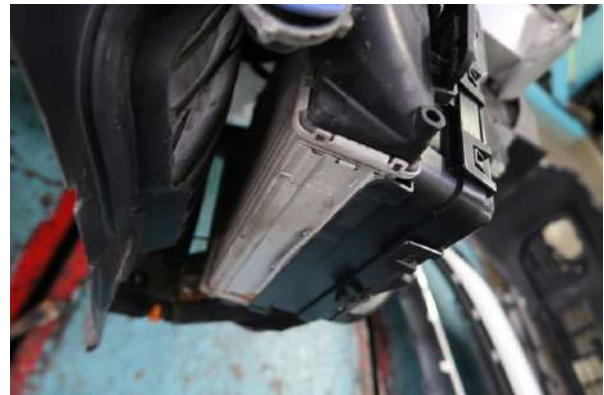
PHOTOGRAPHS FOR VEHICLE NO. GBK 3922M

| Affiliated to Federation Internationale Des Experts En Automobile | | | | |
|---|---|---|---|--|
| THE VEHICLE SUSTAINED DAMAGES AT THE O/S FRONT PORTION. THE UNDERCARRIAGE AFFECTED DUE TO COLLISION.<br><br>DAMAGES SEE DETAILS. | | | | |

RE-INSPECTION
