### PROFESSIONAL SERVICE FEE

Vehicle No. SLL 9225D

## ADJUSTMENT ON REPAIR COST FOR VEHICLE NO. SLL 9225D

### PHOTOGRAPHS FOR VEHICLE NO. SLL 9225D

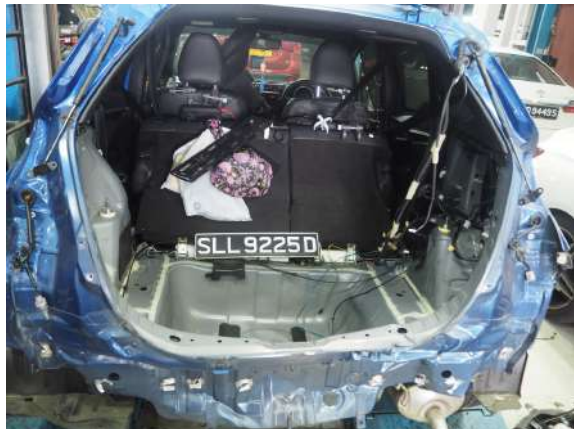
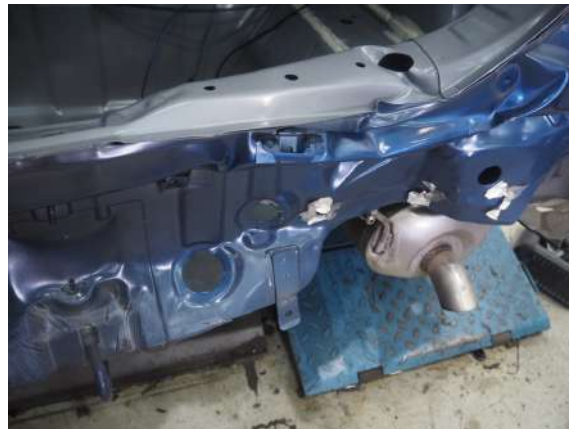
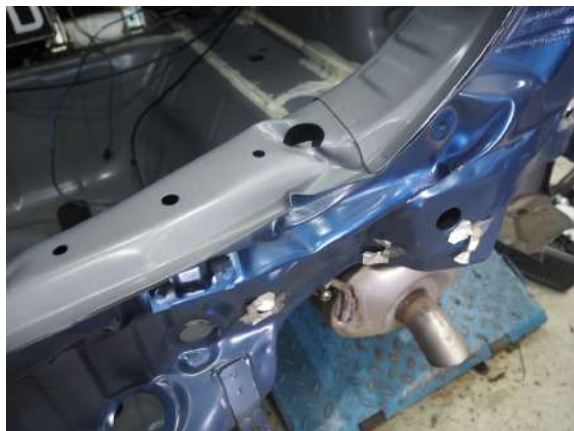
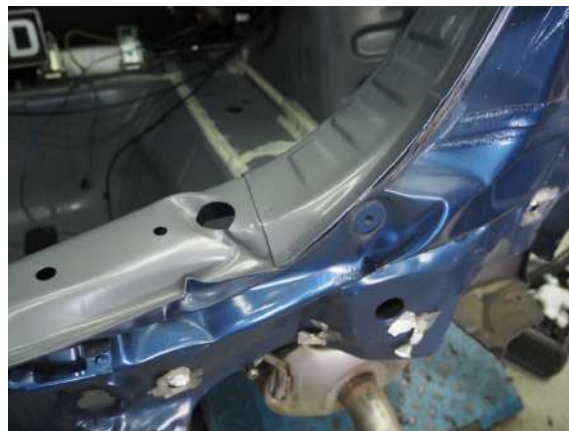
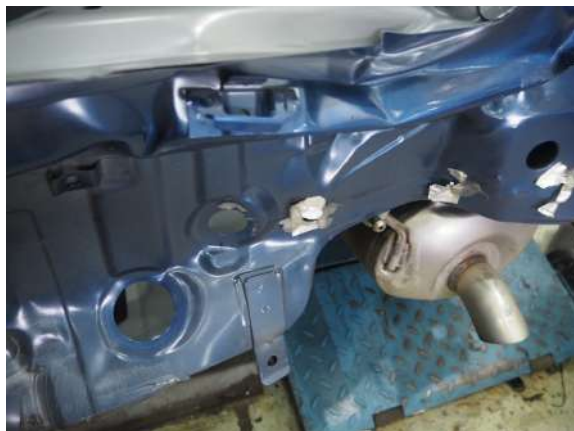
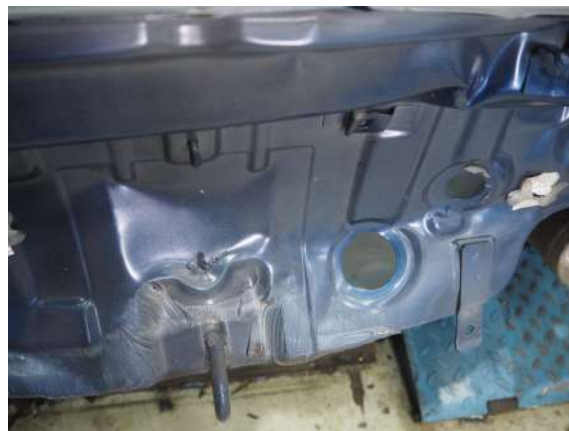
**PHOTOGRAPHS FOR VEHICLE NO. SLL 9225D**

| Affiliated to Federation Internationale Des Experts En Automobile | | | | |
|---|---|---|---|--|
| THE VEHICLE SUSTAINED DAMAGES AT THE REAR PORTION.<br>DAMAGES SEE DETAILS. | | | | |

**RE-INSPECTION**

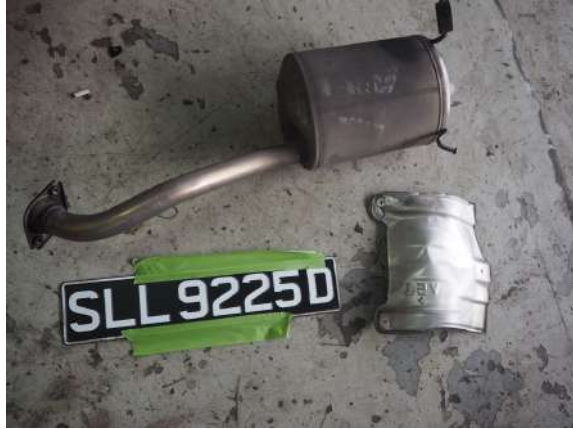
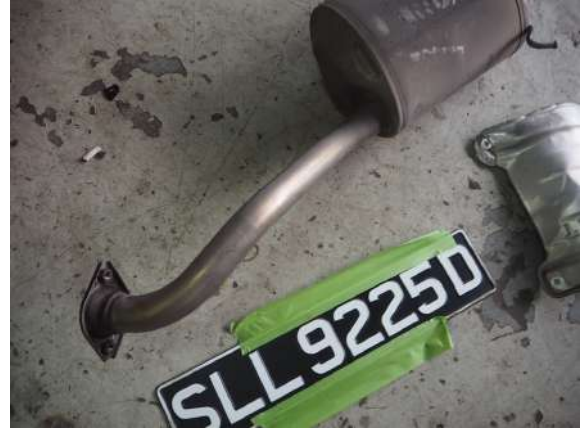
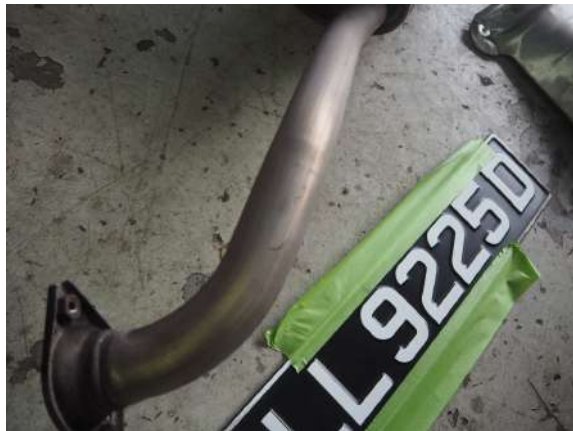
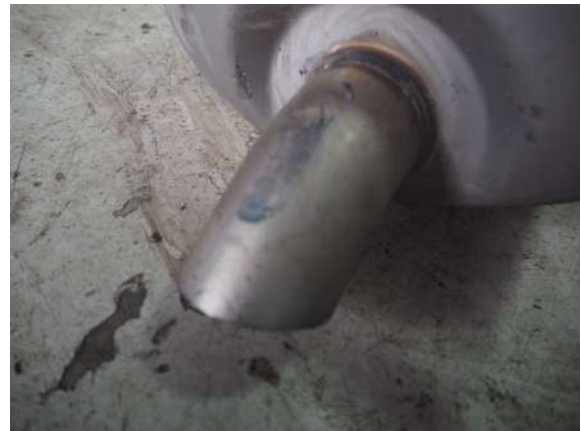
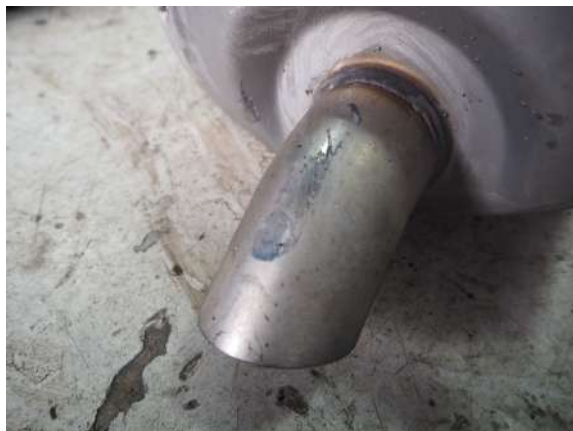
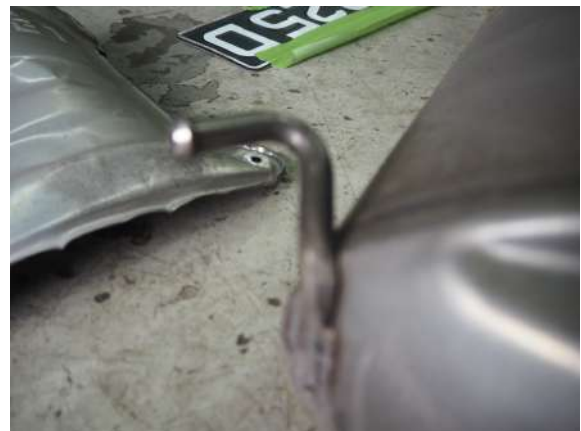
PHOTOGRAPHS FOR VEHICLE NO. SLL 9225D

RE-INSPECTION
