Vehicle No. SGM 9007X

ADJUSTMENT ON REPAIR COST FOR VEHICLE NO. SGM 9007X

PHOTOGRAPHS FOR VEHICLE NO. SGM 9007X

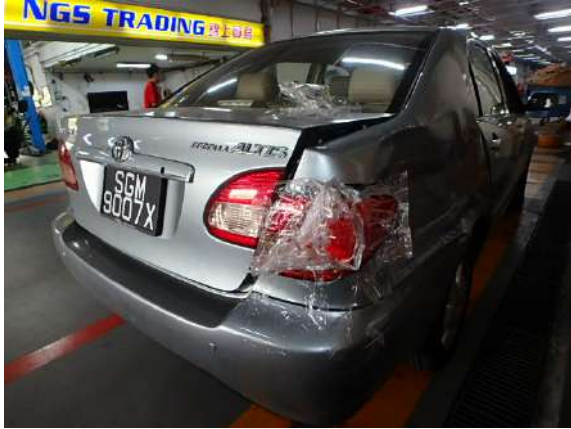
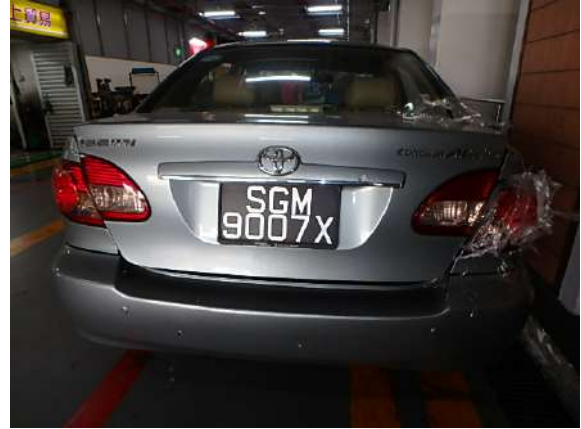
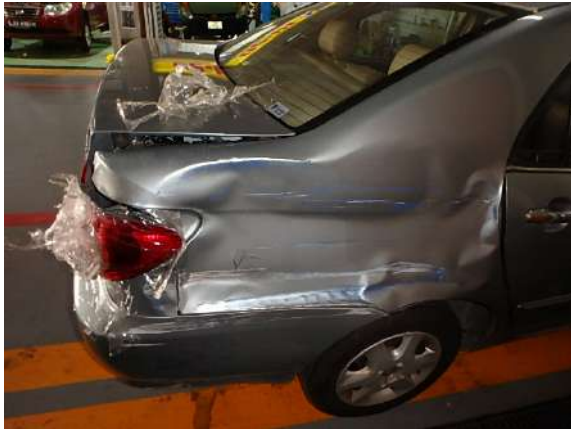
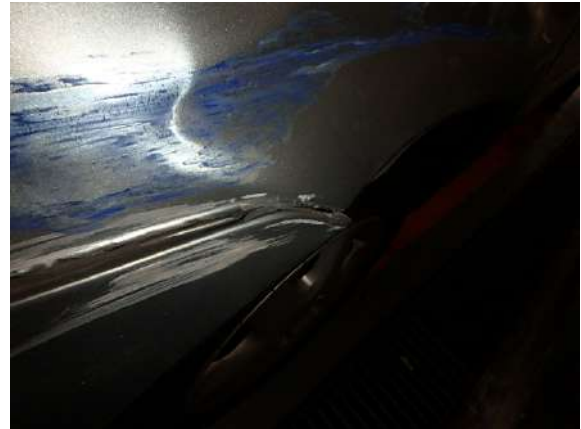
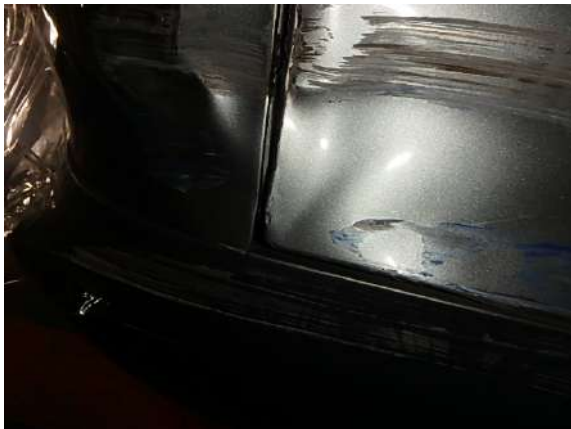
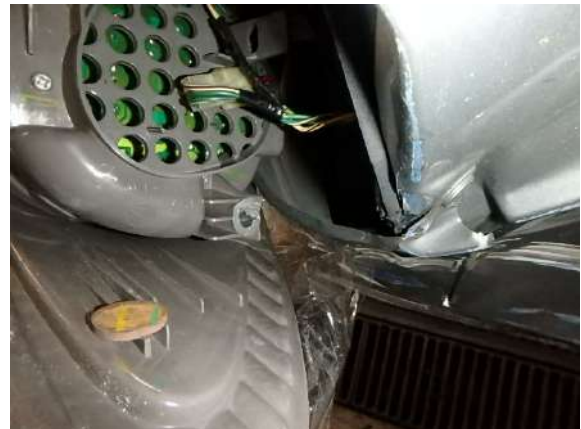
INSPECTION

4. Description of Damages				
THE VEHICLE SUSTAINED DAMAGES AT THE O/S REAR PORTION. DAMAGES SEE DETAILS.				
5. General Information				
Accident Date	13/01/2021	Inspection Date	21/01/2021	
Survey held at	NGS AUTOMOTIVE 10 ANG MO KIO INDUSTRIAL PARK 2A #02-01 AMK AUTOPOINT SINGAPORE 568047			
5a. Remarks

Qty	Description of Parts	Condition	Estimate By Workshop (\$)	Our Adjusted (\$)
	<u>REPLACEMENT OF PARTS</u>			
1	REAR BUMPER	BUCKLED / DENTED	326.44	326.44
1	RETAINER SIDE RH	DISTORTED	18.32	18.32
1	PANEL ,REAR SIDE RH	BENT	39.28	39.28
1	FENDER ,REAR RH	BENT	749.15	749.15
1	TAILLAMP RH	MTG CRACKED	279.02	279.02
1	TAILLAMP GASKET RH	NECESSARY	31.58	31.58
1	GARNISH ,TAILLAMP LOWER PANEL RH	BENT	74.90	74.90
	LESS 25% DISCOUNT		-379.67	-379.67
			1,139.02	1,139.02
	<u>SPECIAL NETT ITEMS</u>			
10	CLIPS ,TAILLAMP RH @\$5.00 (SN)	NECESSARY (4 PCS ONLY)	50.00	20.00
1	SEALANT (SN)	NECESSARY	60.00	40.00

110.00	60.00
	<u>LABOUR</u>			
	TO REMOVE ALL DAMAGED PARTS WITH ALL NECESSARY COMPONENT/ATTACHMENT STRAIGHTEN CHASSIS MEMBER ,CUT & WELD PANEL ,REPAIR /RESHAPE DENTED BODY PANEL,REPLACE DAMAGED PARTS ,REFIT INTO POSITION .		1,200.00	650.00
	TO REMOVE & REPLACE REAR WINDSCREEN .		250.00	120.00
	TO SPRAY PAINTING .		800.00	680.00
	CHECK WIRING /PROPER FUNCTION ON LIGHTS AND ETC.		50.00	20.00
			2,300.00	1,470.00
	GRAND TOTAL		3,549.02	2,669.02
