## LKK Auto Consultants Pte Ltd

## ADJUSTMENT ON REPAIR COST FOR VEHICLE NO. FBL 2901A

PHOTOGRAPHS FOR VEHICLE NO. FBL 2901A

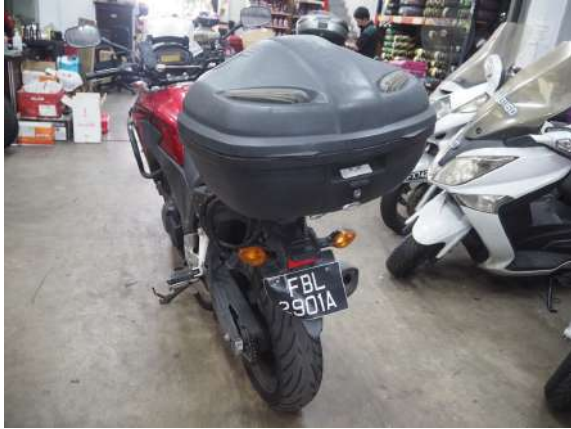
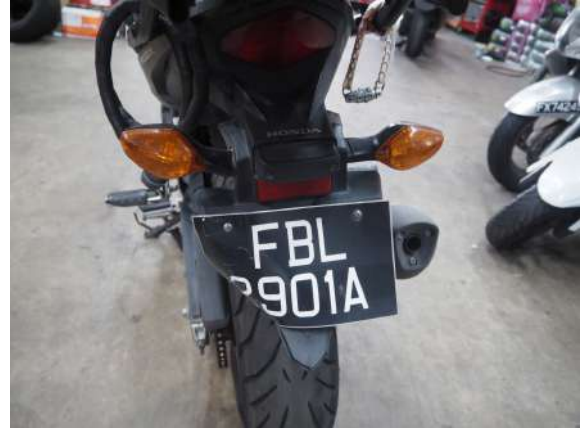
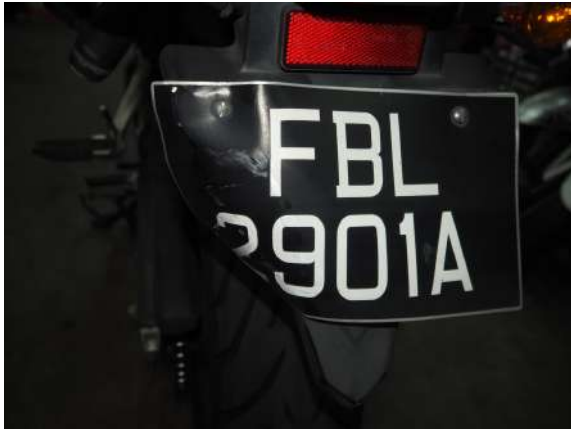
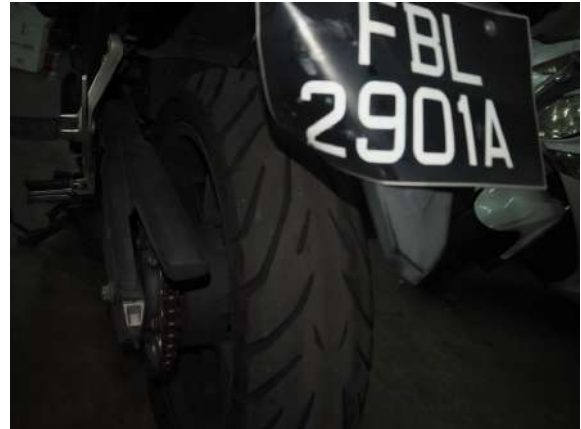
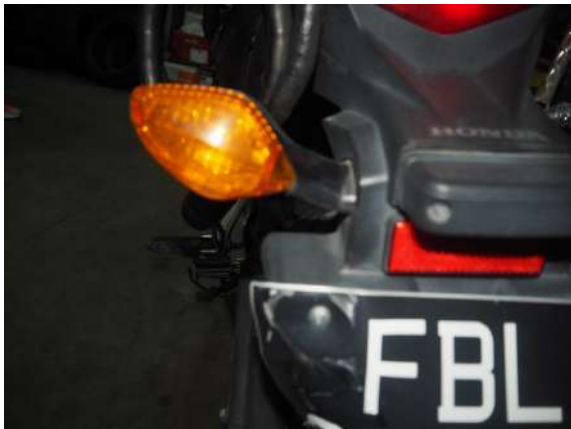
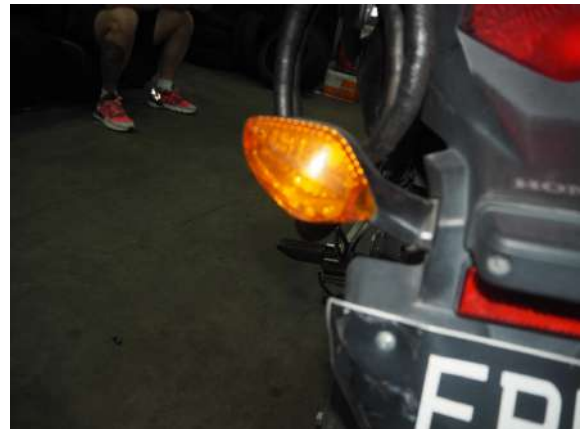
| Affiliated to Federation Internationale Des Experts En Automobile | | | | |
|---|---|---|---|--|
| THE VEHICLE SUSTAINED DAMAGES AT THE REAR PORTION AND O/S BODY.<br>DAMAGES SEE DETAILS. | | | | |

INSPECTION
