## LKK Auto Consultants Pte Ltd

### PROFESSIONAL SERVICE FEE

Vehicle No. SHA 3340Z  
Insured Veh. GBG 5256K  
Claim No. SNM21D200358/LKKDS  
Policy No. DMCVSNW00069802000  
Accident Date 21/01/2021  
Inspection Date 22/01/2021

## ADJUSTMENT ON REPAIR COST FOR VEHICLE NO. SHA 3340Z

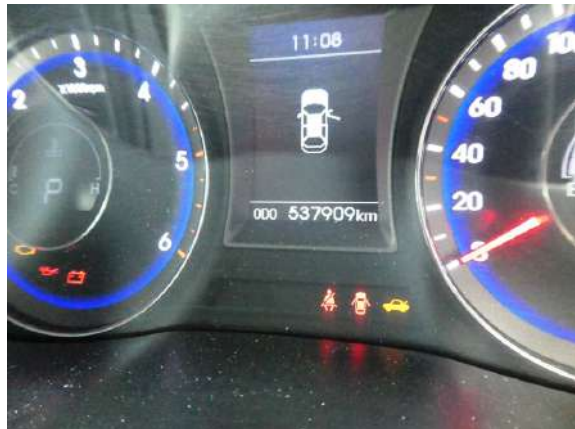
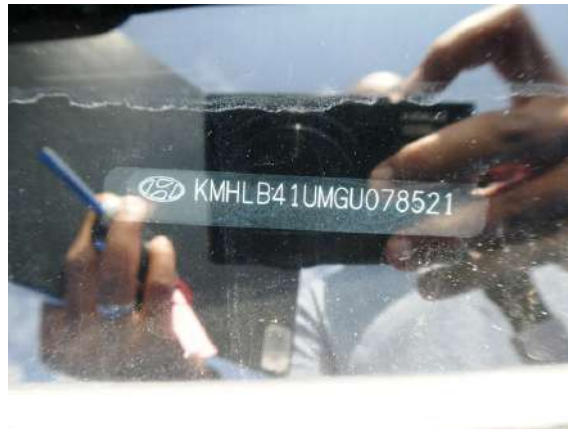
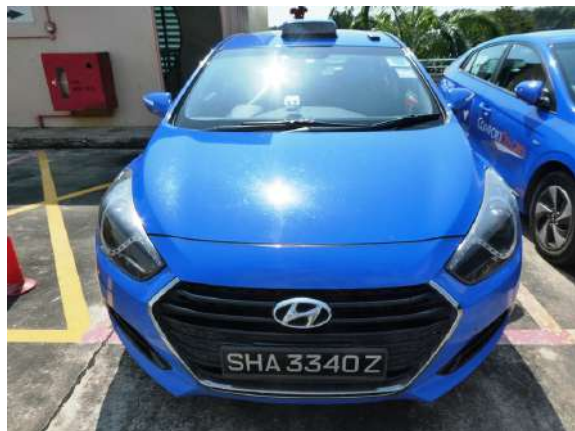
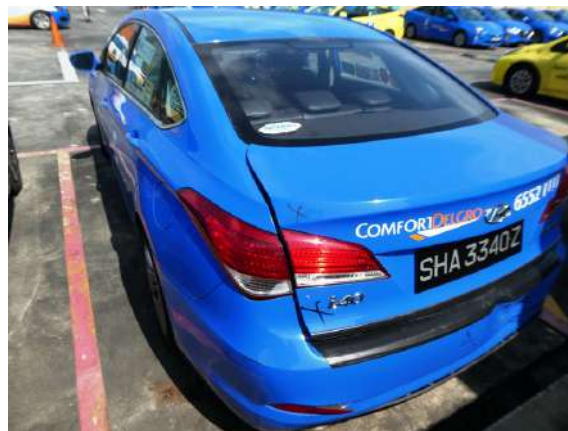
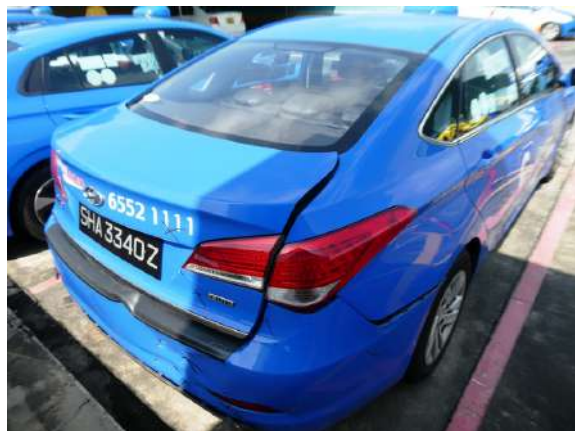
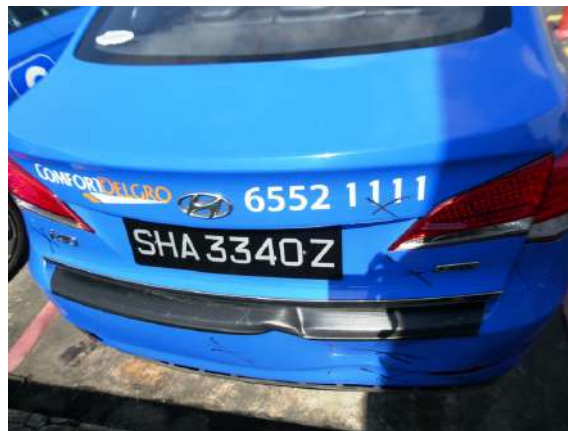
### PHOTOGRAPHS FOR VEHICLE NO. SHA 3340Z

| Affiliated to Federation Internationale Des Experts En Automobile | | | | |
|---|---|---|---|--|
| THE VEHICLE SUSTAINED DAMAGES AT THE REAR PORTION.<br>DAMAGES SEE DETAILS. | | | | |

### INSPECTION

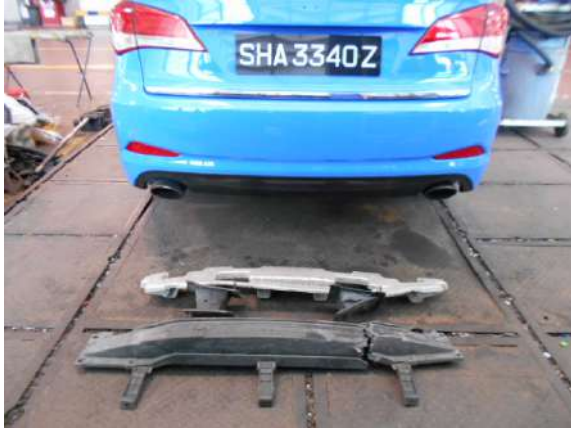
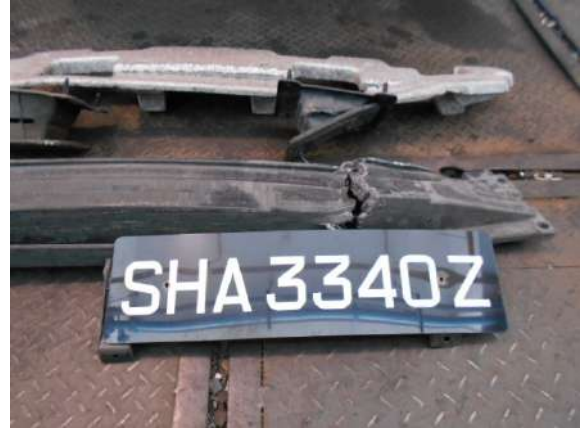
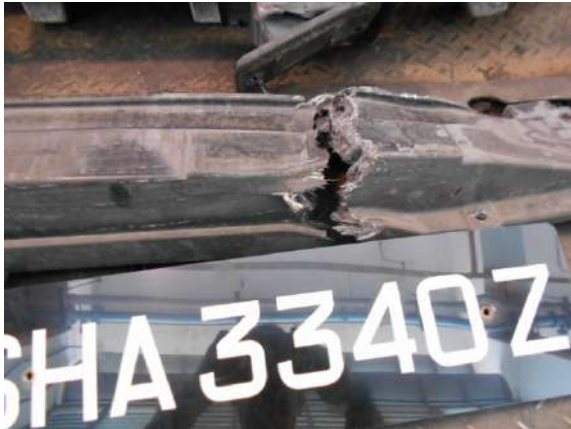
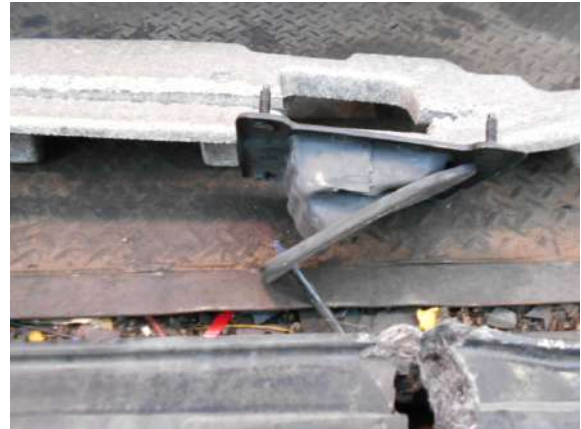
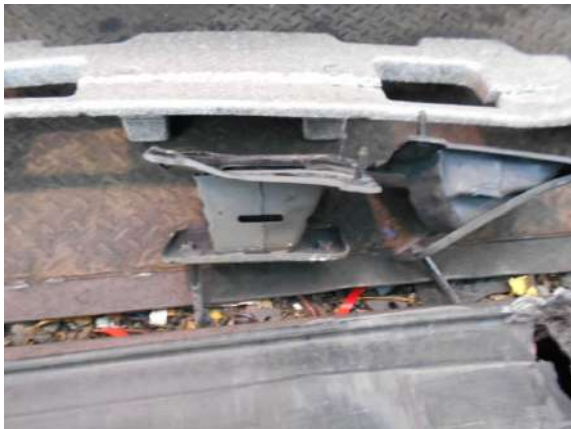
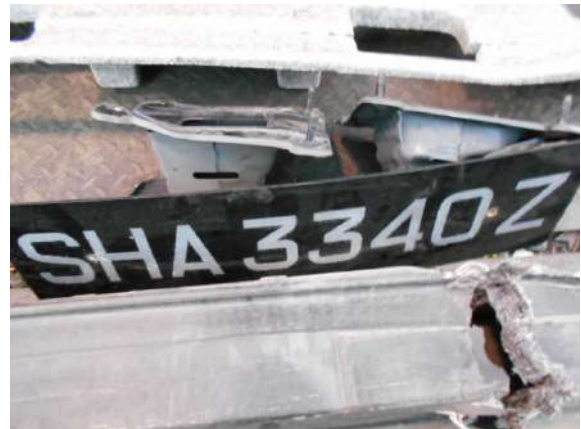
PHOTOGRAPHS FOR VEHICLE NO. SHA 3340Z

RE-INSPECTION
