Vehicle No. SLZ 9278C  
Insured Veh. SMT 2127X  
Claim No. SNM21D200545/LKKDS  
Policy No. DMPCSNW00077852000  
Accident Date 28/01/2021  
Inspection Date 28/01/2021

## ADJUSTMENT ON REPAIR COST FOR VEHICLE NO. SLZ 9278C

### PHOTOGRAPHS FOR VEHICLE NO. SLZ 9278C

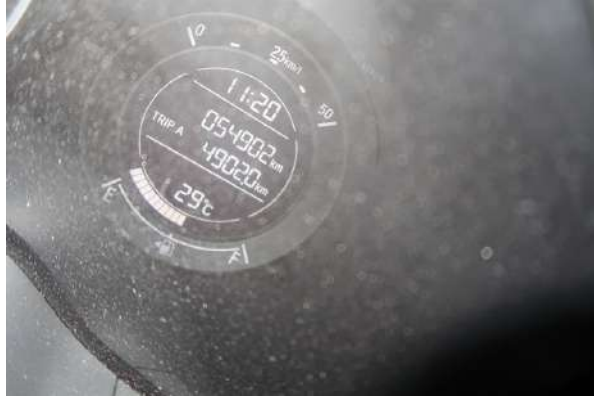
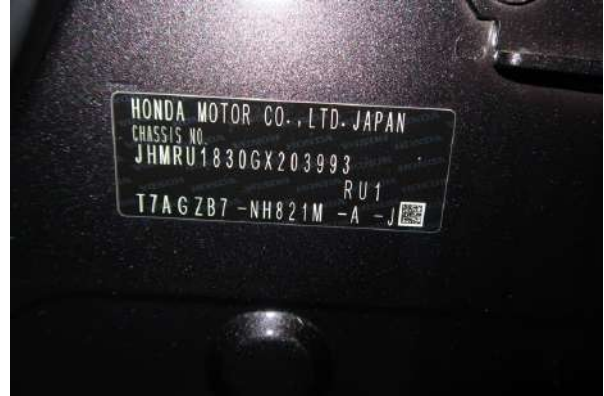
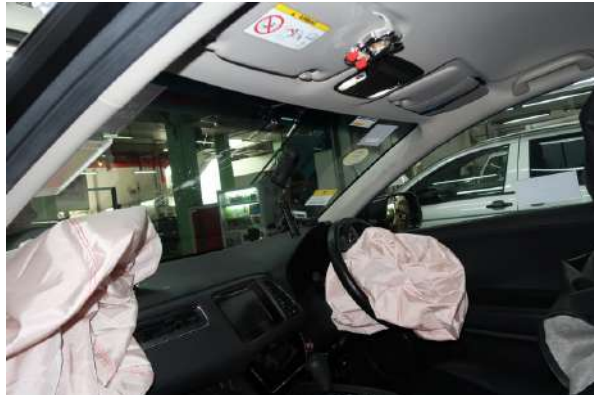
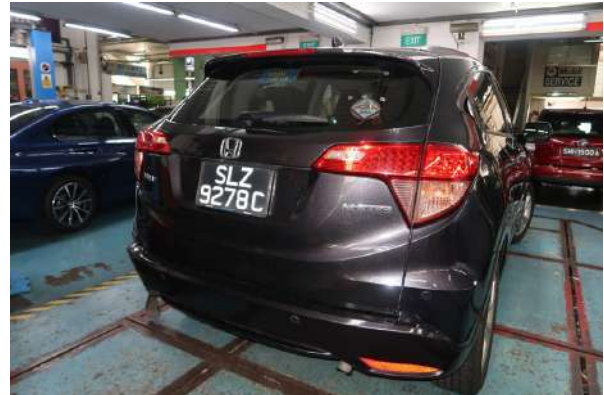
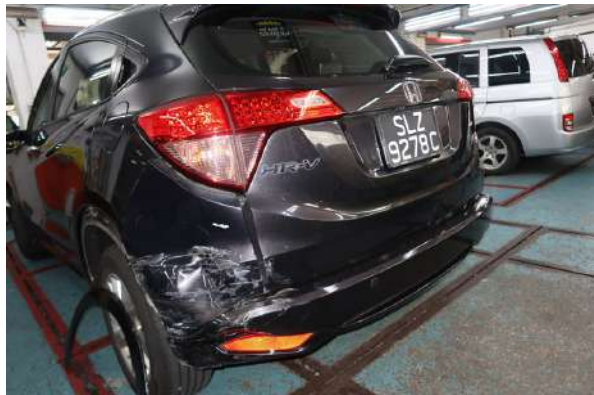
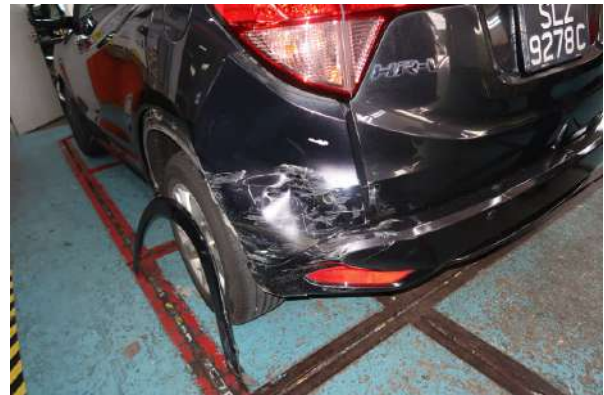
| Affiliated to Federation Internationale Des Experts En Automobile | | | | |
|---|---|---|---|--|
| THE VEHICLE SUSTAINED DAMAGES AT THE REAR N/S & FRONT PORTION.<br>DAMAGES SEE DETAILS. | | | | |

### INSPECTION

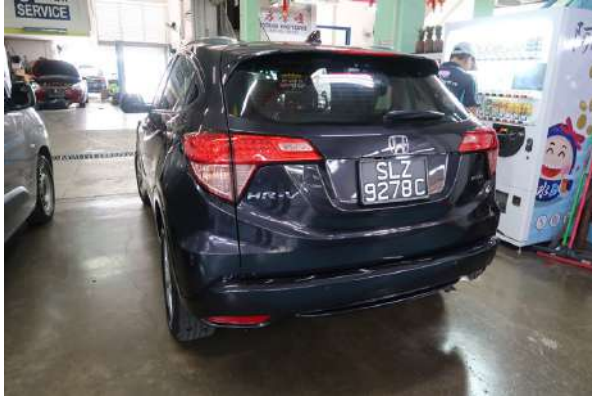
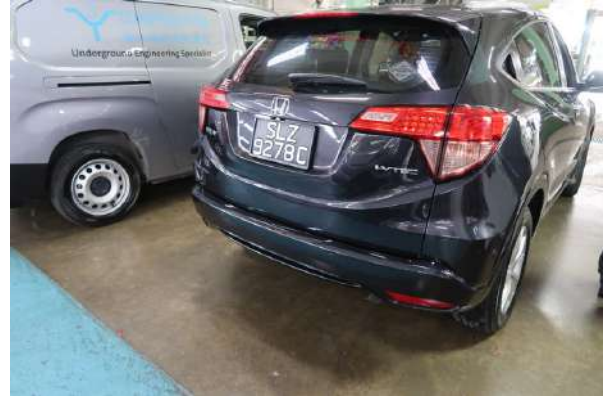
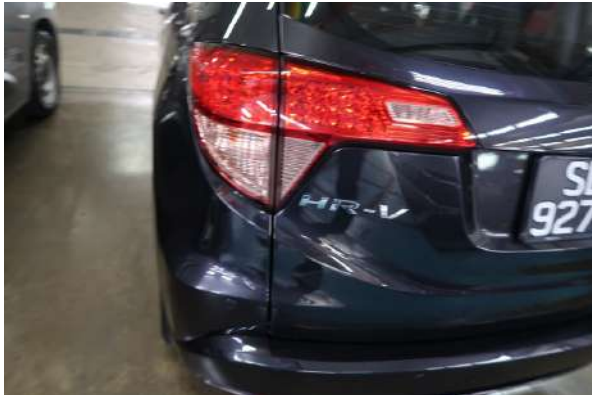
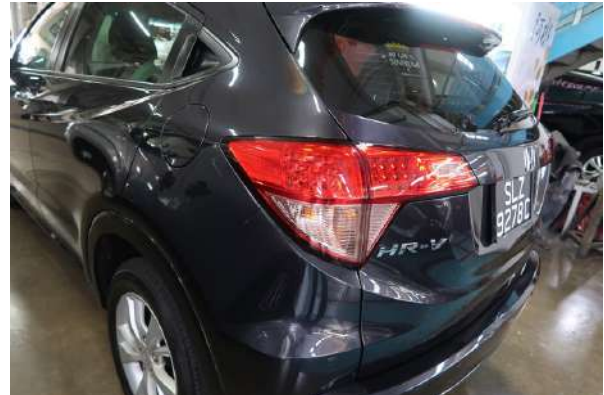
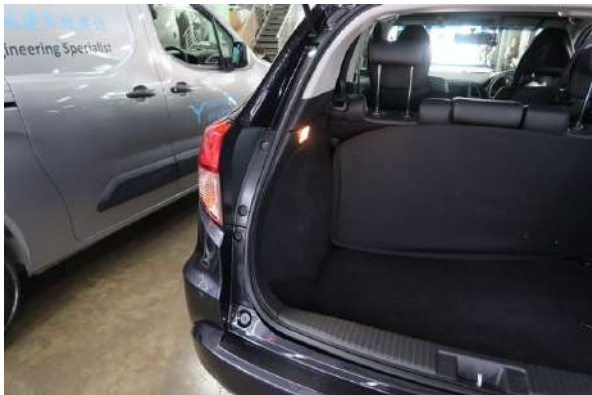
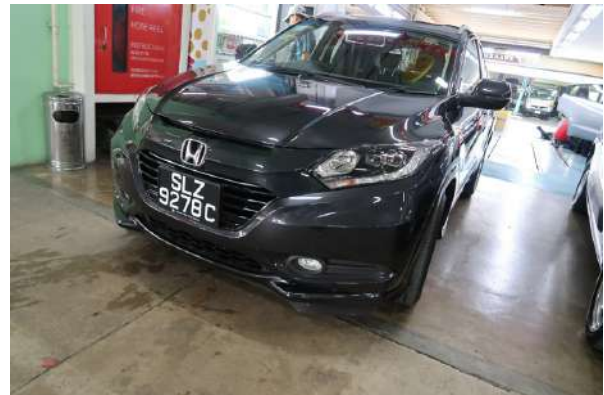
### PHOTOGRAPHS FOR VEHICLE NO. SLZ 9278C

### RE-INSPECTION
