## LKK Auto Consultants Pte Ltd

### TAX INVOICE

## ADJUSTMENT ON REPAIR COST FOR VEHICLE NO. YN 5837A

### PHOTOGRAPHS FOR VEHICLE NO. YN 5837A

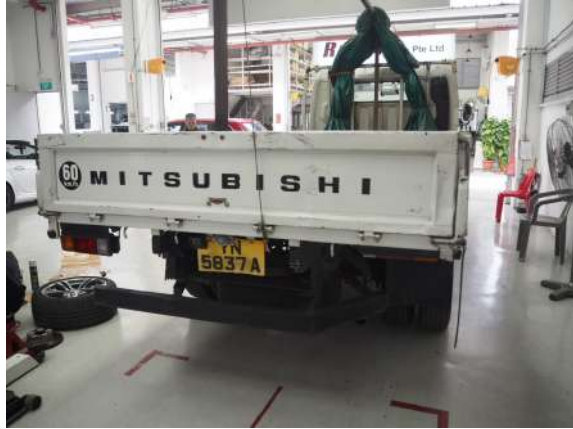
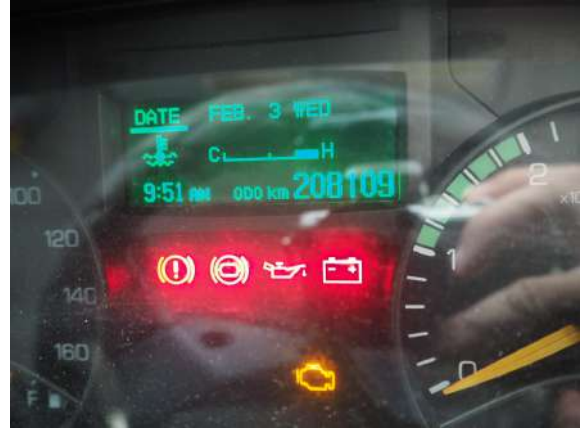
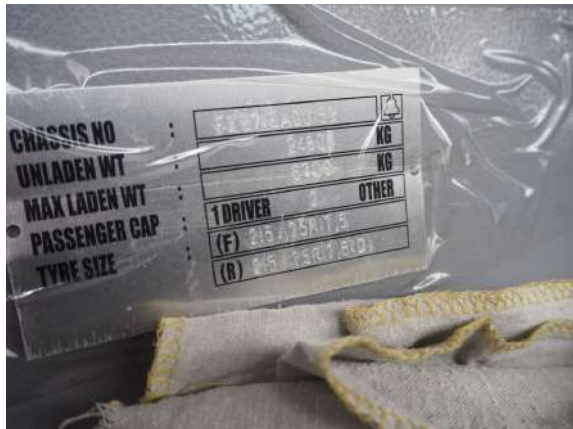
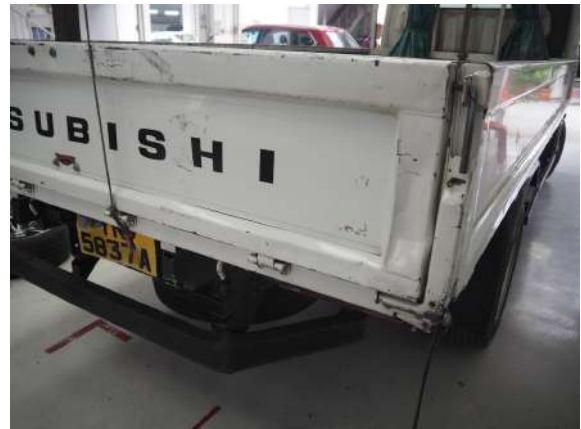
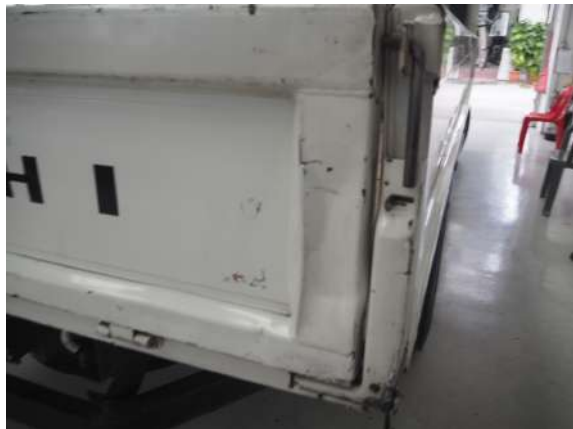
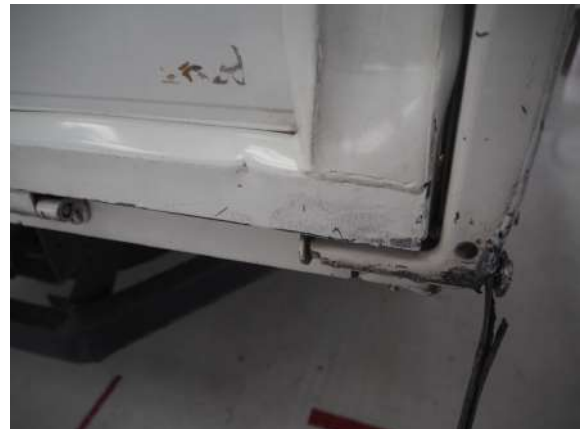
| Affiliated to Federation Internationale Des Experts En Automobile | | | | |
|---|---|---|---|---|
| | THE VEHICLE SUSTAINED DAMAGES AT THE REAR O/S PORTION.<br><br>DAMAGES SEE DETAILS. | | | |

### INSPECTION
