## ADJUSTMENT ON REPAIR COST FOR VEHICLE NO. SHD 1662S

### PHOTOGRAPHS FOR VEHICLE NO. SHD 1662S

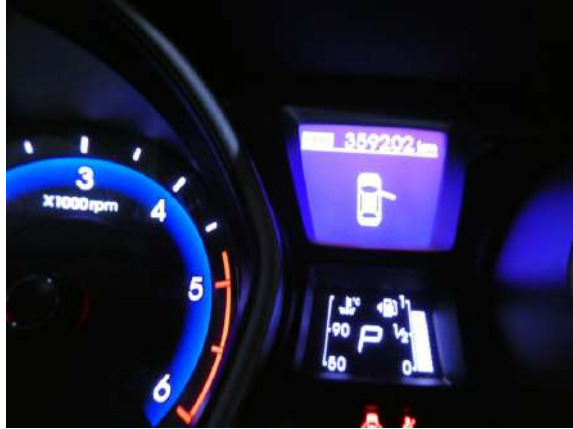
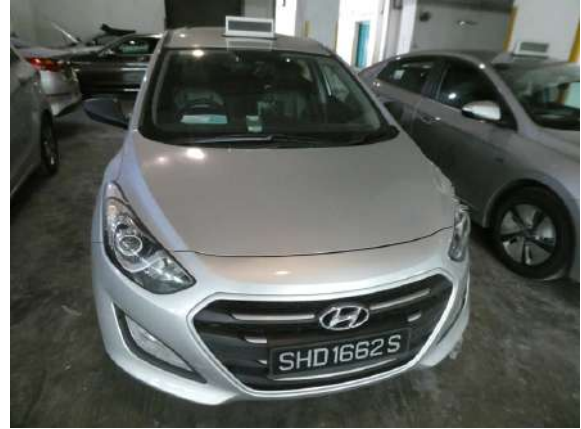
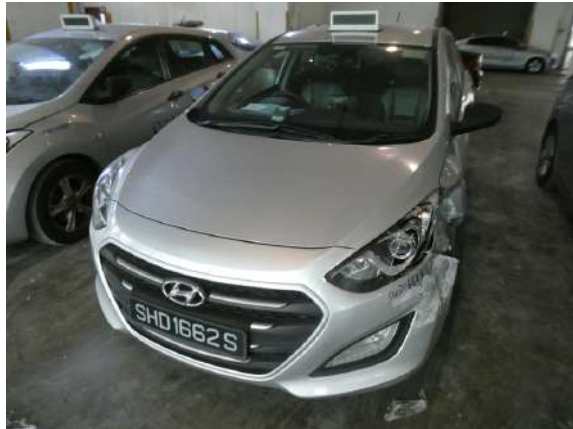
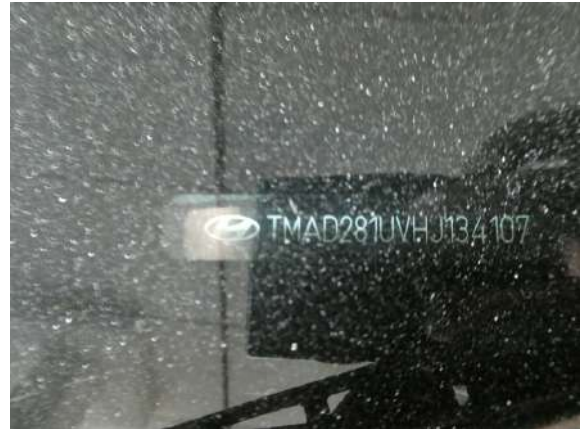
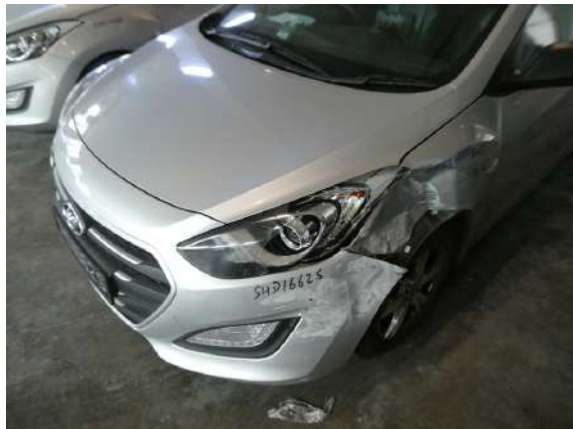
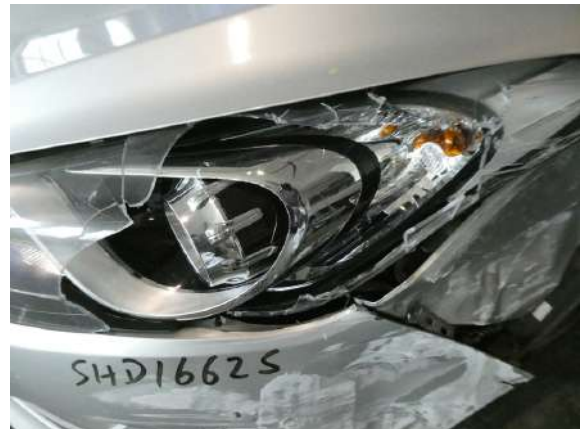
### INSPECTION

| Affiliated to Federation Internationale Des Experts En Automobile | | | | |
|---|---|---|---|--|
| THE VEHICLE SUSTAINED DAMAGES AT THE N/S BODY AND UNDERCARRIAGE.<br>DAMAGES SEE DETAILS. | | | | |

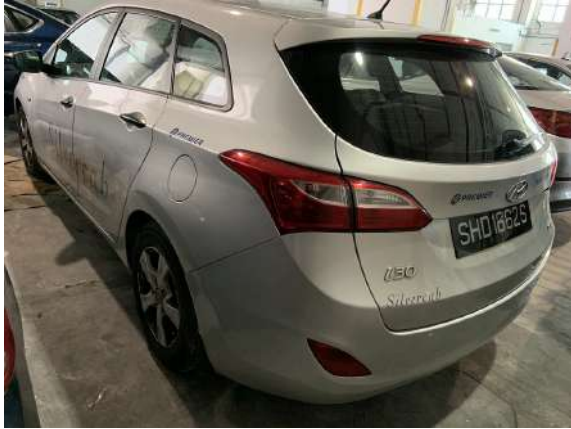
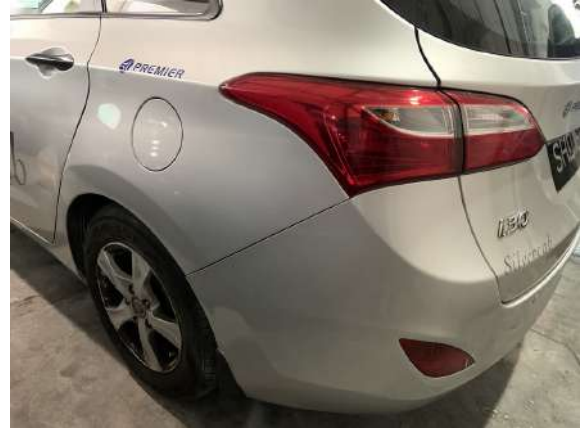
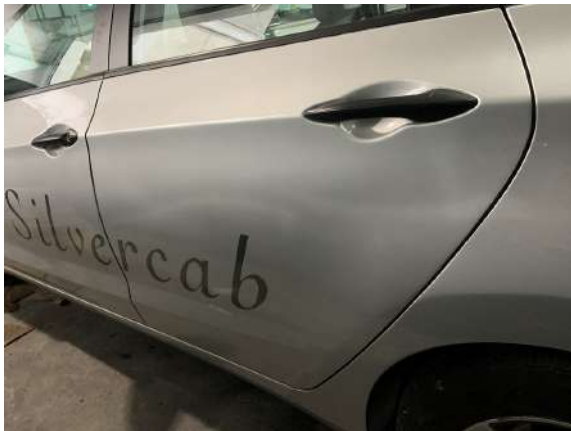
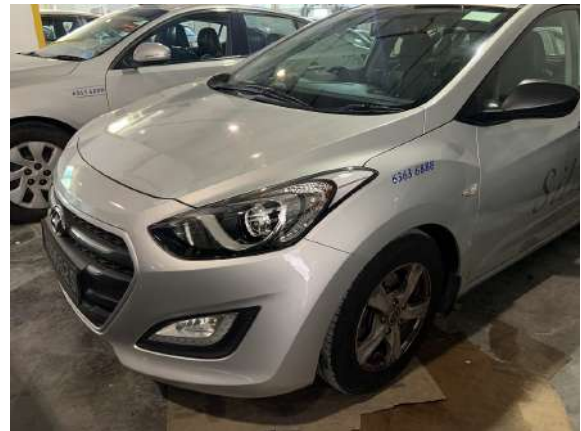
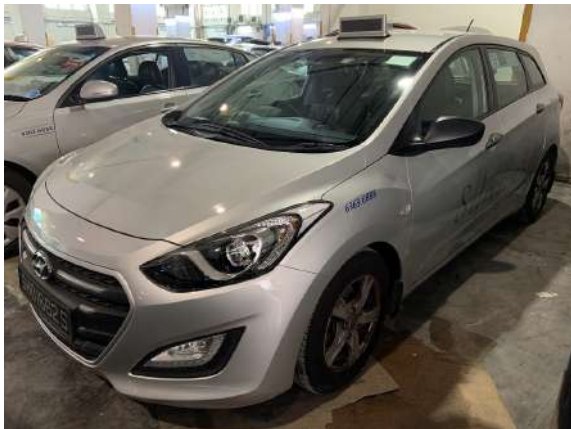
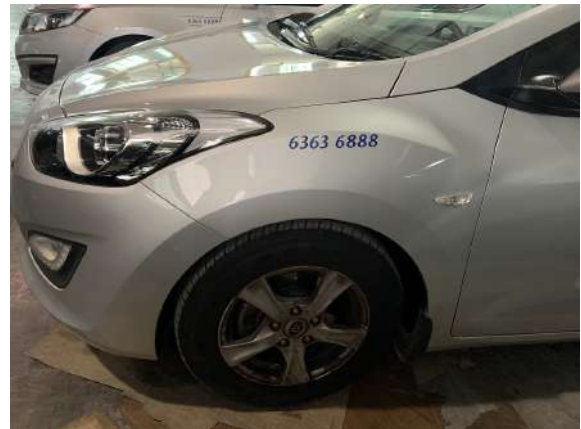
RE-INSPECTION

PHOTOGRAPHS FOR VEHICLE NO. SHD 1662S
