## LKK Auto Consultants Pte Ltd

Vehicle No. SMK 5791E  
Insured Veh. GBC 7006Z  
Claim No. 20/21/21/VC00/024227  
Policy No. Z/20/VC00/107490  
Accident Date 09/02/2021  
Inspection Date 22/02/2021

## ADJUSTMENT ON REPAIR COST FOR VEHICLE NO. SMK 5791E

### PHOTOGRAPHS FOR VEHICLE NO. SMK 5791E

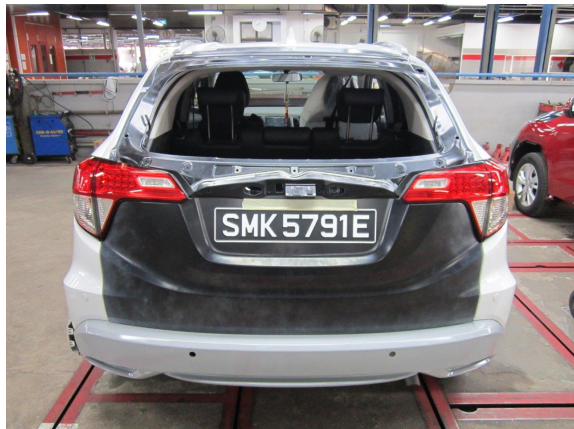
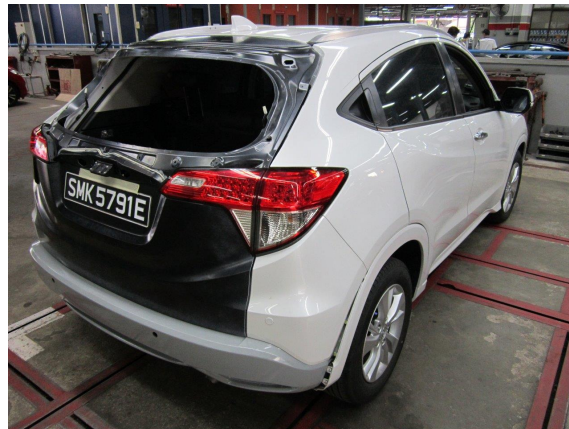
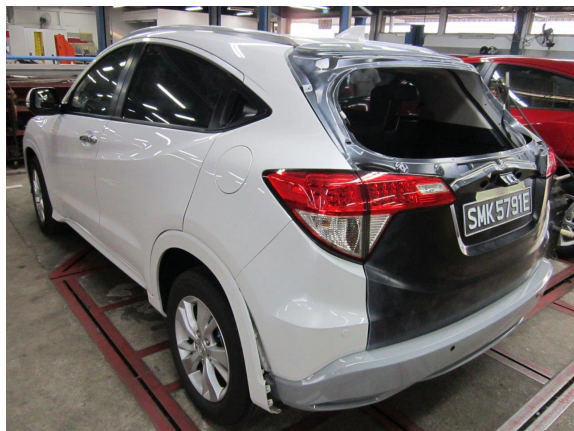
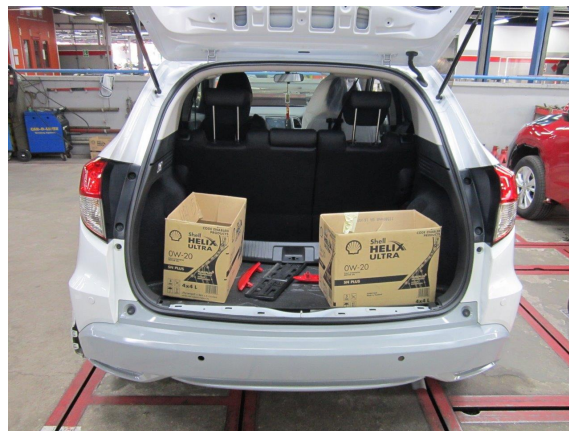
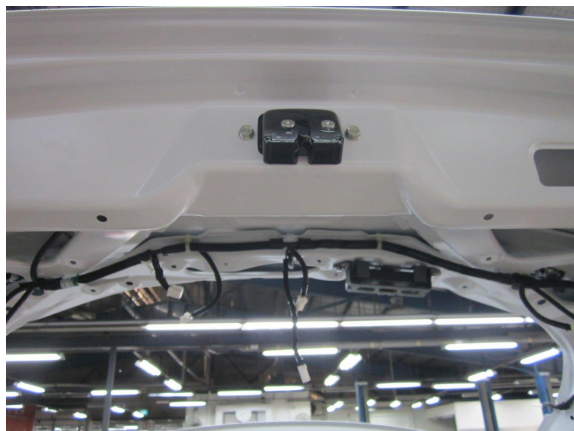
### RE-INSPECTION

| Affiliated to Federation Internationale Des Experts En Automobile | | | | |
|---|---|---|---|--|
| THE VEHICLE SUSTAINED DAMAGES AT THE REAR PORTION.<br>DAMAGES SEE DETAILS. | | | | |

### PHOTOGRAPHS FOR VEHICLE NO. SMK 5791E
