Vehicle No.	SJJ 4828G
Insured Veh.	SMY 1531S
Claim No.	SNM21D201048/LKKDS
Policy No.	DMPCSNW00038542100
Accident Date	23/02/2021
Inspection Date	24/02/2021

ADJUSTMENT ON REPAIR COST FOR VEHICLE NO. SJJ 4828G

PHOTOGRAPHS FOR VEHICLE NO. SJJ 4828G

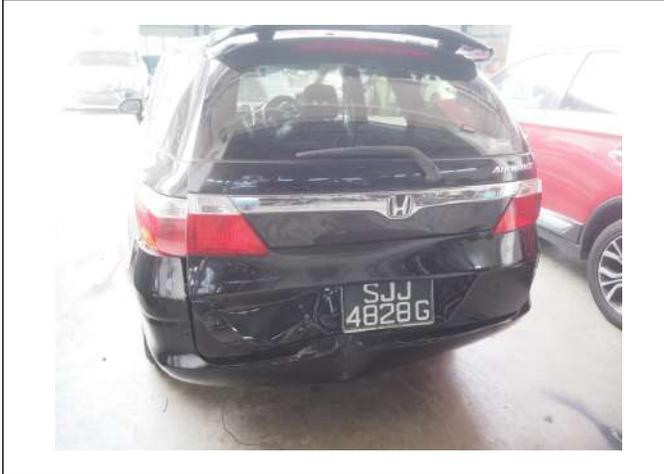
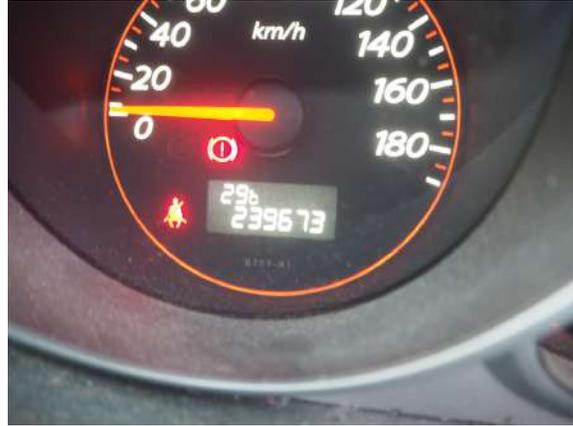
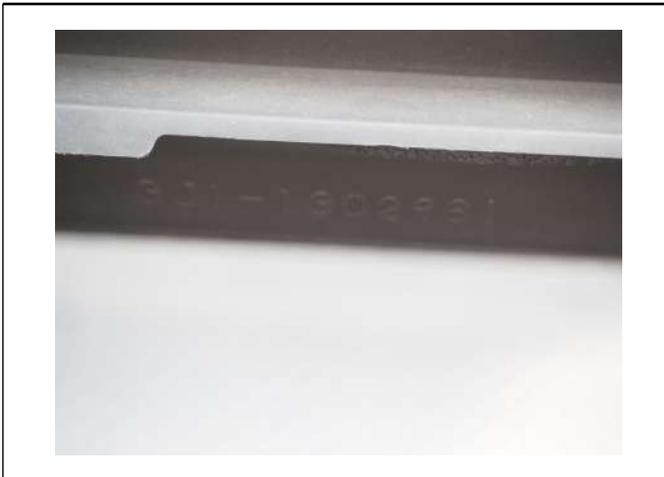
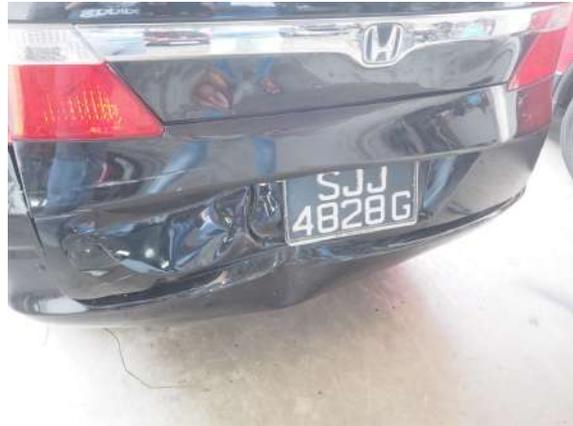
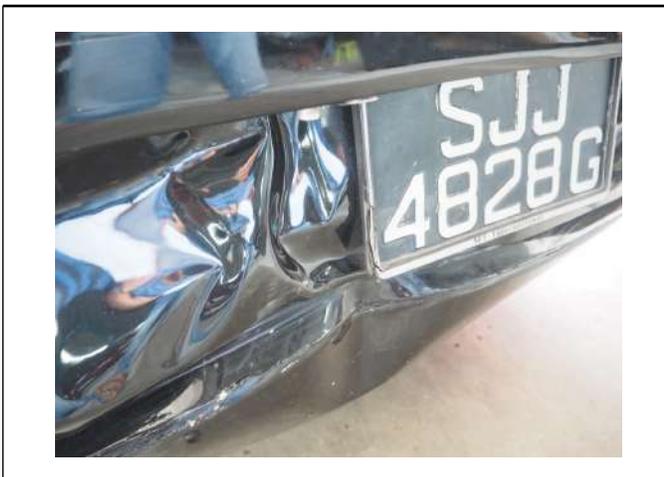
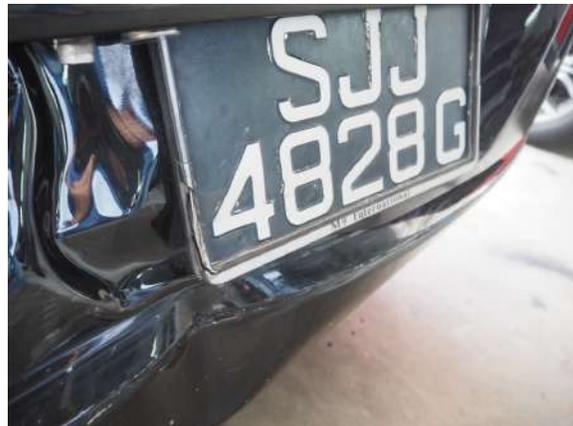
4. Description of Damages			
	THE VEHICLE SUSTAINED DAMAGES AT THE REAR PORTION. DAMAGES SEE DETAILS.		
5. General Information			
Accident Date	23/02/2021	Inspection Date	24/02/2021
Survey held at	ISHARE AUTO PTE. LTD. 8 KAKI BUKIT AVENUE 4, #08-09, PREMIER @ KAKI BUKIT, SINGAPORE 415875		
5a. Remarks			
	A)THE INSPECTION WAS CONDUCTED ON A"WITHOUT PREJUDICE" BASIS. B)IN ACCORDANCE TO YOUR INSTRUCTIONS, WE HAVE NOT AUTHORISED REPAIRS.		
5b. Estimate Days of Repair			
	ESTIMATED NORMAL PERIOD FOR REPAIR:		9 Working Days

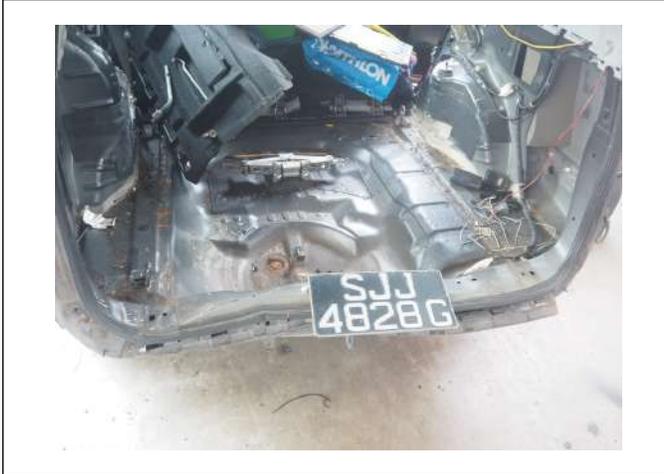
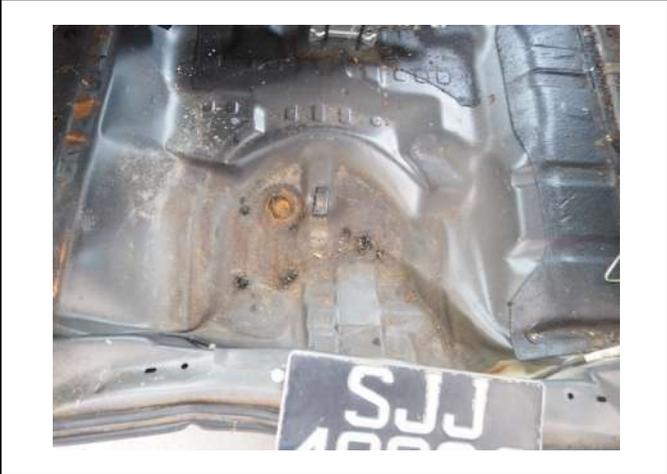
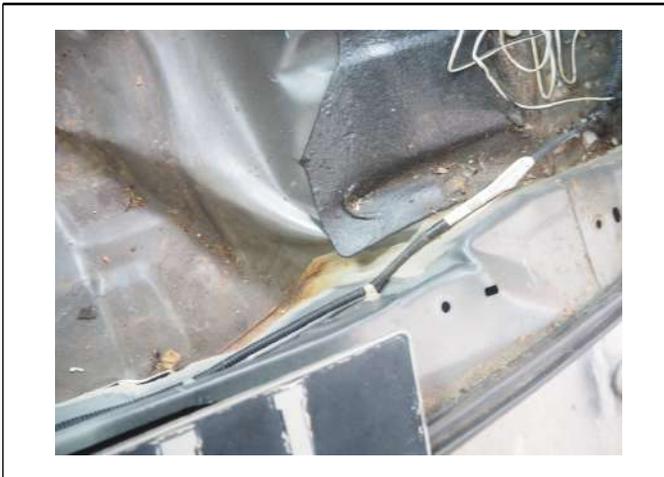
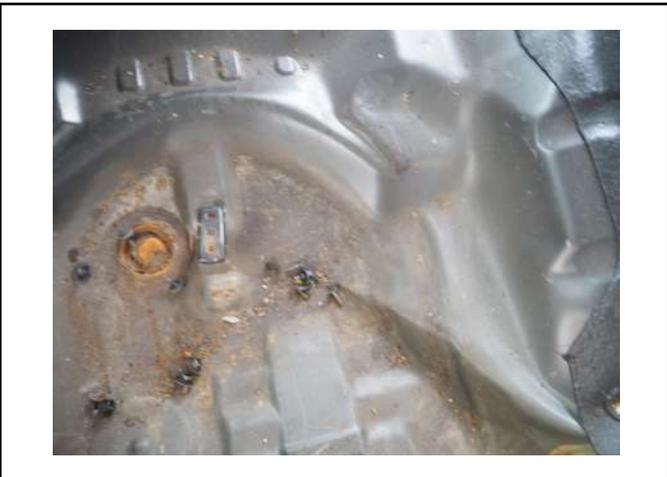
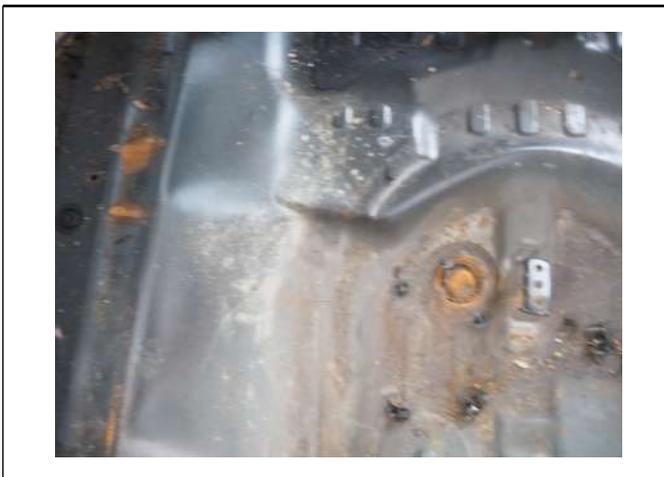
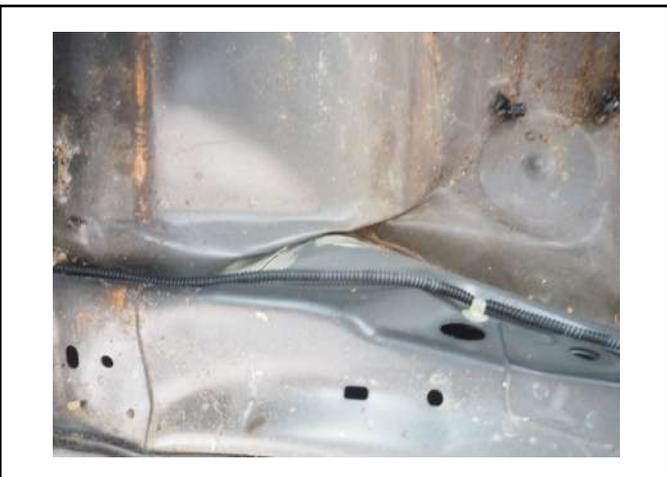
PHOTOGRAPHS FOR VEHICLE NO. SJJ 4828G

RE-INSPECTION
